UNITED STATES COAST GUARD

FORMAL INVESTIGATION INTO THE CIRCUMSTANCES
SURROUNDING THE ALLISION OF THE
T/V EAGLE OTOME
WITH THE
M/V GULL ARROW
AND SUBSEQUENT COLLISION WITH THE
T/B KIRBY 30406
PUSHED BY
UTV DIXIE VENGEANCE
AND OIL SPILL IN THE SABINE-NECHES WATERWAY ON
JANUARY 23, 2010.

**ALLISION OF THE T/V EAGLE OTOME WITH THE M/V GULL ARROW AND
SUBSEQUENT COLLISION WITH T/B KIRBY 30406, PUSHED BY THE UTV DIXIE
VENGEANCE, AND OIL SPILL IN THE SABINE-NECHES WATERWAY ON
JANUARY 23, 2010**

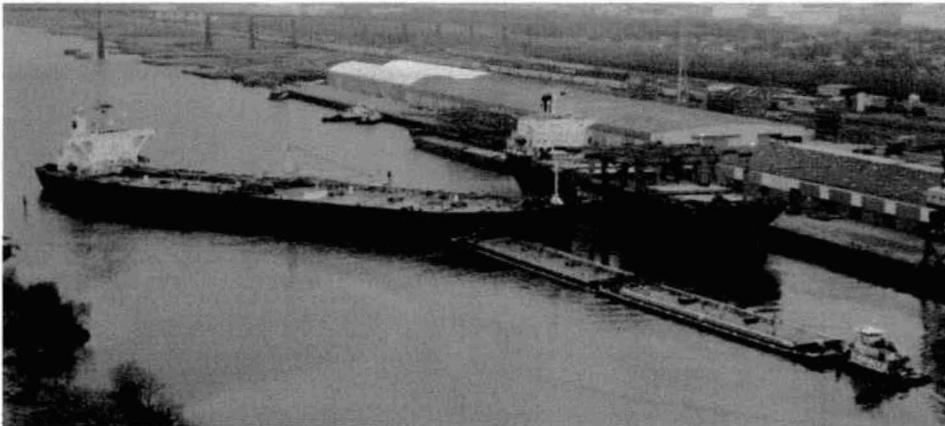
Figure 1: EAGLE OTOME with KIRBY 30406 in the starboard bow.

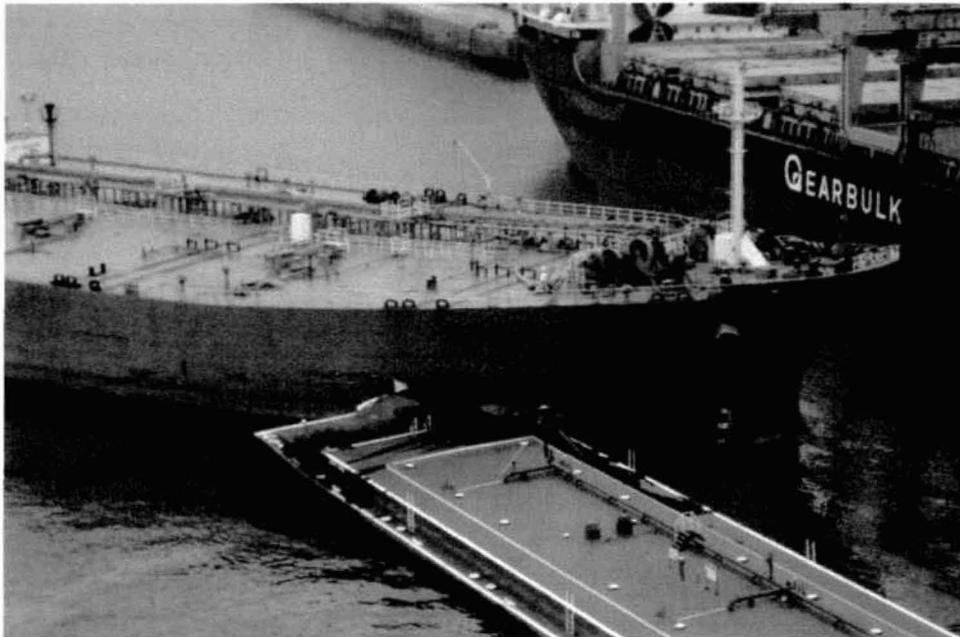
Figure 2: Closer view of post collision positions of EAGLE OTOME, KIRBY 30406 and GULL ARROW. Also visible is the damage to the GULL ARROW on the hull at the juncture of the deck with the house (white superstructure).

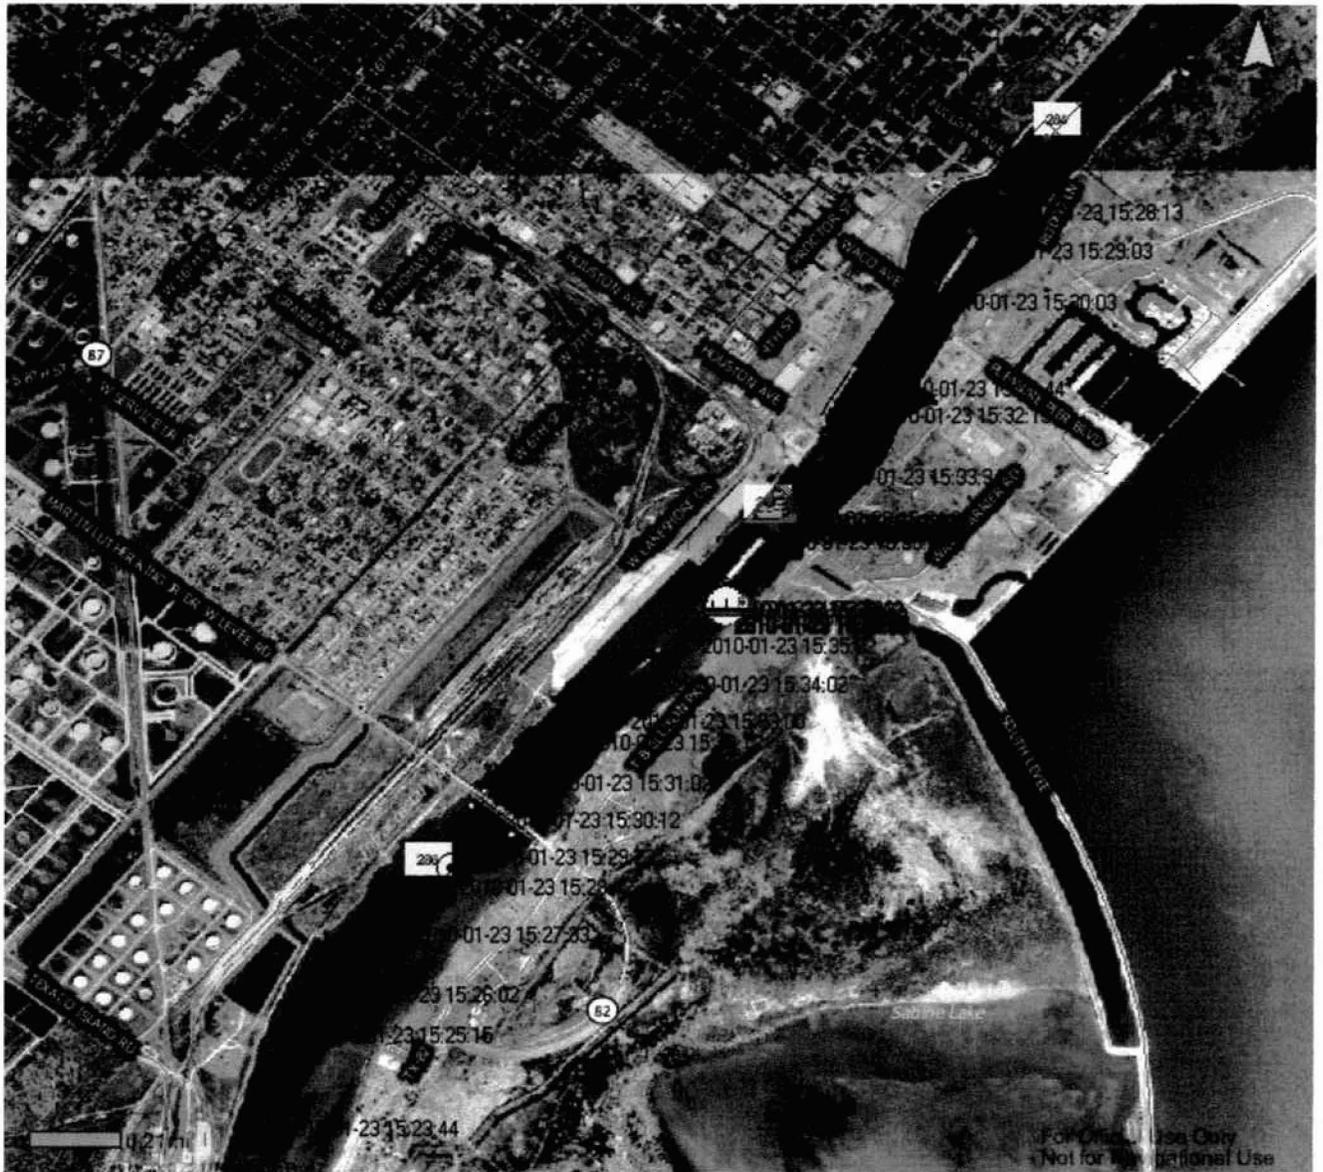
Figure 7: AIS tracks for EAGLE OTOME and DIXIE VENGEANCE plotted on a satellite image of the Sabine-Neches Waterway beginning at the time of the passing agreement.

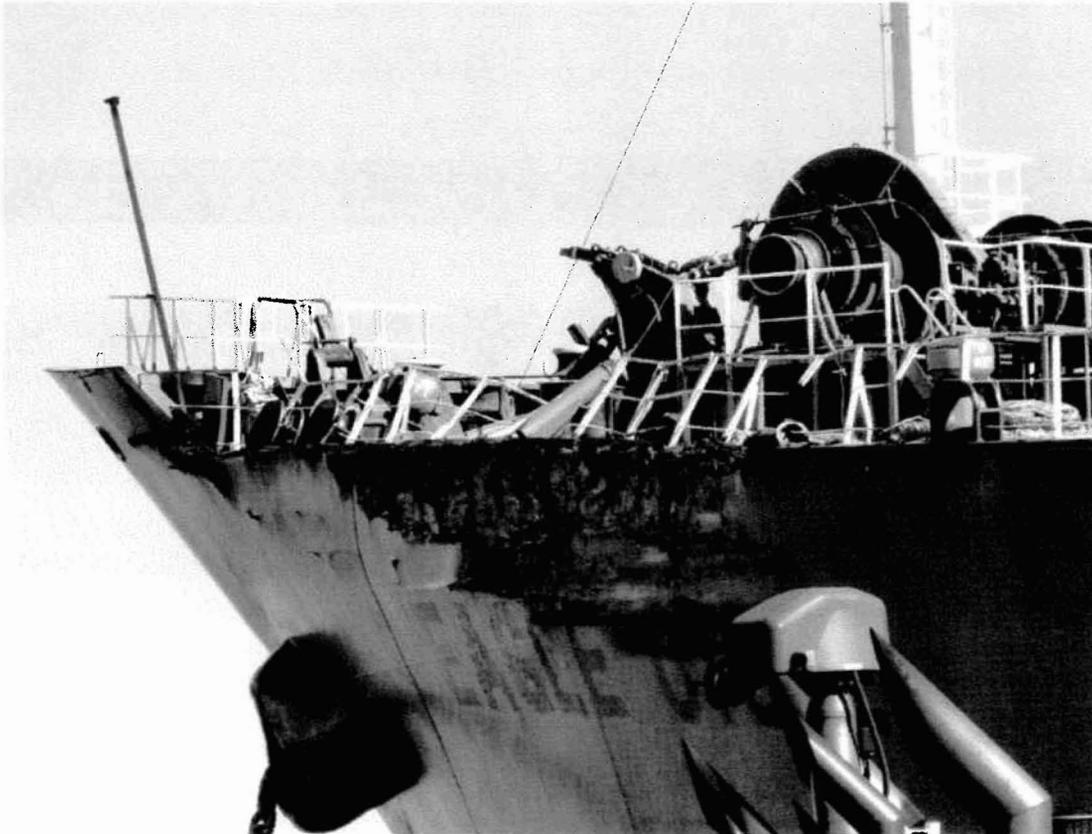
48. Damage to the EAGLE OTOME included port side shell and upper deck plating in the way of the No. 1 Port Ballast Tank were set in. The deck plating cracked and separated from the sideshell and the stanchions in the area were bent and broken. On the starboard side, the side shell plating at the loaded waterline in the way of the No. 1 Starboard Ballast Tank was punctured between frames 90 and 95. Damage extended to the internals and the No. 1 Center Cargo Tank was punctured. The vessel made contact with the bottom of the channel at the stern. It is uncertain if dry dock repairs to shell plating on the starboard side at the stern are related to the grounding or not.

Figure 8: Damage to EAGLE OTOME port side bow.

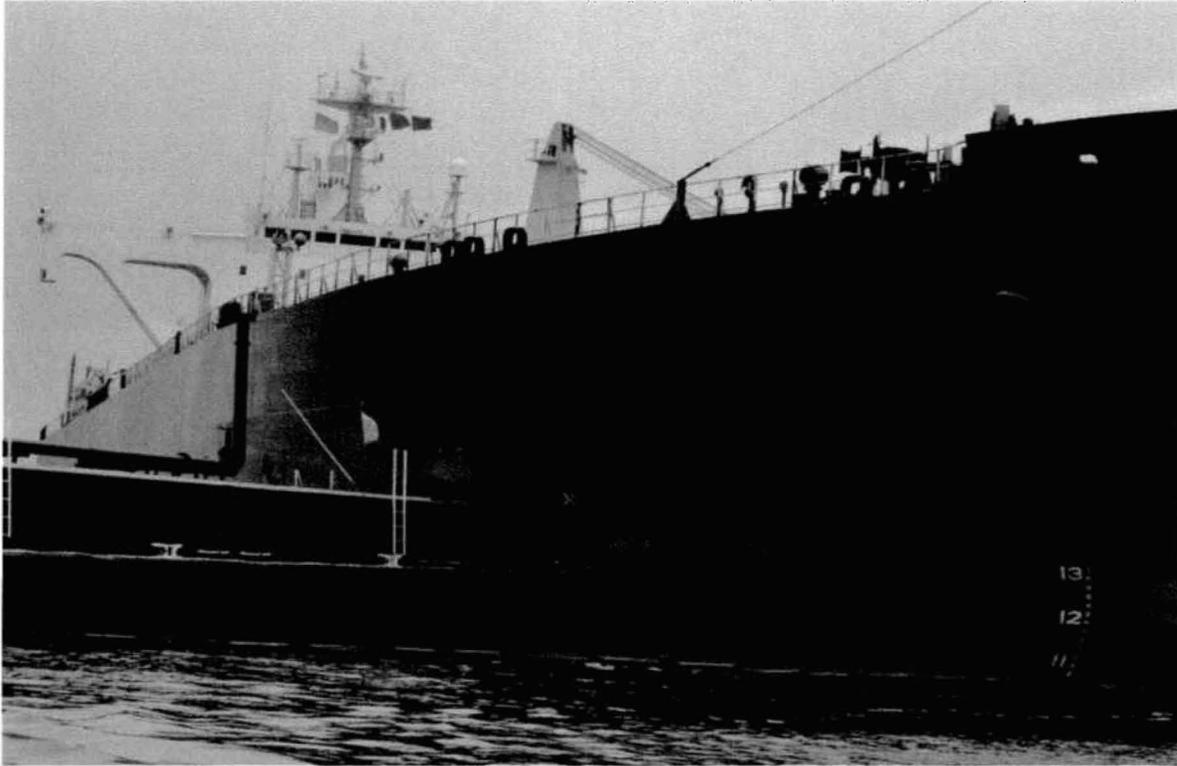
Figure 9: Damage to starboard bow of EAGLE OTOME in No. 1 Starboard Ballast Water Tank and No. 1 Center Cargo Tank.

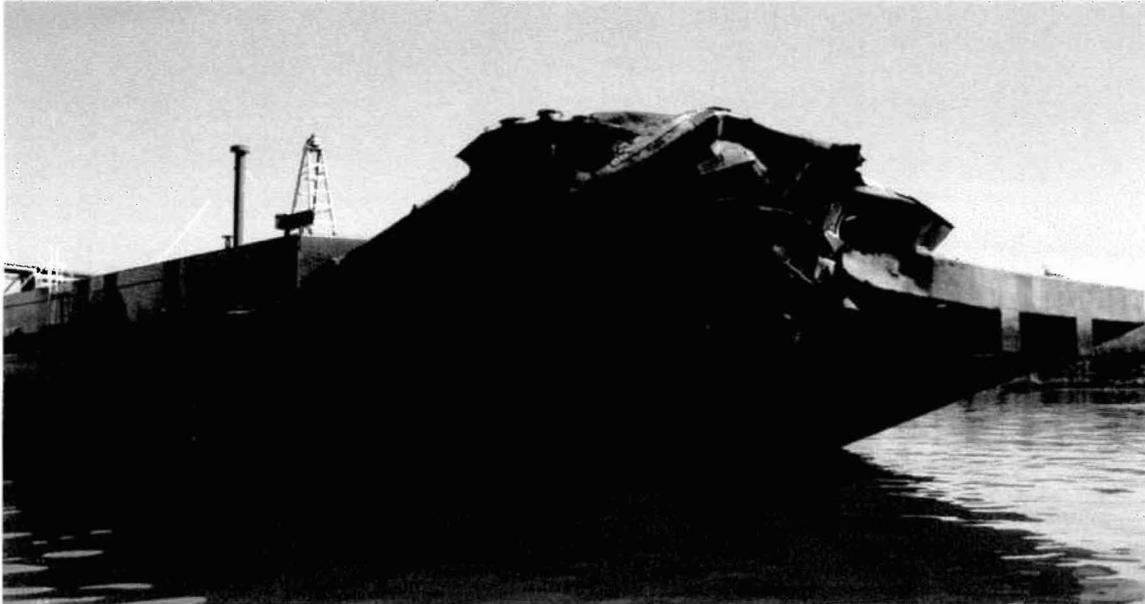
49. Damage to the KIRBY 30406 included damage to the forward rake, including replacing or rebuilding 30 feet by 10 feet of the barge on the starboard side, replacing the barge push knees and the following internals: 18 longitudinals, 18 deck longitudinal stiffener plates and 16 vertical stiffener plates.

Figure 10: Bow damage to KIRBY 30406

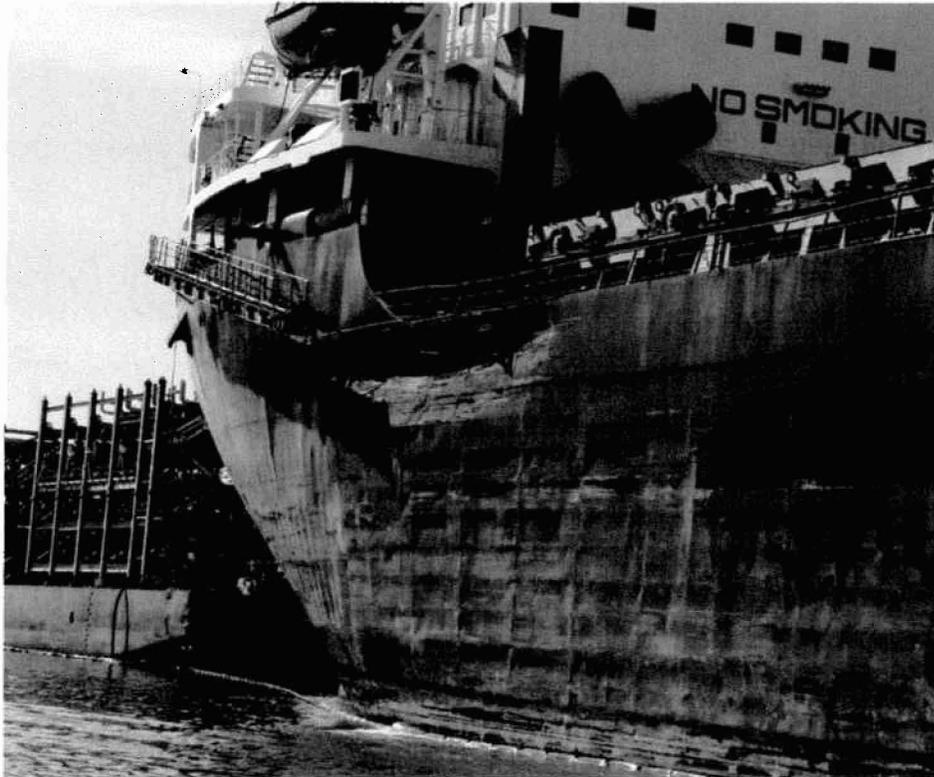
50. Damage to the GULL ARROW included indentation from frames 29 through 55 around the first longitudinal stiffener below the main deck. The ship's hull was ruptured from frame 32 through 53. Systems affected included piping for ship's service air, lube oil, and sewage. The ship's accommodation ladder (deployed on the port side during the incident) was also damaged. Also on the port side, shell plating and buckling of eight frames in way of No. 2 Port and No. 3 Port ballast tanks. Buckling was also found in #7 Port Fuel Oil settling tank and Sludge Tank #7 Starboard.

Figure 11: Damage to starboard side of GULL ARROW.

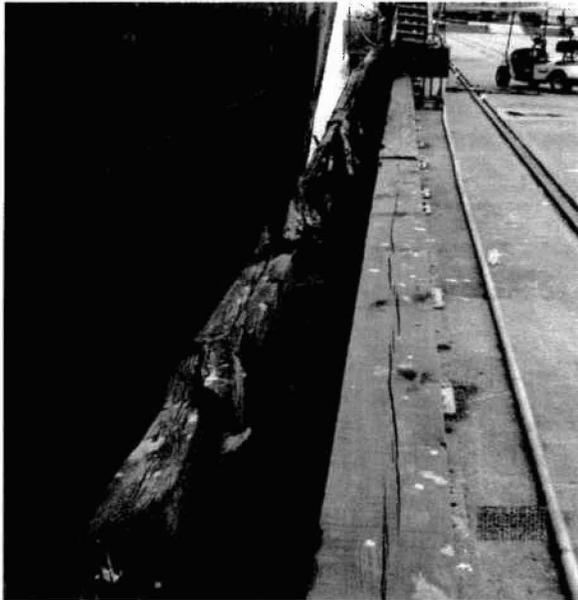
51. Damage to Berth 2 at the Port of Port Arthur included 193 feet of the fendering system set inshore and upstream over the full height of the fendering system. The system is 12 inch by 12 inch treated timbers on 12 inch steel H-beams with rubber fender blocks, galvanized chain and fittings. Damage also included some spalling and fractures in the concrete dock structure over a span of 60 feet.

Figure 12: Damage to Berth 2, Port of Port Arthur
