**THE REPORT OF INVESTIGATION
INTO THE
TANK VESSEL GENESIS RIVER (IMO 9791224)
COLLISION WITH TOWING VESSEL VOYAGER (O.N.
563475) IN THE HOUSTON SHIP CHANNEL ON MAY
10, 2019**

**THE TANK VESSEL GENESIS RIVER COLLISION WITH THE TOWING VESSEL
VOYAGER IN THE HOUSTON SHIP CHANNEL ON MAY 10, 2019**

INVESTIGATING OFFICER'S REPORT

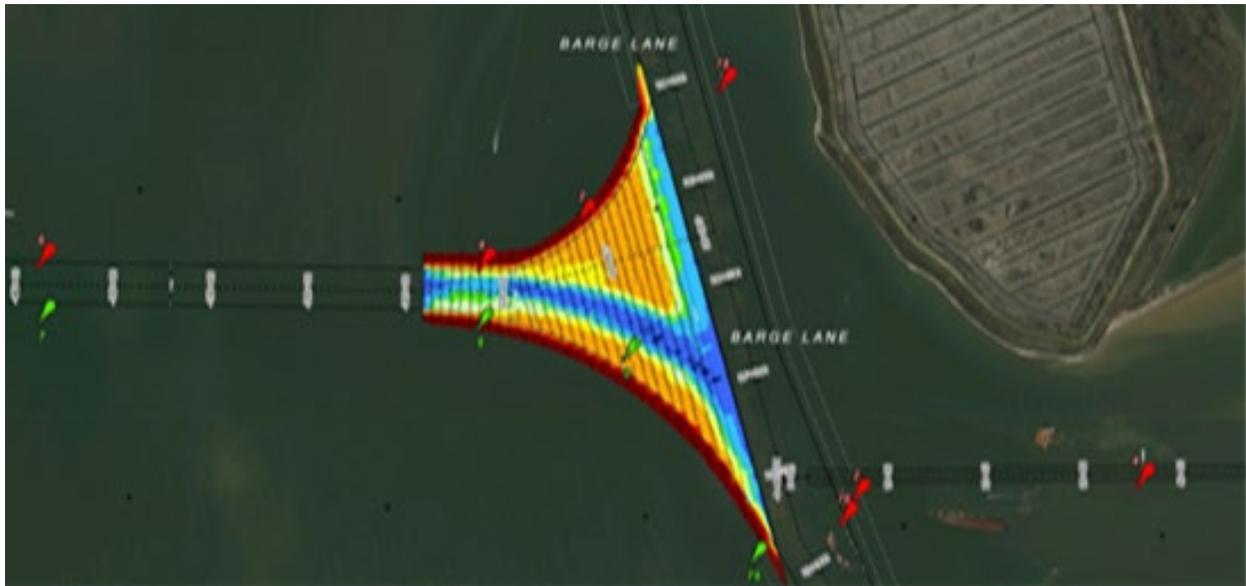
Figure 5. USACE Survey of Bayport Flare. (February 2020/USACE)

4.2.3. In 2018, U.S. Army Corps of Engineers (USACE) initiated a project to ease the slope of the flare to assist vessels entering Bayport Channel. The Bayport Flare was dredged in 2017 after Hurricane Harvey.

5.4.1. *Awareness of Channel Conditions.* The Bayport Flare area was last dredged in 2017 after increased shoaling caused by Hurricane Harvey. However, the opening to the Bayport Flare was modified in 2018 to ease the transition of the entrance to the Bayport Channel so that vessels entering the channel would not be subject to severe turns. The last surveys of the area were conducted in April 2019 and a contract was initiated to conduct dredging of the area in November 2019.²¹

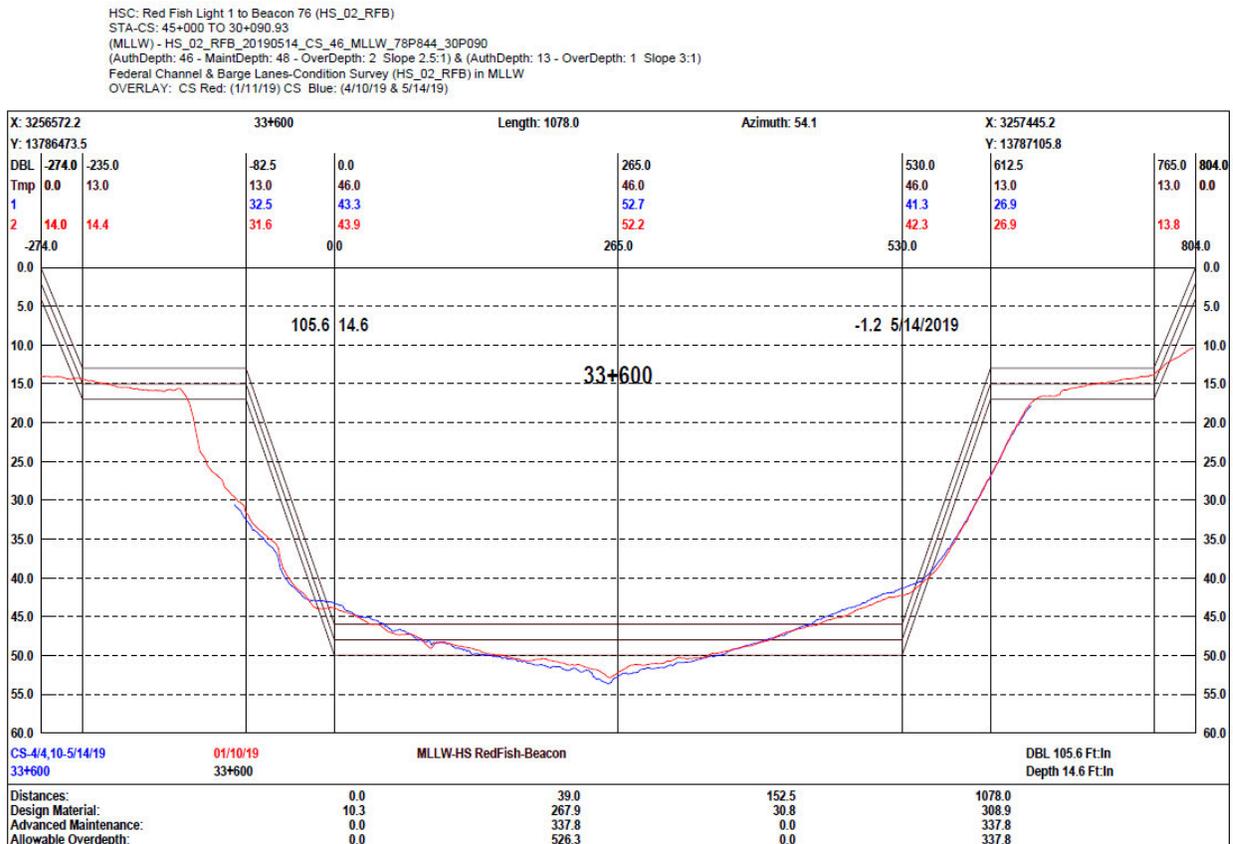
4.2.5. Surveys of the HSC were conducted in January 2019 (annotated by the red line in the *Figure 8*), and included the entire channel depth and the barge lanes. In April of 2019, an additional survey was conducted (annotated by the blue line in *Figure 8*), but did not include a survey of the barge lane. Dredging of the Bayport Flare was scheduled for November 2019.

Figure 8. USACE Houston Ship Channel survey results. Cross section 33+600 correlates to Light No. 74. The left side of the diagram is the “green buoy” side of the channel. The GENESIS RIVER was travelling outbound on the “green” side of the channel. The right side of the diagram is the “red” side of the channel. The VOYAGER was travelling inbound on the “red” side of the channel.

4.2.5.1. The January 2019 survey showed that near HSC MM 18.8, at Light No. 74, the outside half of the barge lane on the “green” side of the channel was 14.4 feet deep and the outside half of the barge lane on the “red” side was 13.8 feet deep. This area was not surveyed after the incident occurred.

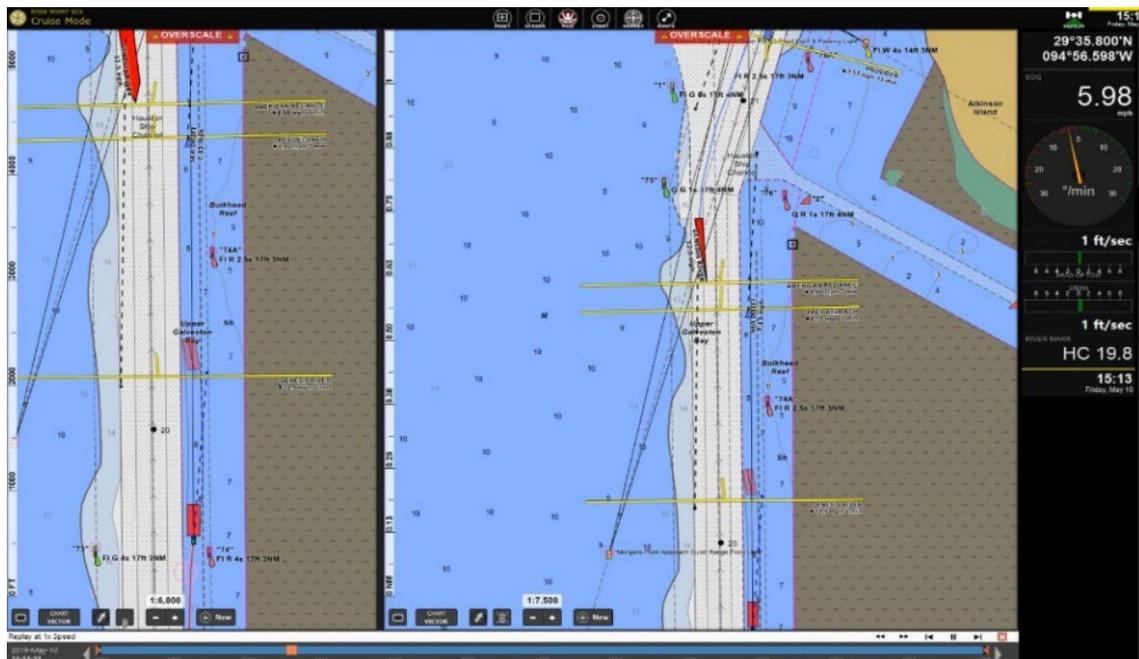
There is no indication in VOYAGER’s Rose Point data to suggest any slowing of speed. The first major change of speed came when after directed by Pilot 2, the VOYAGER turned to port. There was no other suggestion that the VOYAGER’s Mate considered any other option. There wasn’t any slowdown of the vessel, any contact with the PROVIDER behind the VOYAGER, no alarm to the crew, nothing to show any options beyond what later, was directed by Pilot 2. This action reduced the tow’s speed from approximately 6 mph to 4 mph. The VOYAGER’s Mate also stated that it would take two tow lengths for the VOYAGER to come to a crash stop.²⁰ But when the GENESIS RIVER was swinging starboard, the VOYAGER did not make any attempts to avoid collision at this juncture but continued to maintain speed, as per the last direction of Pilot 2 to “go VOYAGER go. Go go

go”. The VOYAGER’s Mate abdicated control of his situation to Pilot 2.

Figure 9. VOYAGER Rose Point screenshot just prior to making a turn for the green side. Note the lack of reduction in speed. GENESIS RIVER was continually swinging to the red side. VOYAGER speed will reduce by 1/3 as the tow turns to port. Distance between vessels is a little over ½ mile.
