REPORT OF INVESTIGATION INTO THE TOWING VESSEL KRISTIN ALEXIS (O.N. 596468) AND CRANE BARGE MR ERVIN (O.N. 1282567) Allision with the Sunshine Bridge Involving an Overhead Strike ON October 12, 2018

THE ALLISION OF THE UNINSPECTED TOWING VESSEL KRISTIN ALEXIS' TOW, THE CRANE BARGE MR ERVIN, WITH THE SUNSHINE BRIDGE ON THE LOWER MISSISSIPPI RIVER NEAR DONALDSONVILLE, LA ON OCTOBER 11, 2018

TOWING VESSEL KRISTIN ALEXIS (O.N. 596468) AND CRANE BARGE MR ERVIN (O.N. 1282567) ALLISION WITH THE SUNSHINE BRIDGE INVOLVING AN OVERHEAD STRIKE

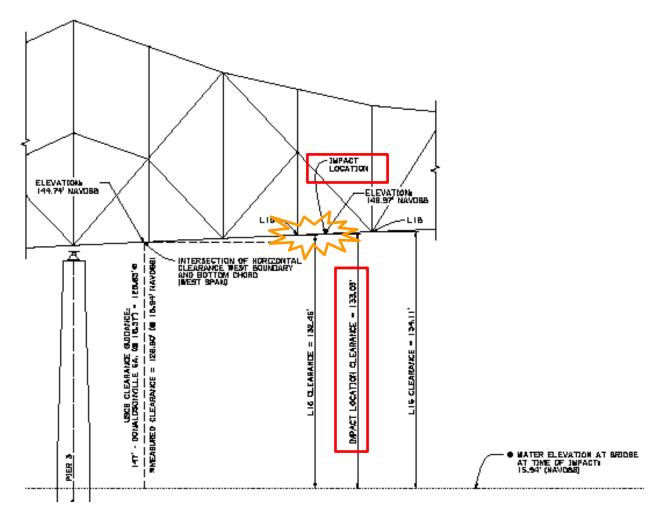
5.1.1. <u>Initiating Event – Allision with Sunshine Bridge</u>. The initiating event of this incident occurred when the upper portions of steel structure of the MR ERVIN crane barge, being pushed by the KRISTIN ALEXIS, struck the Sunshine Bridge's structural members on the underneath side (resulting in an overhead strike or allision) of the alternate span. As a result, the crane became lodged underneath the bridge until it was safely ballasted down and removed the following morning. Below, Figure 13 depicts the bridge piling on the immediate West side of the alternate span along with the western portion of the 725' wide horizontal clearance charted on the USACE map. It also shows the point of impact right next to chord #15. Measurements show that at the time of the accident, there was 128 feet of vertical clearance at the lowest steel portion of that span, and that there was 133.03 feet of vertical clearance available at the point of impact.

Figure 13. A plan drawing of the Sunshine Bridge, showing the point of impact for the allision. It also shows the actual vertical clearance of 133.03 feet at the spot on the bridge where impact occurred, provided by LADOTD.

Other measurements taken after the accident by LADOT surveyors (not depicted above) revealed that there was 140 feet of vertical clearance at the center of this alternate West span, meaning they would have safely cleared the bridge if they were at the center of the alternate West span. It is very interesting to note that the NOAA Chart listed the vertical clearance as 133 feet, and the actual point of impact was also 133 feet. Even though those numbers were the same, the reference point was different because the impact was far to the West on the alternate span, whereas NOAA's measurement was taken from the 1927 High Water mark of the main channel span.

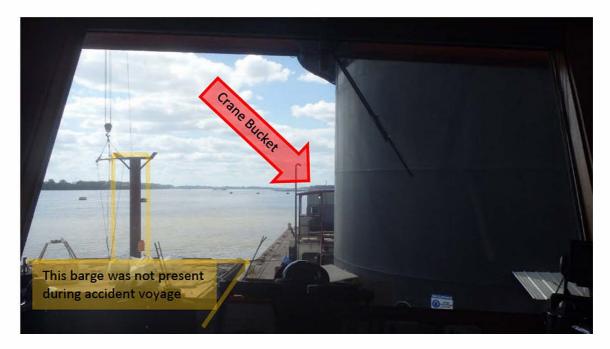
Secondly, **reduced navigation visibility** from the operating station on the KRISTIN ALEXIS' wheelhouse was a significant factor in this accident. That was as a result of the Pilot's visibility being obstructed by the crane's structure; the Pilot opted to navigate the tow as closely as possible to the right descending bank...his left side of the channel. This was done because he knew what he could see on his left, and he just stayed as closely as he safely could to the bank, giving the widest berth possible to the other traffic in the center of the river. The Captain and Pilot both took prudent measures by sending deckhands forward on the barge to serve as lookouts, and making radio broadcasts of their reduced visibility, but other measures should have also been taken in order to compensate for the reduced visibility. Testimony revealed that while pushing the MR ERVIN, the view from the pilot house of the KRISTIN ALEXIS was 100% blocked by the steel structure of the crane on an arc of the horizon from dead ahead to 60 degrees on their starboard (just forward of the starboard beam is where they could see again). This structure also served to nullify and block the usefulness of their RADAR as well.

Figure 14. Image taken from the KRISTIN ALEXIS as it was made up to push the MR ERVIN on the accident voyage, looking out the wheelhouse window from the Captain's Chair observing the view being blocked by the MR ERVIN Crane. Image taking by Coast Guard Investigators.

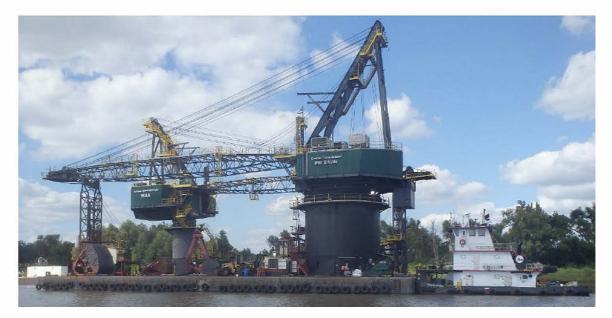
Figure 15. Photograph of the towing vessel KRISTIN ALEXIS as it was made up to the MR EVIN, with crane buckets still present. Note the crane barge HULK also in the background, Image taken by Coast Guard Investigators.

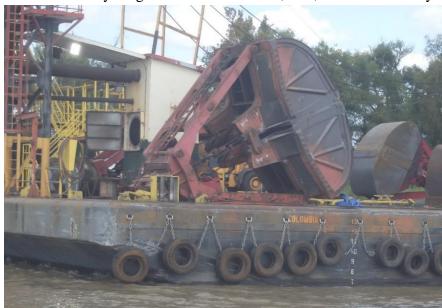
The third contributing factor was extra **crane equipment on deck that further decreased the field of view from the operating station**. The MR ERVIN had three spare buckets stowed on deck during transit and when not in use. On the night of the accident, there was a large 55-yard capacity bucket standing 17' 6" in height on the forward port side of the deck of MR ERVIN. That height, plus the freeboard forward which was roughly 7' 6", gives approximately 25' in height of obstruction. The height of eye of the wheelhouse on the KRISTIN ALEXIS was approximately 26' 4". This means that the operators of the towing vessel were roughly 16 inches in height of eye above the grab bucket. Calculations performed based upon known measurements taken after the accident, revealed that the Captain and Pilot could see the horizon in front of them. However everything closer than .75 miles, or 3,800²¹ feet directly in front of them where

the bucket was, created a blind spot where they couldn't see. This obstructed view created by the bucket further exacerbated their restricted visibility and compounded the difficulty in safely navigating and may have further influenced the Pilot's reasoning and decision making that took place.

Figure 16. Photograph of the crane bucket on the forward portion of the deck of the MR ERVIN following the accident. Image taken by Coast Guard Investigators.

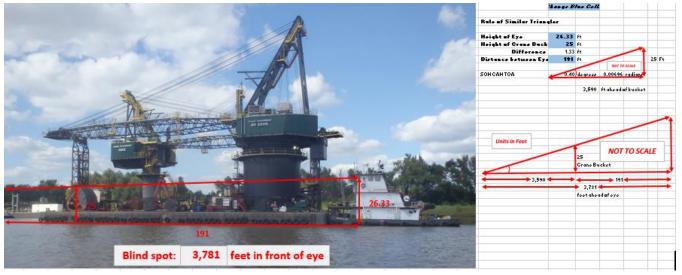
Figure 17. Photograph depicts the height of eye of an operator of the KRISTIN ALEXIS and shows how far the blind spot would be in front of the crane bucket. Image taken and calculations performed by U.S. Coast Guard

²¹ These calculations are very rough numbers. The results of the distance of blind sector changes drastically, in excess of 1,000s of feet of distance further when adjusting the height of eye by even a few inches. The Pilot was at least 6 inches shorter than the Captain, which would increase his blind spot by over 2,000 feet.

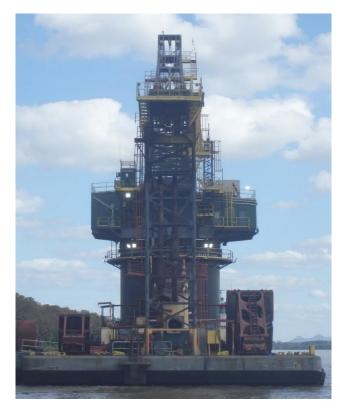
The KRISTIN ALEXIS was moored up to the port side on the stern in order to see around the crane; this positioning put them directly in line with the spare bucket in question. The width of the bucket was no more than 3-5 degrees over the arc of the horizon, and on its own wasn't that much of a concern, but when compounding that obstruction with an already existing 60 degree arc of visibility being obstructed, this became a big issue for the Captain and took him out of the zone of what he was comfortable with. This obstruction increased their amount of reduced visibility and made the transit more difficult. As such, the Captain requested to have the bucket removed, but that request was never acted upon.

Figure 18. Photograph of the MR ERVIN taken from the water, looking at the forward end of the crane with the towing vessel KRISTIN ALEXIS barely visible in between the crane bucket and crane. Image taken by Coast Guard Investigators.

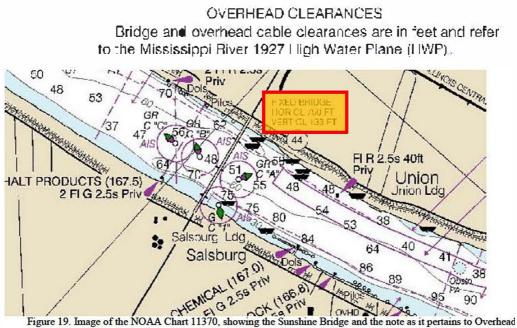
The two U.S. Government mapping agencies, NOAA and USACE, both produce charts (NOAA's nautical chart and ENC, and USACE's river map book) for this area and both include the Sunshine Bridge. A side-by-side comparison will show any novice user different and confusing bridge vertical clearance information. The difference between the two charts is that the NOAA chart only gives you the vertical clearance (133 FT), and additional information that overhead clearances were derived from the 1927 High Water Plane. No other clarification, detail, or information is provided on how that number is derived, nor how one would calculate to find out what the real-time vertical clearance is when factoring in river stage. There is, however, a separate special note that sends readers to Coast Pilot 5 for supplemental information, but only has very minimal details about the bridge including the width of the channel, and nothing on vertical clearance.

Clearances, provided by NOAA.

In addition to reviewing all of this, I recommend additional information like what is found in Figure 22 be added to the notes section of chart 11370, but also that Coast Pilot V be revised to discuss more of this information in detail. Figure 22 comes from the Sunshine Bridge file. A table similar to this should be added for both the Sunshine Bridge and the Huey P. Long Bridge in New Orleans, LA. Final information from this working group should be used to produce chart updates.

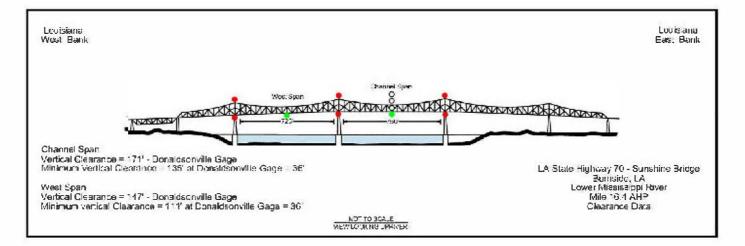
In contrast, the USACE River Map Book gives a profile view of the bridge which shows both the main channel and alternate West span(s), providing vertical and horizontal clearances with both the maximum and minimum air drafts with the source datum at the Donaldsonville gauge, which would allow readers to calculate the real-time bridge clearances.

Figure 20. Image of the Sunshine Bridge profile view as displayed in the USACE River Map Flip Book, provided by USACE.

While the NOAA chart doesn't provide the baseline reference information, if one were to somehow know it was based on the Donaldsonville gauge, and that 36' was the high water mark from 1927, you would still have a **two foot difference in vertical clearance** between the two charts (133' at the highest water level possible on the NOAA chart, and 135' at the highest water level possible on the USACE chart).
