# UNITED STATES COAST GUARD

**REPORT OF INVESTIGATION INTO THE  
CIRCUMSTANCES SURROUNDING THE INCIDENT  
INVOLVING  
CFV MAVERICK / CFV VIKING STORM  
COLLISION/DEATH**

**THE COLLISION BETWEEN COMMERCIAL FISHING VESSELS MAVERICK  
AND VIKING STORM RESULTING IN THE SINKING OF THE MAVERICK  
AND SUBSEQUENT LOSS OF LIFE 30 MILES WEST OF LA PUSH, WA ON  
SEPTEMBER 28, 2012**

COLLISION / DEATH INVOLVING THE U.S. CFV MAVERICK (O.N. 549879)  
AND THE CANADIAN CFV VIKING STORM (O.N. 800025) ON SEPT 28, 2012

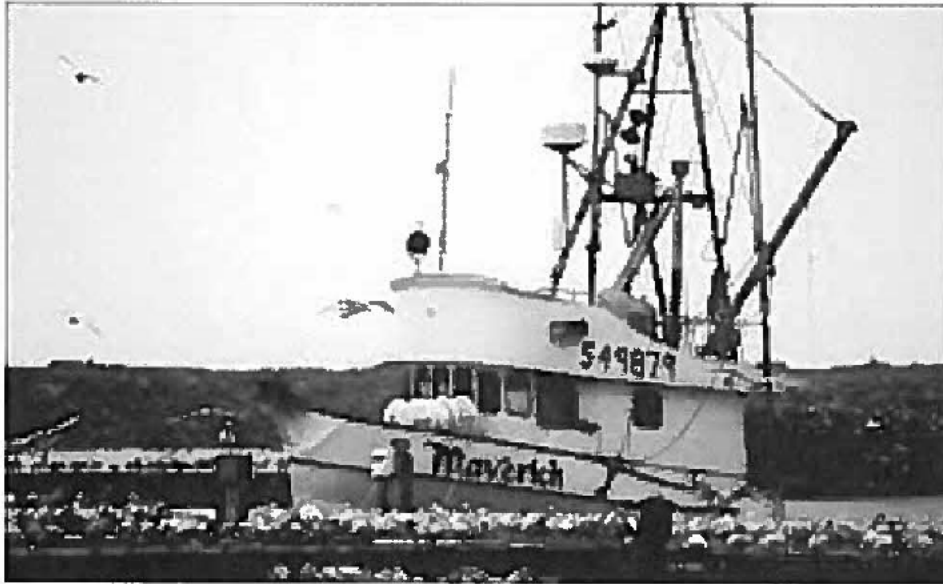
**Photo 1: CFV MAVERICK time and date unknown**

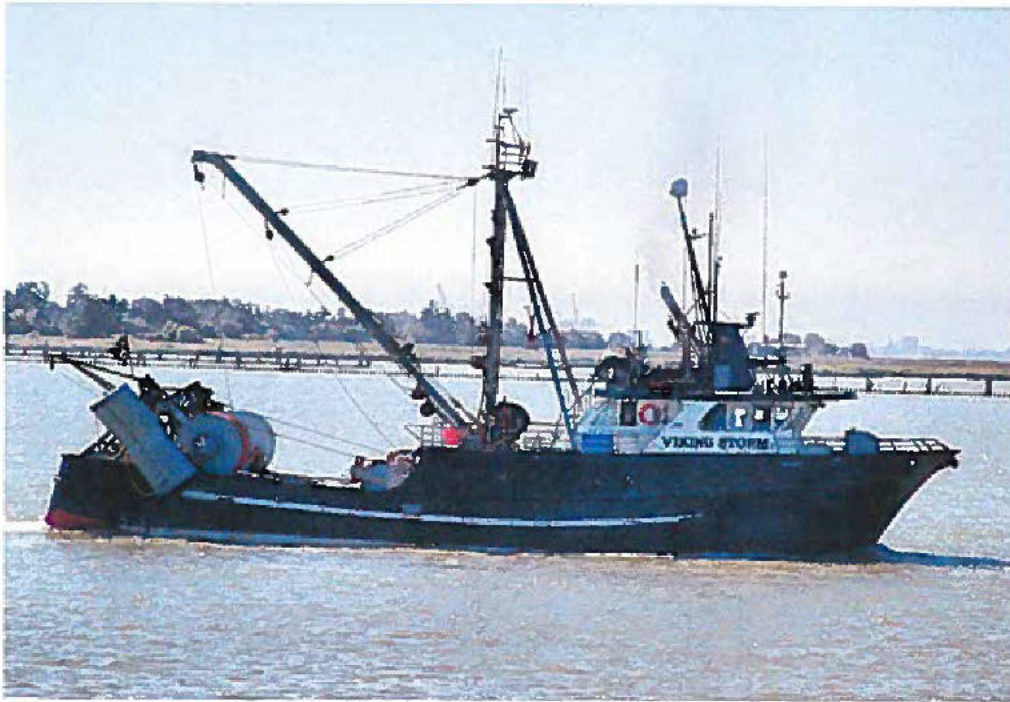
**Photo 2: Canadian CFV VIKING STORM time and date unknown**
