# **UNITED STATES COAST GUARD**

## **Report of Investigation Into the Loss of Life During the Thunder On The Narrows Race Event Near Kent Narrows, MD on June 28, 2015**

**ALLISION OF THE POWER BOAT THIS IS HEAVEN WITH SPECTATOR VESSELS  
DURING THE THUNDER ON THE NARROWS RACE RESULTING IN LOSS OF LIFE  
AND MULTIPLE INJURIES IN PROSPECT BAY NEAR HOG ISLAND, MD  
ON JUNE 28, 2015**

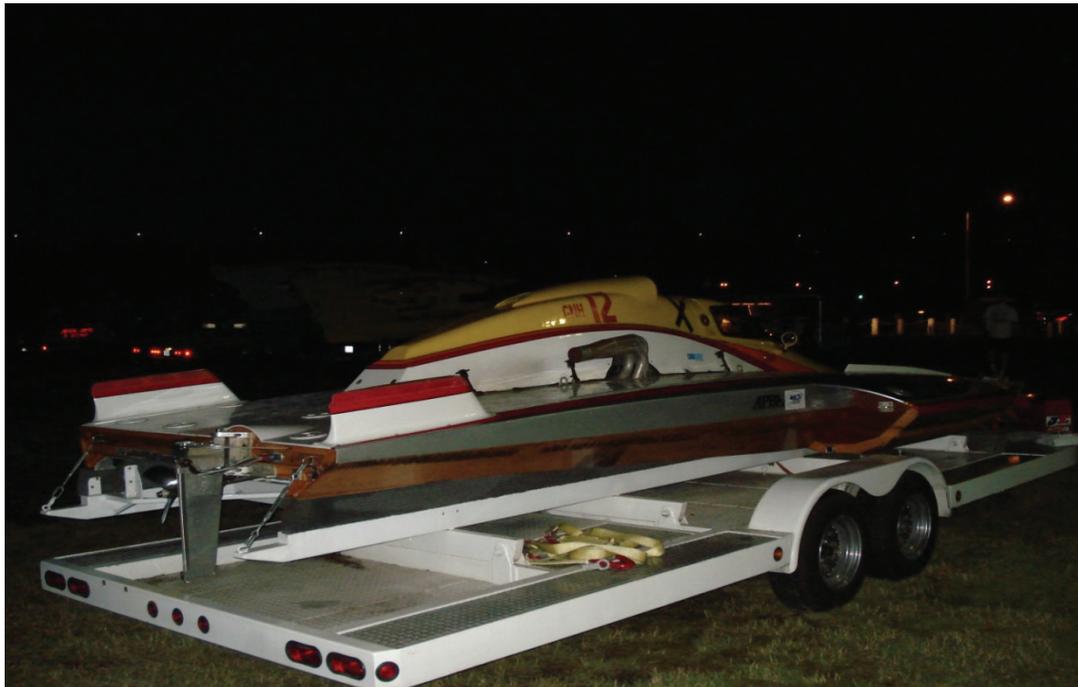
Figure 3.2- Images of starboard quarter of the GNH-12 taken night of casualty on June 28<sup>th</sup> 2015

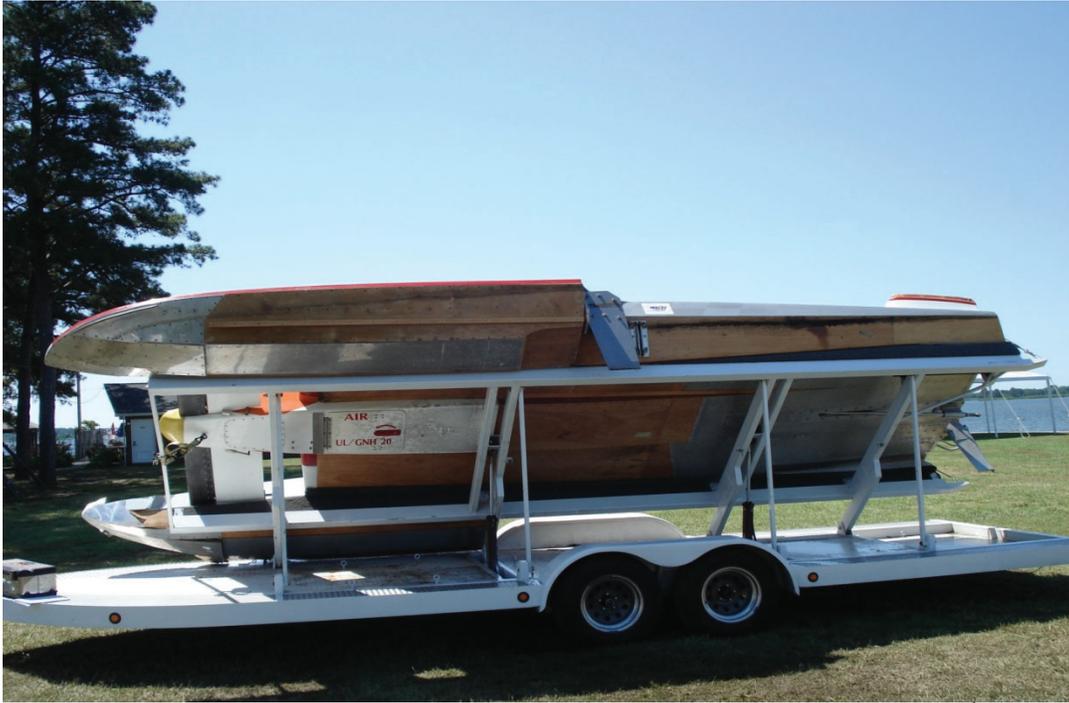
Figure 3.2- Image of the GNH-12's bottom and riveted aluminum areas taken on June 29<sup>th</sup>, 2015

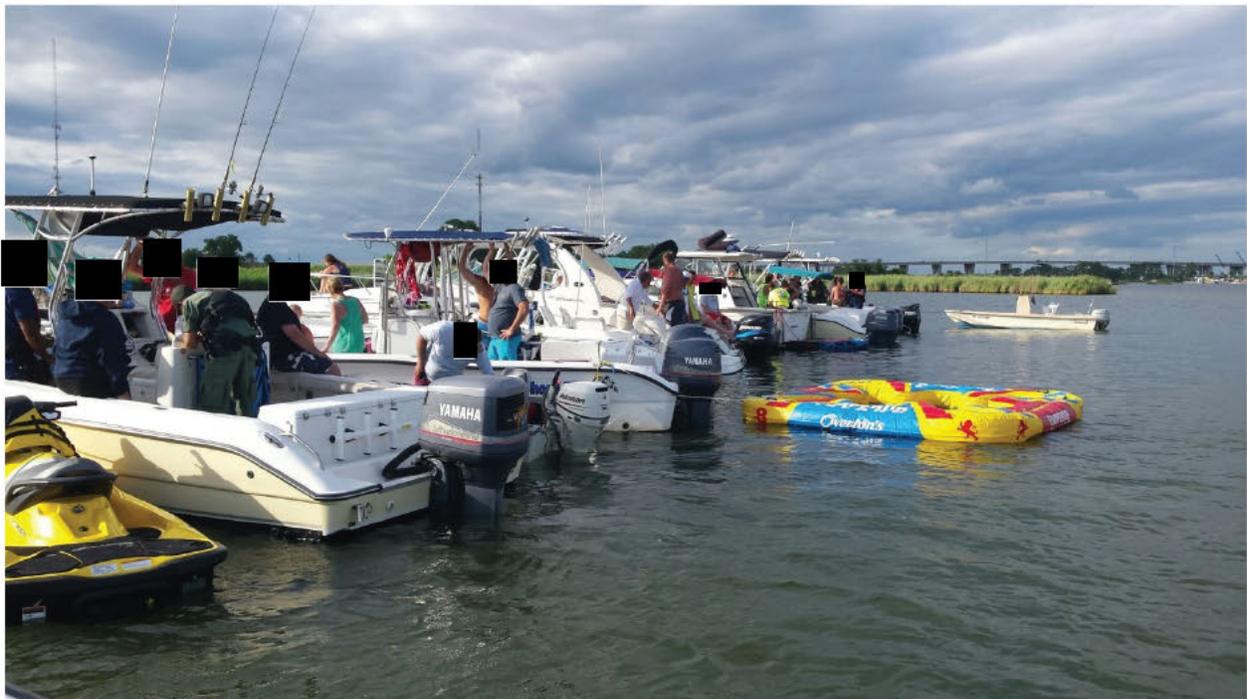
Figure 9 – String of moored and anchored spectators on back stretch that the “SEA MONKEY” was tied off to. Image taken on June 28, 2015 shortly after casualty occurred.

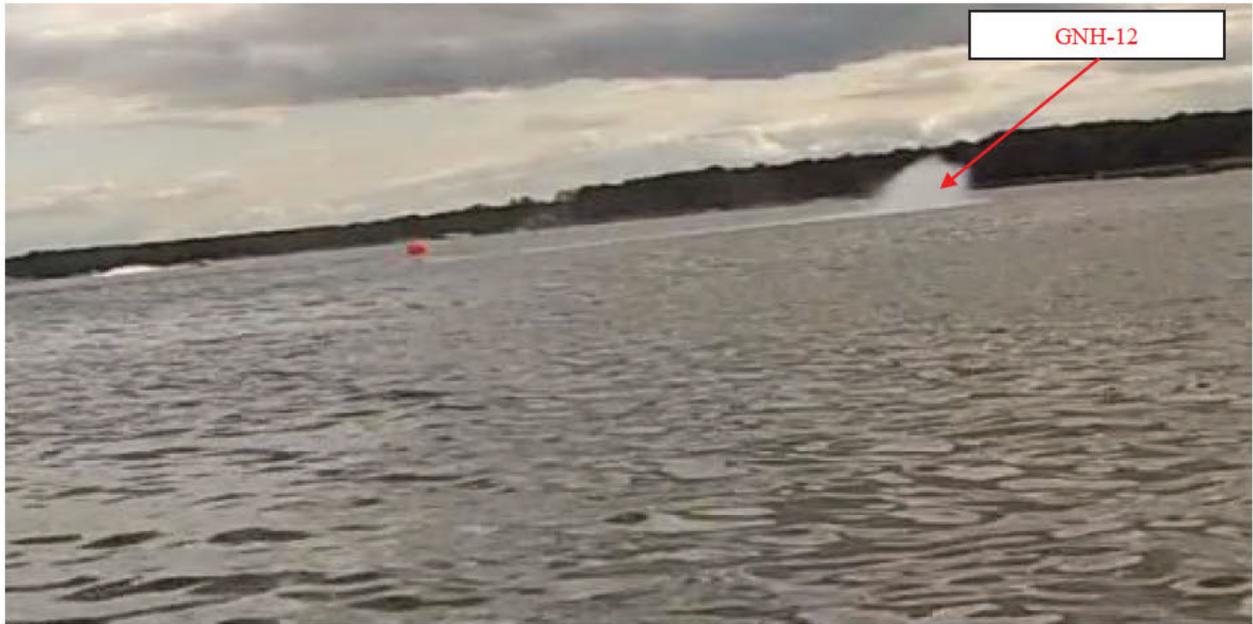
103. On June 28, 2015, at 1643, [REDACTED] [REDACTED] completed his second lap and emerged from the first turn when the GNH-12 began to slow down and come off plane. The five minute “milling period” was nearly completed and the “1 minute gun” was about to start, which was the official countdown to the start to the heat. While using a clock start, drivers attempt to time the final minute of the milling period in order to cross the start-finish line at exactly 0:00 to commence the official start of the race. Crossing the start-finish prior to the official start of the heat will result in a penalty. The GNH-12 was out ahead of the three other participants.

Figure 11.3 - GNH-12 slowing down and coming off plane in anticipation of the official start of the race. Image taken from video footage of the incident.

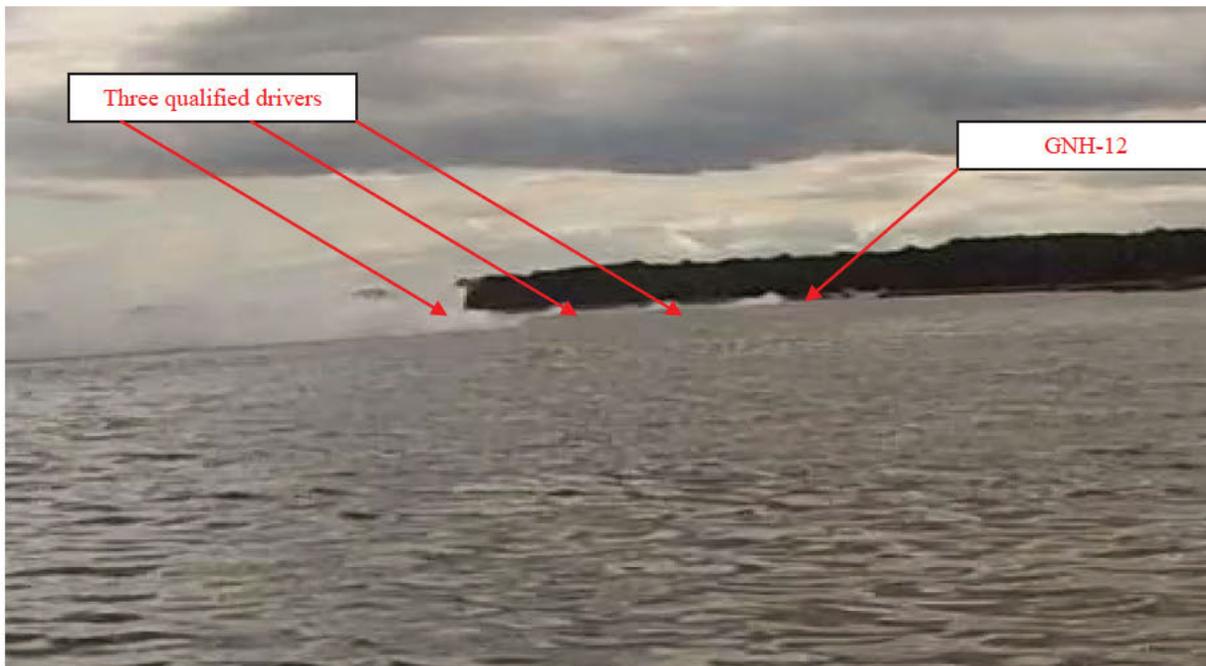
104. On June 28, 2015, at 1644, the GNH-12 began to spray water over the vessel's port sponson onto the windshield of the cockpit's canopy. The water spray obscured the driver's vision. [REDACTED] [REDACTED] observed the other participants approaching his stern through the vessel's side mirror. Their vessels were jockeying for position in anticipation of the official start of the heat. As an Unqualified Rookie, [REDACTED] attempted to stay clear of the qualified race participants veering right and headed in the direction of the string of spectator vessels.

Figure 11.4 - GNH-12 veering right to avoid impeding the qualified drivers and in the direction of spectator vessels. Image taken from video footage of the incident

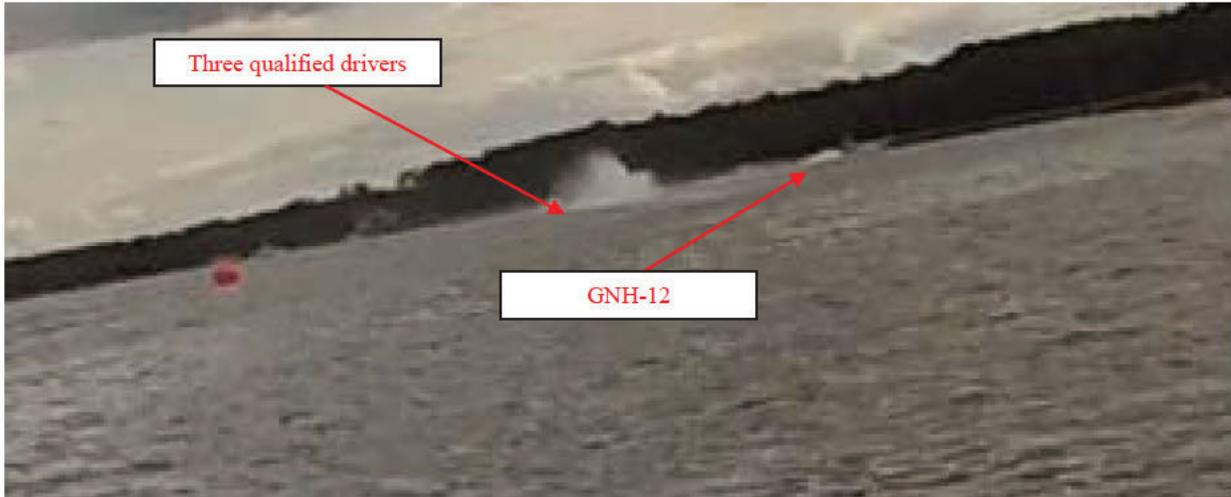
105. On June 28, 2015, at 1649, [REDACTED] [REDACTED] ran into the string of spectators just outside the start of turn two on the vessel's starboard side. The GNH-12 struck the decedent and Mrs. [REDACTED] who were observing the race in a large inflatable raft tied off the stern of the "SEA MONKEY." The GNH-12 additionally struck Mr. [REDACTED] who was in another smaller inflatable raft in the vicinity of the decedent and Mrs. [REDACTED]

Figure 11.5 - GNH-12 seconds before the allision with the MD2223D. Image taken from video footage of the incident

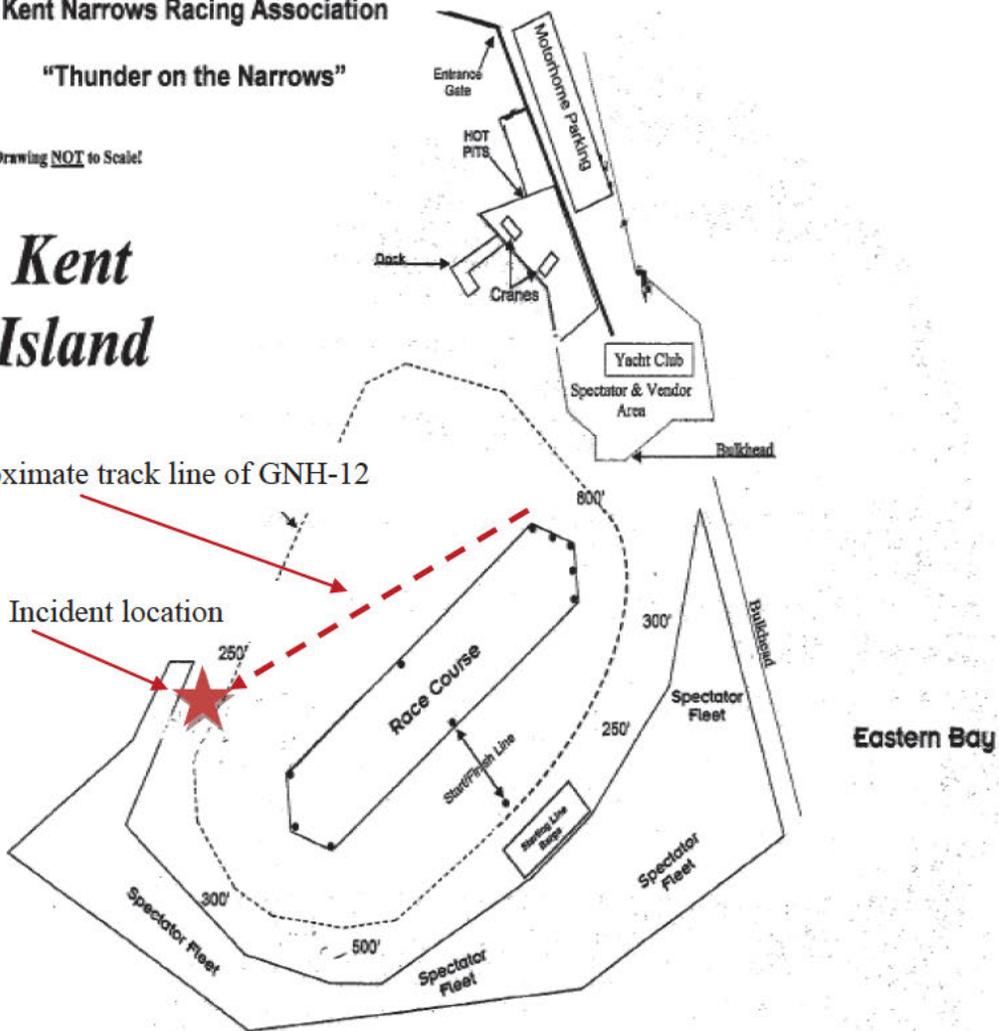
Figure 12 – Image of the approximate track line of the GNH-12 and incident location

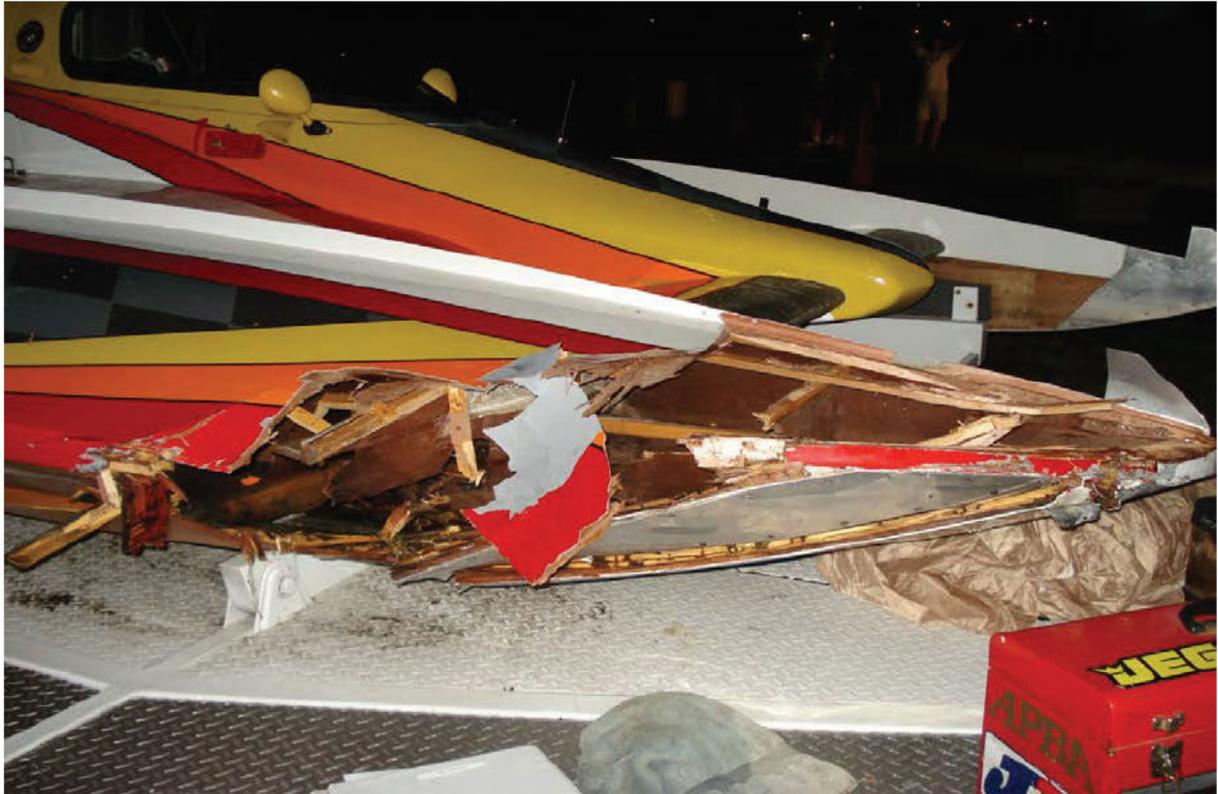
Figure 13.1 - Image of the extent of damage to starboard sponson of the GNH-12 taken the night of casualty.

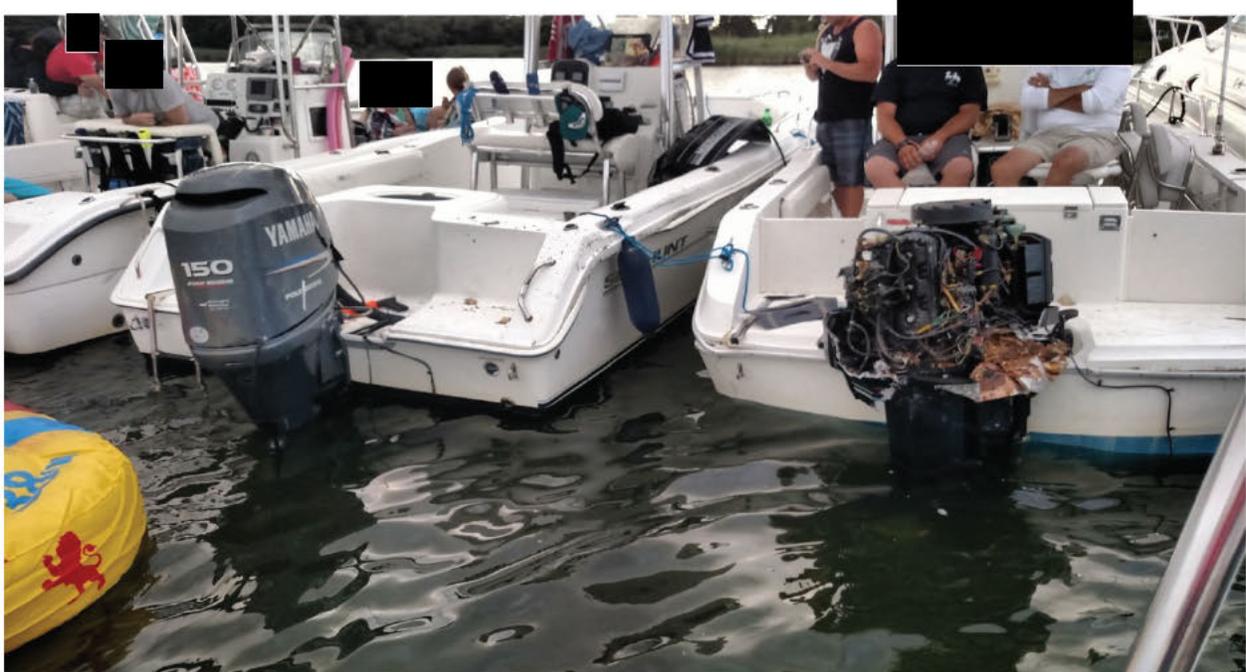
106. The GNH-12 continued in the water and allided with the stern of the MD2223D. The tip of the starboard sponson lodged into the outboard of the MD2223D causing an approximate 5 ½' x 2' opening in the starboard sponson. The impact caused "the MD2223D in turn to allide with other spectator vessels on either side of his vessel. Debris from the damaged sponson struck Mrs. [REDACTED] who was on the dive platform of the "SEA MONKEY" with the decedent's mother, [REDACTED].

Figure 13.2 – Image of the outboard motor of the MD2223D with the tip of the GNH-12 starboard sponson lodged in the damaged outboard.

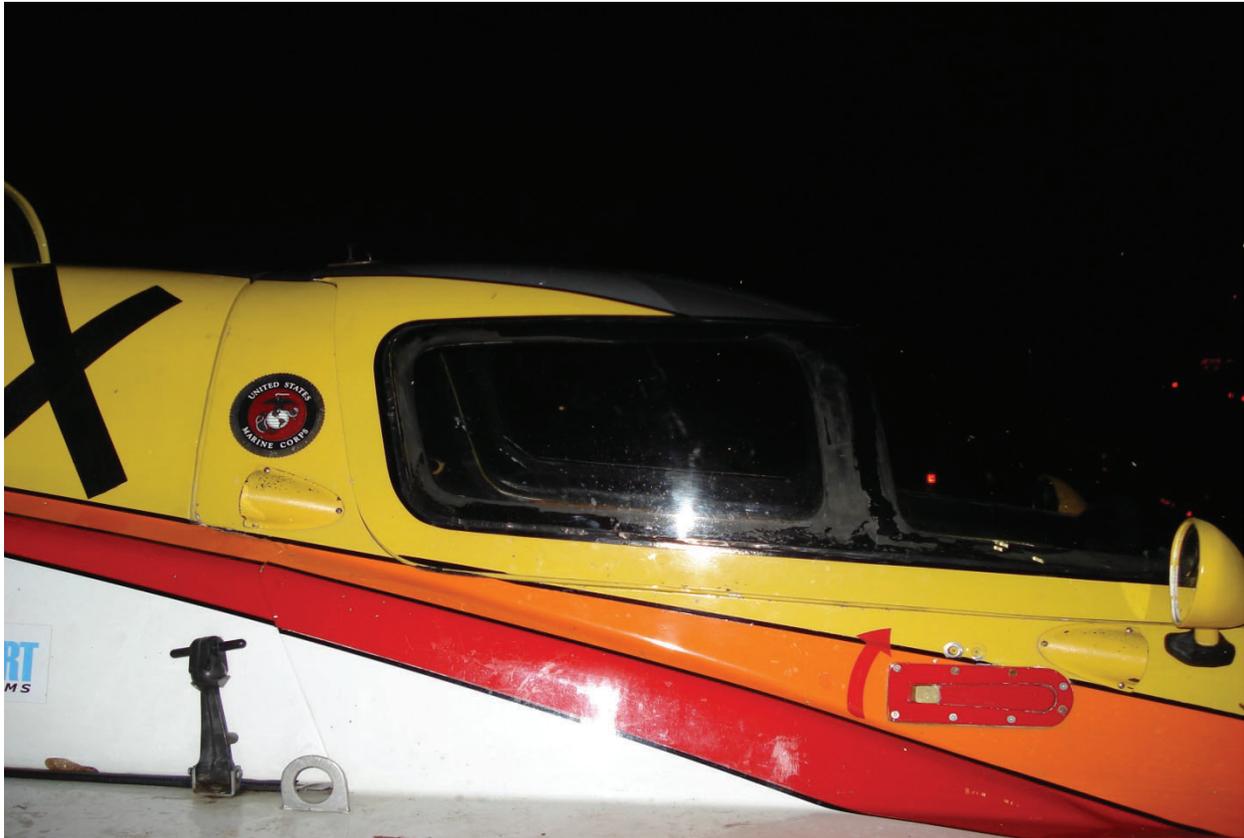
Figure 14 - Image of cockpit with GNH-12 with "Unqualified Rookie" "X" marked on the side. Image taken night of the casualty.

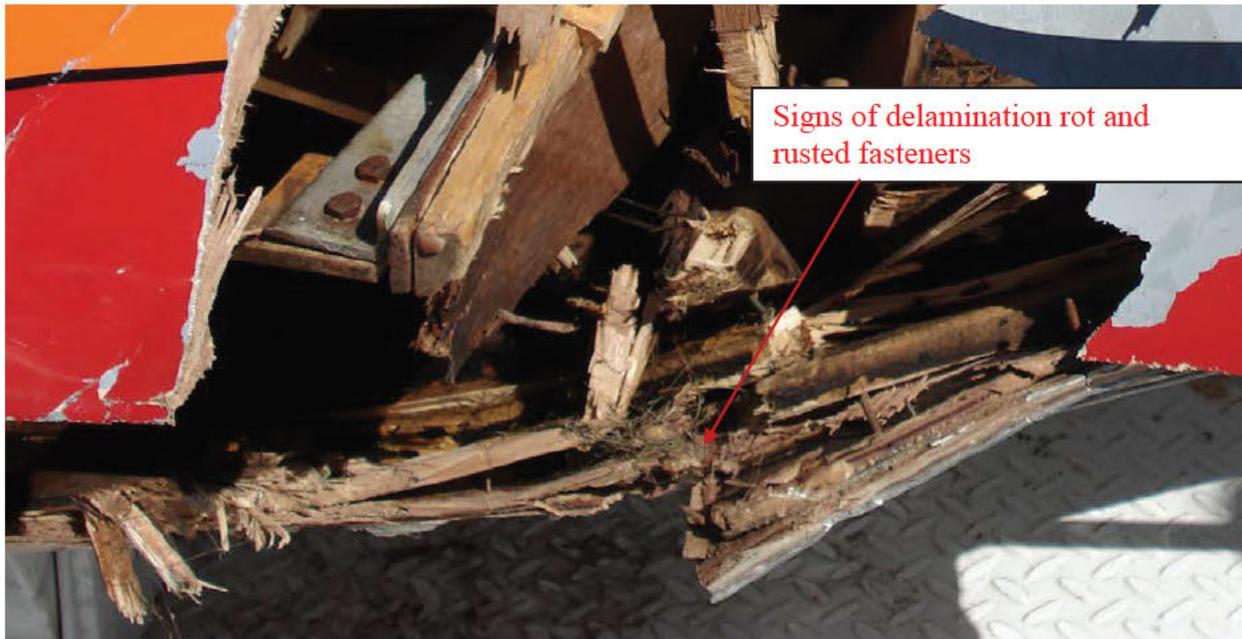
b. As it relates to conclusion #1.c.1, it should be noted the post-casualty inspection of the damaged GNH-12 showed moisture, rot and mold on structural members and the hull, including signs of delamination and rusted fasteners. This evidence along with testimony

provided by both the boat's primary driver and the driver involved in the collision indicate its weight and structural condition may have negatively impacted the hydroplane's performance characteristics, making it more difficult to remain on plane and more susceptible to sea spray, thus obstructing the driver's visibility. The degree this contributed to the cause of the casualty is unknown.

Additionally, fasteners in the vicinity of the damaged area appeared rusted and worn. This was consistent with the age and material of the vessel and the indication of having normal water intrusion in the sponson. While it's possible that the GNH-12 sustained damage to the starboard sponson prior to the allision due to the material condition of the hull, the damage discovered during the post-casualty inspection was more consistent with impact damage as a result of the allision with the "A SHORE THING's" outboard motor and stern.

Figure 15 – Close up image of the damage to the GNH-12 indicated signs of delaminating, rot, and rusted fasteners

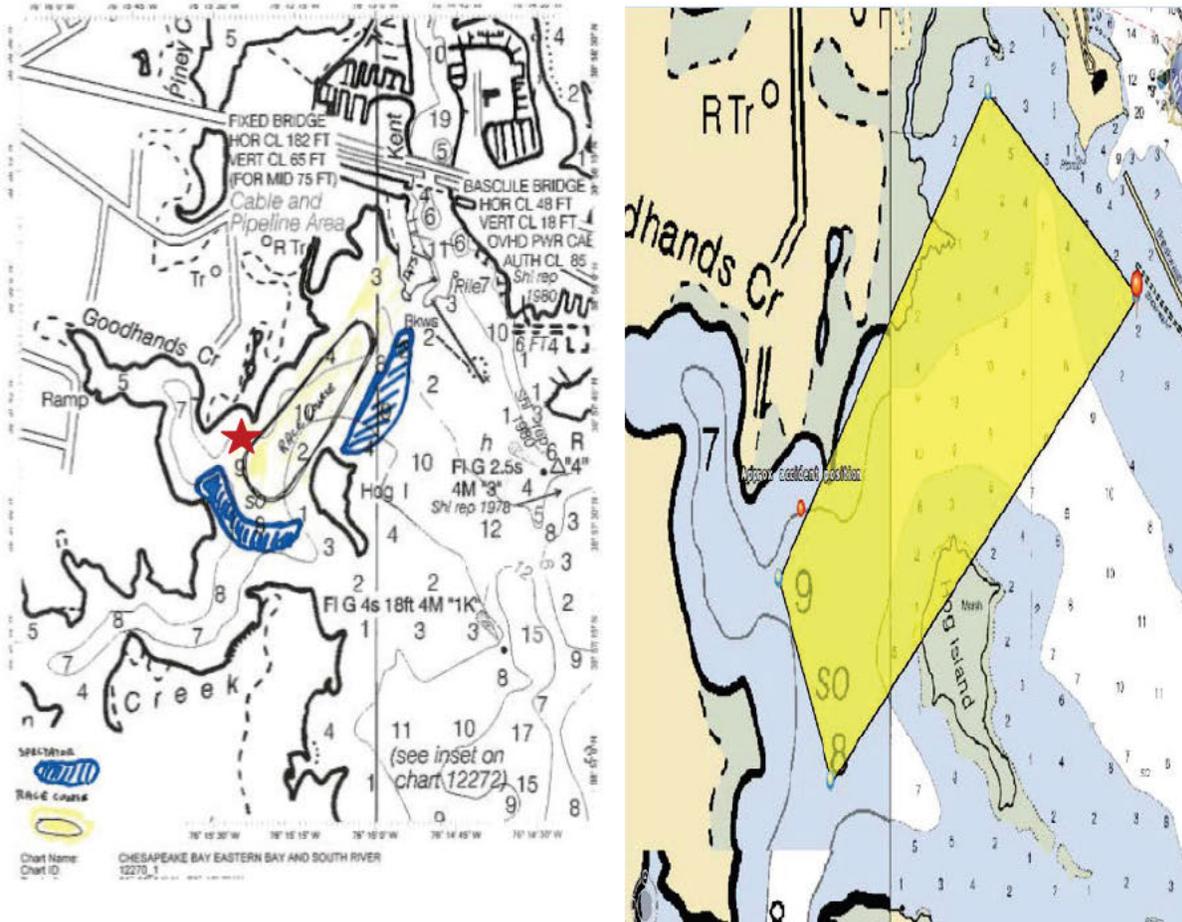
application met the requirement, analysis of the spectator areas drawn on the chartlet were not accurately portrayed in comparison to the incident location and the course diagram (see figure 10) submitted with the APBA insurance application.

Figure 18 – Side-by-side comparison of the hand drawn spectator area submitted with the chartlet showing the incident occurred outside a spectator area and the regulated area with the incident location.
