### **Marine Safety Unit Lake Charles**

Findings of Concern 009-19

## **Corrosion Caused Casualties**

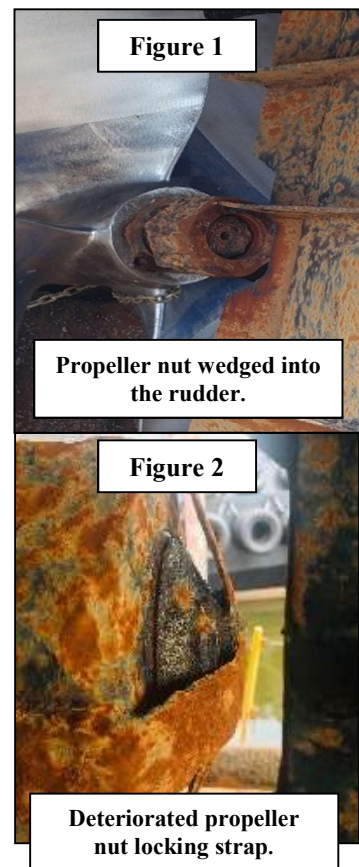
**The Incident.** On September 25, 2018, an Inspected Towing Vessel (ITV), pushing a loaded tank barge, experienced a loss of steering and subsequently ran aground. The marine casualty investigation determined the initiating event to be the port shaft propeller nut wedged into the rudder, which prevented the free and full movement of the steering gear. (Figure 1)

**Contributing Factors and Analysis.** The investigation identified the initiating event causal factors to be a material failure of the port shaft propeller nuts locking strap (missing), the lack of a secondary securing mechanism (second nut/cotter pin) on the port propeller nut, and an inadequate corrosion mitigation preventative maintenance program. Visual analysis of the starboard shaft locking mechanism noted significant deterioration of the locking mechanism (Figure 2), requiring immediate replacement. Based on the analysis of this casualty, Marine Inspectors inspected the locking nuts straps of several other ITV's during scheduled dry-dock exams which showed similar corrosion issues.

- Review company corrosion prevention systems/programs. If necessary, engage with a corrosion specialist from the American Boat and Yacht Council (ABYC) and/or National Association of Corrosion Engineers (NACE).
- Ensure adequate primary and secondary propeller shaft securing devices (cotter pins, double nut, locking strap, etc.) are in place at all times, with consideration given to vessel operations and environmental conditions.
- Ensure propeller fasteners are inspected routinely/during every dry-docking and recommend replacing IAW manufacture's instructions.
