UNITED STATES COAST GUARD

FINDINGS OF CONCERN

Findings of Concern 001-26

HAZARDS ASSOCIATED WITH TRANSITING BETWEEN ARTICULATED TUG AND BARGE COMBINATIONS

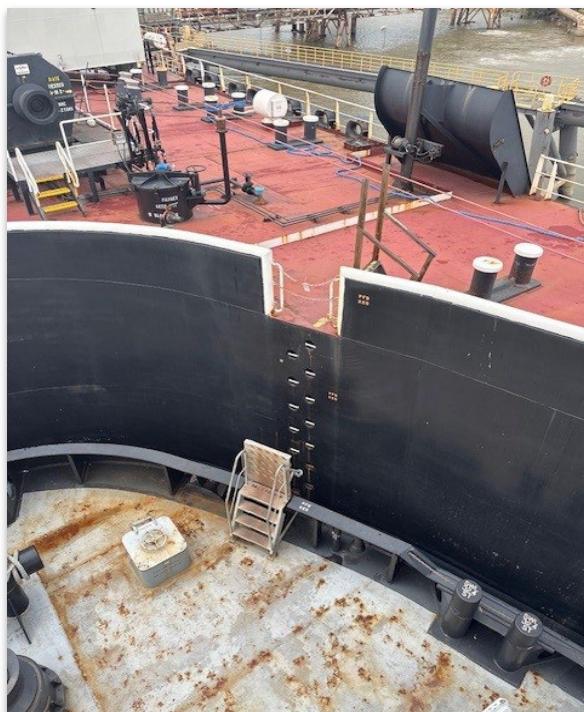
The Incident. While moored at a refinery in Chalmette, Louisiana, a towing vessel crew member fell approximately 30 feet into the tow notch of an ocean-going articulated tug and barge (ATB) after overextending their reach and losing their footing while climbing the barge's set-in pigeonholes. The fall resulted in multiple head and facial fractures, and the crew member became pinned within the tow notch, requiring mechanical movement of the tow pin system for water rescue. This accident was classified as a Serious Marine Incident, as the injured crew member received medical treatment beyond first aid and was deemed unfit for continued shipboard duties.

Figure 1: Barge pigeonhole embarkation station

- Owners and operators of towing vessels whose crews regularly climb pigeonholes or set-in barge ladders at significant heights during transit to and from tows should ensure that appropriate fall prevention or fall arrest equipment is installed or readily available for use.

- Owners and operators of towing vessels who have already implemented procedures requiring fall arrest equipment use during tug to barge transits should ensure all crew members receive adequate training on how and when to use the equipment.

- If fall arrest equipment is not available, secure gangways should be used whenever possible to reduce the risks of the overwater transit including the possibility of falling overboard and becoming entrapped.

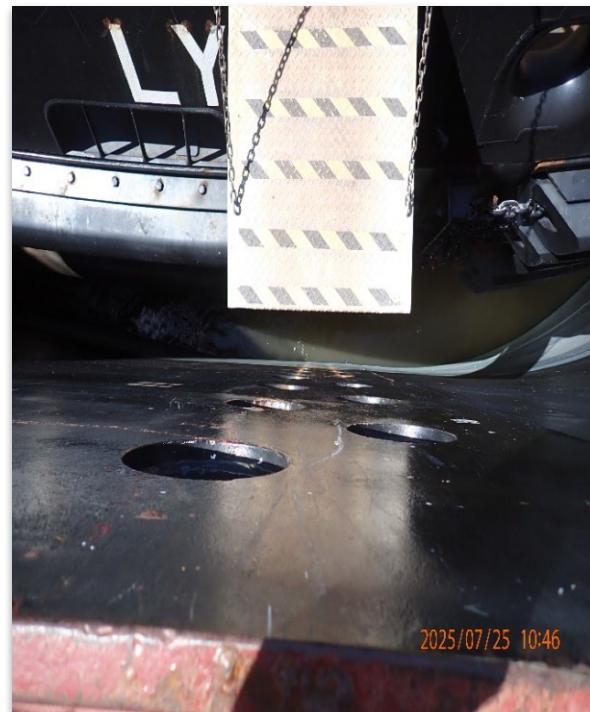
Figure 2: View from the deck of the barge showing the pigeonhole vertical drop to the tow notch

Contributing Factors and Analysis. The U.S. Coast Guard (USCG) investigation into the casualty revealed that the marine employer had safety management system (SMS) procedures requiring the use of fall-arrest equipment (i.e., safety harnesses with self-retracting connection lines) for tug-to-barge transits at heights of six feet or more. At the time of the incident, the towed barge was in ballast with a molded depth measurement of 47 feet, which presented the highest possible freeboard for crew pigeonhole climbing.
