# UNITED STATES COAST GUARD

## FINDINGS OF CONCERN

Findings of Concern 004-26

## POTENTIAL HAZARDS WHEN WORKING ALOFT

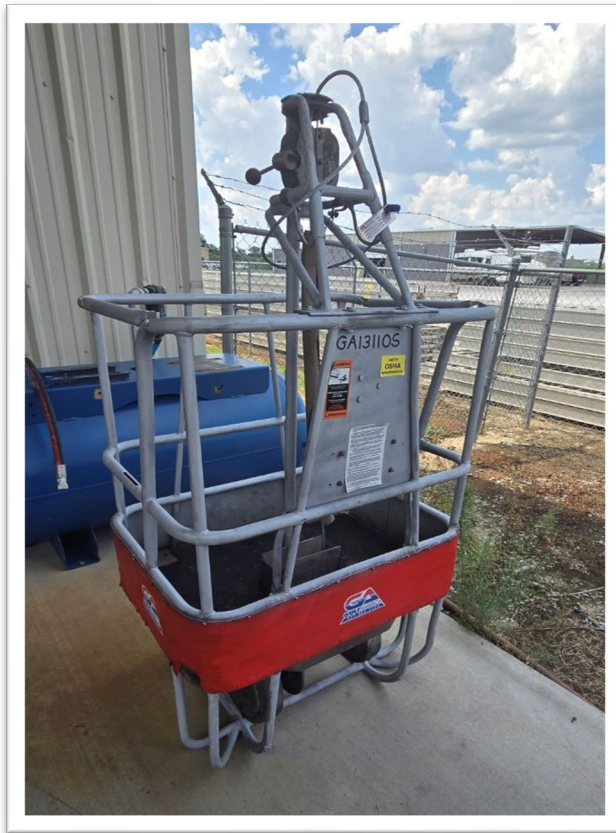
Figure 1

In October of 2025, a painting contractor was working aloft in a pneumatically operated work basket (Figure 1) aboard a U.S.-flagged floating offshore production facility in the Gulf of America. While positioned approximately five feet above the water, the basket experienced a material failure and fell into the ocean with the worker still inside. Nearby crew members quickly sounded the alarm and safely recovered the worker from the water. The individual subsequently sustained minor muscle strain injuries while unhooking the fall protection harnesses.

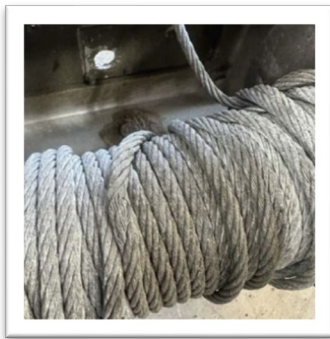
Figure 4

- The wire rope was severely bird-nested, with layers of loose and tight wiring spooled together. It also showed compression-induced flat spots and sheared wire strands. (Figures 2 and 4)
- The air hoist drum's internal components displayed signs of inadequate lubrication which resulted in excessive wear and burn patterns.
- The air hoist drum's transmission gears were found rounded off. (Figure 3)
- The basket overload switch and bracket system were found broken and out of alignment.

- The involved work basket was a commonly used pneumatically controlled wire rope unit. The applicable manufacturer maintains detailed inspection and maintenance guidelines for most portions of the air hoist unit to include daily, 30-day, 90-day, and annual maintenance/inspection items.
  - All wire rope suspension work baskets currently in service within the maritime environment should be strictly maintained as per their manufacturer's guidelines.
  - Work baskets found with safety deficiencies should be removed from service until properly repaired with particular attention paid to the condition of any wire ropes used for hoisting and internal transmission system components.
