FINDINGS OF CONCERN

Sector New York

Findings of Concern 007-23

RISK OF FIRE DUE TO MISALIGNMENT OF HIGH-PRESSURE DIESEL FUEL PUMP ASSEMBLY

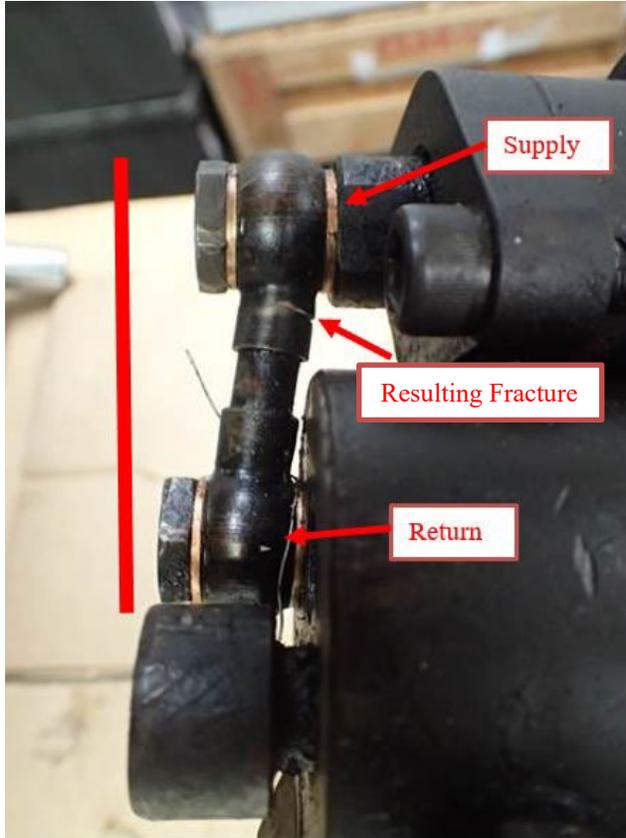
- 2.3 Tighten the cheese head screws (Fig. 3/8) with a torque of
M = 65 Nm
Make sure that the cone (15) remains in correct position during tightening.
- 2.4 Tighten the cheese head screws (9) with a torque of
M = 60 Nm
- 2.5 Mount the tube (7). Firmly tighten the banjo bolts (16).
- 2.6 Mount the nozzle leakage pipe (Fig. 1/6).
- 2.7 Insert the fuel pipes (Fig. 2/4). Shift the sleeves (3) with shaft seal (17) and plate (18) to the right or to the left up to limit stop.
- 2.8 Daub the cheese head screws (2) with Molykote paste "G-Rapid Plus" and tighten them with a torque of
M = 25 Nm
- 2.9 Open the shut-off cocks and firmly tighten the screw plug (Fig. 1/1) with a torque of
M = 80 Nm
- 2.10 Replenish the fuel system by means of the stand-by pump and vent it.
- 2.11 Mount the pump space cover. .

MAK M32 Manual notating no established torque specification

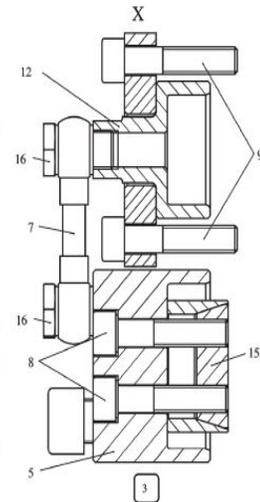
The Incident. Recently, the Coast Guard investigated a main space engine room fire onboard a chemical tank ship. The vessel was underway after conducting a routine overhaul on the Main Diesel Engine high pressure diesel fuel pump. Shortly into the voyage, a high-pressure diesel fuel leak was identified on the high-pressure diesel fuel pump collective pipe igniting into a main space fire which resulted in substantial damage.

1. Misalignment of fuel oil collective pipe assembly.
2. Utilization of used parts on overhauled fuel oil pump.
3. A lack of fuel oil collective pipe mounting hardware torque specifications.
4. Material failure of the fuel oil collective pipe.
5. Inadequate load test of the #2 Main Diesel Engine.

Photograph of misaligned fuel oil collective pipe, tightened to the point of fracture.

- Vessel safety management preventative maintenance procedures should specifically identify the importance of proper fuel pipe assembly alignment when overhauling main diesel engine high pressure fuel pumps.
- Vessels utilizing MAK Caterpillar M32 Engines should take caution when tightening fuel distributing collecting pipe banjo bolt screw connection (Part No. 9.8517-510), due to the lack of established torque specification by manufacturer.
- Vessel safety management preventative maintenance procedures should specify which parts are a one-time use “consumable” in accordance with manufacturer recommendations.
