U.S. Department of Homeland Security FINDINGS OF CONCERN

Marine Safety Detachment Vicksburg

September 16,2024 Vicksburg, MS Findings of Concern 008-24

UNSAFE VEHICLE TRANSPORT PRACTICES

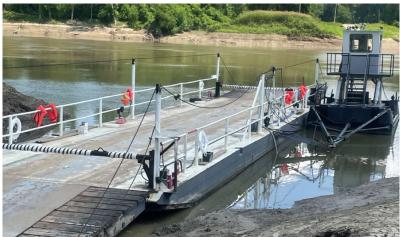
<u>Contributing Factors and Analysis</u>. The Coast Guard's investigation determined contributing factors that led to this casualty. While the investigation revealed the primary factor leading to the loss of life was the lack of procedures to verify the equipment was secured on the barge, there were also several additional factors that contributed to the casualty or were identified as unsafe conditions. Crewmembers onboard the vessel did not verify that the vehicles on the barge were in park with the parking brake engaged. No chocks for the vehicle's tires were provided or in place. The passenger barge was not equipped with a safety chain or bar to prevent vehicles from rolling off the vessel. Crewmembers did not provide a safety orientation or flotation devices to the passengers before getting underway.

Figure 1. Photograph of deck barge post casualty with recommended bar installation on bow and stern.

- Install a bar or chain of adequate strength that needs to be raised or moved for the vehicles to enter or depart the vessel.
 - Have the crew provide a safety orientation before getting underway to all passengers, with instructions on emergency procedures, PFD stowage location and wearing a lifejacket while the vessel is moving.
