### **Sector Mobile**

Findings of Concern 008-25

## **INADEQUATE WATER MIST SYSTEM PRESSURE AND NOZZLE POSITIONING**

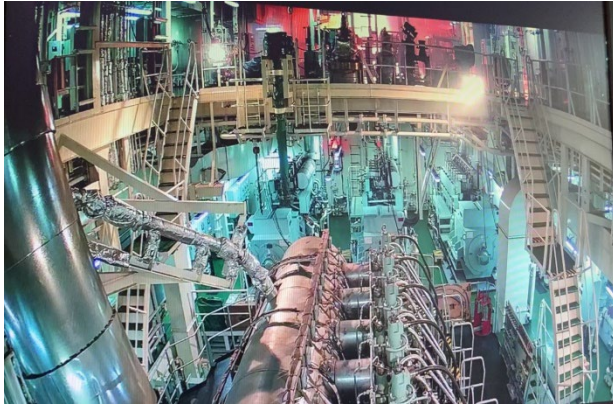
- Witness interviews, onboard surveillance footage, and the on-scene investigation strongly indicated that the fixed water mist fire suppression system likely failed to perform as designed due to improper actuation pressure. Specifically, the system discharged water at suboptimal atomization, producing larger-than-intended droplets. The nozzle's proximity to the burner unit and the resulting droplet size generated a downward force that pushed ignited fuel through open deck gratings. This contributed to vertical fire spread via pooling and migration of the fuel/water mixture, ultimately extending the fire's impact beyond the boiler space into multiple lower compartments.

*Dispersion of ignited fuel down two additional decks*

- Verify that water mist systems are calibrated to actuate at the correct pressure and that nozzle placement does not promote unintended fuel dispersion in the event of fire. This is especially important for machinery installed over grated deck plating, which can lead to the rapid spread of fuel-based fires. Maintenance, inspection, and testing of water mist system actuation pressures should be part of routine fire suppression maintenance. Operators are encouraged to utilize the guidance outlined in the International Maritime Organization's (IMO) Maritime Safety Committee (MSC.) 1/Circular (Circ.) 1432, as amended by MSC.1/Circ.1516, in accordance with the International Convention for the Safety of Life at Sea (SOLAS) II-2/14.2.2 to assist in the process.

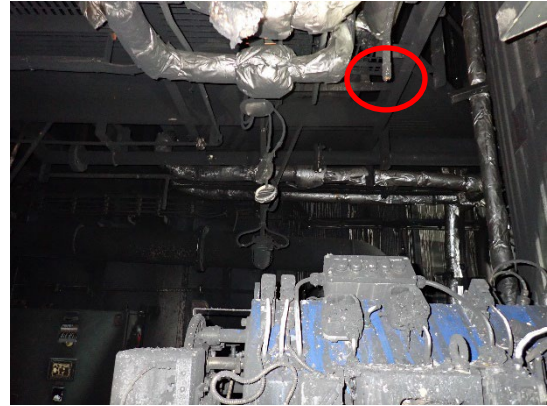
*Water mist nozzle - proximity to burner assembly*
