# UNITED STATES COAST GUARD

## FINDINGS OF CONCERN

Findings of Concern 010-25

## SHIPYARD WORK BARGE POLICIES AND OPERATIONS

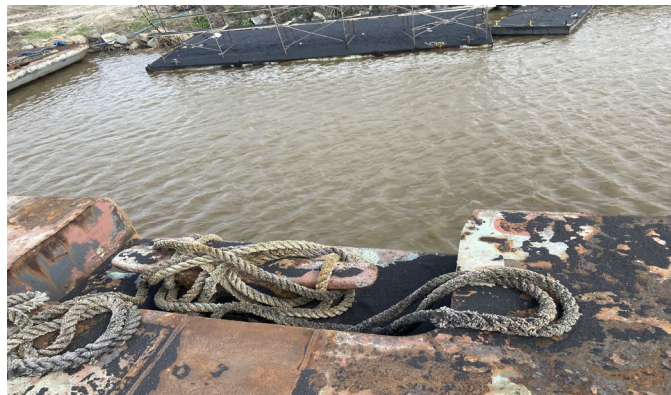
The supervisor untied the work barge's line from the cleat and began to walk backwards to pull the line and reposition the barge. As he was repositioning the barge, he tripped on another cleat and fell off the side of the barge, striking his head on the work barge just prior to entering the water. The deceased supervisor was recovered by law enforcement officers several hours later beneath the starboard side of the freight barge.

Photograph of cleat with mooring line secured to it on the top deck of freight barge.

Contributing Factor and Analysis. There were multiple concerns found aboard the freight barge that contributed to the incident including trip and fall hazards, lack of temporary handrail installations, and no written policy for using assist boats. Additionally, there was inadequate personal protective equipment (PPE) relative to the hazards presented by the current job, such as a hard hat with a chinstrap.

- Consider developing policies that denote requirements for the use of push boats within shipyard waterways to assist with moving small work barges around the shipyard, limiting the use of shipyard workers physically pulling lines to move work barges.
- Ensure development and proper implementation of policies regarding the use of guard rails, safety nets, or personal fall arrest systems while working on vertical or horizontal walking/working surfaces with a side or edge that is six feet or more above a lower level. Most freight barges offer minimal to no handholds to prevent falling over the side.
- Ensure that proper PPE is used and worn correctly, including hard hats with chinstraps. Wearing a chinstrap properly can prevent a hard hat from falling off if someone falls over the side.

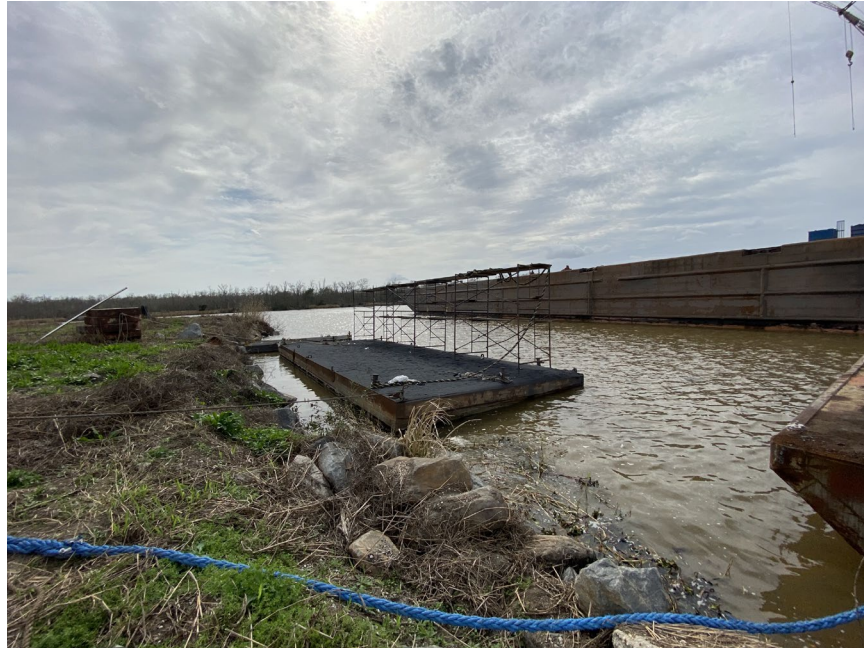
**Photograph of small work barge with scaffolding adjacent to the side hull of the freight barge.**
