## **FINDINGS OF CONCERN**

### **Sector San Francisco**

Findings of Concern 013-25

## **UNSAFE ANCHOR RETRIEVAL OPERATIONS**

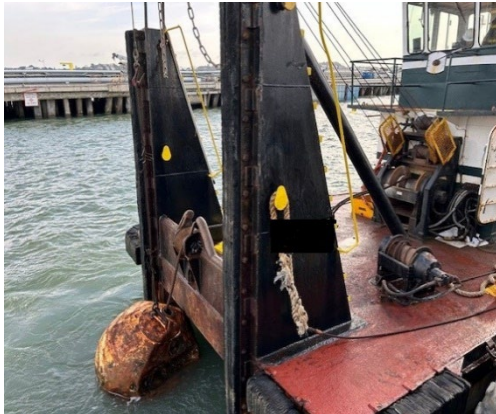
Dredge tug bow with anchor ball connected.

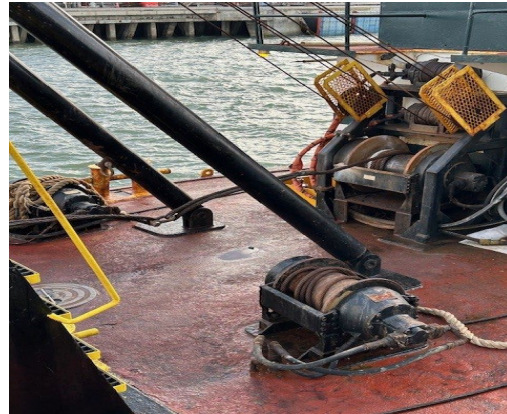
The Incident. As the crew of a towing vessel was hauling in their anchor, a deckhand was manually guiding the anchor wire onto the winch drum to keep the anchor wire shackle from contacting the wire eye coupler swage and avoid damage to the anchor wire rigging. The anchor got stuck on the bottom resulting in the anchor line becoming taut which caused it to shock-load and create stored energy. In an attempt to protect the anchor wire and associated gear, the deckhand pushed against it. When the vessel was repositioned, the anchor line shifted and resulted in a release of the stored energy. This caused the deckhand to be thrown into the nearby gantry A-frame and resulted in a fractured leg.

Dredge tug working deck and close-up of gantry A-frame.
