### **Great Lakes District**

Findings of Concern 020-25

## **SAFEGUARDING VESSELS: PREVENTING FLOODING RISKS DURING LAYUP**

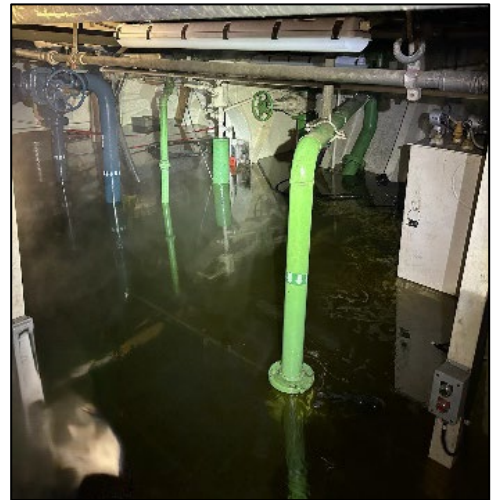
The Incident. During a layup period, a moored, foreign flagged vessel experienced progressive flooding that led to the vessel grounding. Shoreside personnel noticed a significant list and subsequently discovered flooding in the engine room. Divers subsequently determined that an open raw water strainer was the primary source of the flooding. While the incident did not cause pollution or personnel casualties, it resulted in extensive equipment damage and required substantial salvage operations. The vessel was scrapped in the summer of 2025.

*Engine room flooding.*

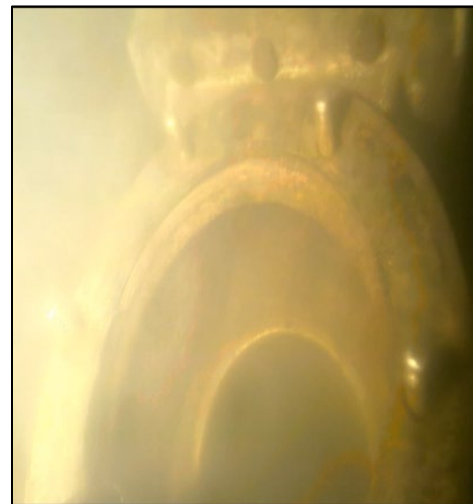
*Open strainer found during dive operations.*

- Some strainers, drains, vents, and valves were left partially or fully open which created pathways for flooding. Components that are appropriately closed mitigate flooding propagation.
- Watertight doors and fittings were left open, compromising the watertight integrity of compartments which permitted progressive flooding to occur.
- The vessel was visited only three times per week, with no visits conducted over the weekend preceding the incident. This infrequent monitoring limited the ability to detect the flooding event at an early stage.

- If the layup period occurs during the winter months and no approved installed heating source is in use, ensure that freeze protection measures for freshwater systems are implemented before freezing temperatures begin.
- Before departing the vessel, establish procedures to confirm watertight boundary conditions, including doors, hatches, manholes, and bulkhead closures. Additionally, inspect engineering spaces to ensure all raw water system components—such as valves, strainers, drains, and vents—are properly closed or securely sealed.
- Consider incorporating monitoring plans that include daily inspections and the installation of remote bilge monitoring systems to detect flooding. This is especially important during and after periods of inclement weather.
