FINDINGS OF CONCERN

Sector Delaware Bay

Findings of Concern 022-22

PROACTIVE MAINTENANCE FOR STRIKER PLATES

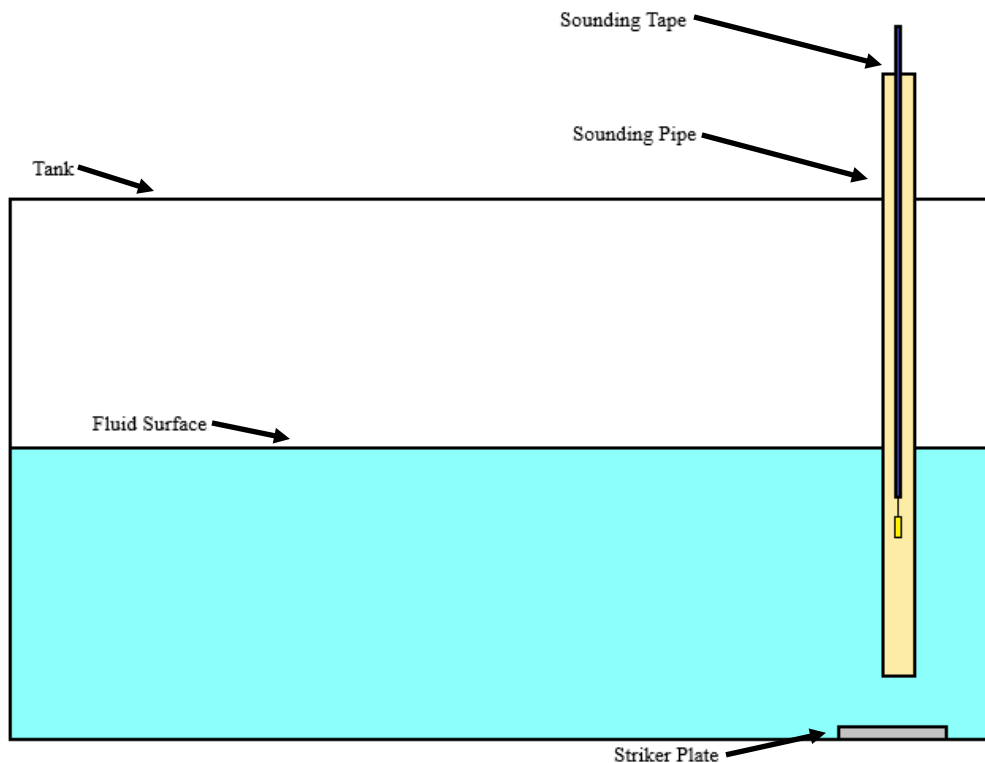
The Incident. During transit, a bulk carrier experienced flooding in the aft oily bilge tank. USCG investigators discovered that the cause of the flooding was the wastage of the hull in way of the striker plate used to sound the tank. The striker plate is a small piece of steel welded over the inner hull of a vessel which serves to protect the hull steel from degradation due to repeated striking (see Figure 1). During tank soundings, which the crew conducted approximately 6 times daily, the weight at the end of the sounding tape within the sounding tube would strike the striker plate at the bottom of the tank. Over time and with repeated strikes, this action wore a hole in the striker plate steel.

Figure 1 – Diagram of tank with sounding pipe and striker plate.

- Establish a preventative maintenance system that proactively identifies and repairs and/or replaces damaged double bottom deck striker plates.
- Establish a consistent maintenance schedule for the double bottom striker plate to be overhauled within an appropriate time period.
