**BERMUDA SAFETY BULLETIN**

**Failure of Large Planetary / Reduction Gear Components of LSA Winch Equipment**

Notice to all Ship and Vessel Owners, Ship Operators and Managers, Masters and Officers of Bermuda Registered Ships Incorporating Davit Launched Lifeboats and Rescue Boats

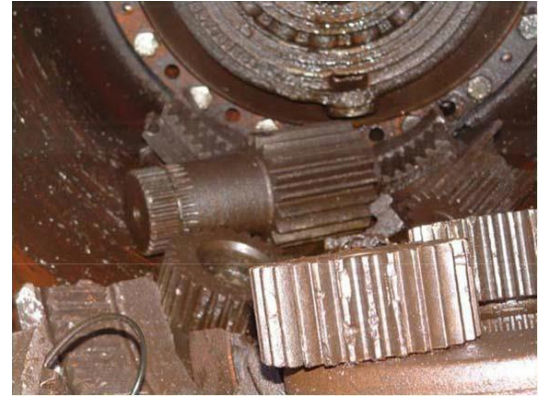
Fig. 2: Planetary Gear after excessive running speed

Ship Owners/Operators whose ships are fitted with the above listed winch model numbers should ensure that the winches are inspected and maintenance carried out in accordance with OEM's instructions.

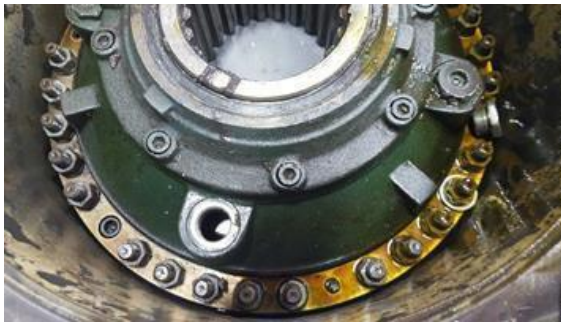
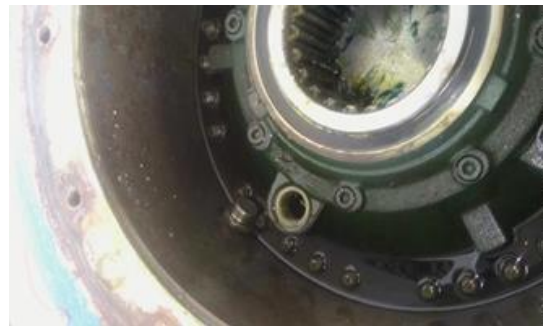
The reason for this is understood to be due to the planetary gear fill plug either falling out or leaking, leading to the gears running in a dry condition. These large Planetary/ Reduction gears are located in an inaccessible area and oil levels can only be monitored by either fully dismantling the winch or performing an internal video inspection of the drum.

Figs. 3 and 4: Interior of winch drum showing ordinarily inaccessible planetary gear and filling plugs that have fallen out. Note that there was no external indication of an oil leak.

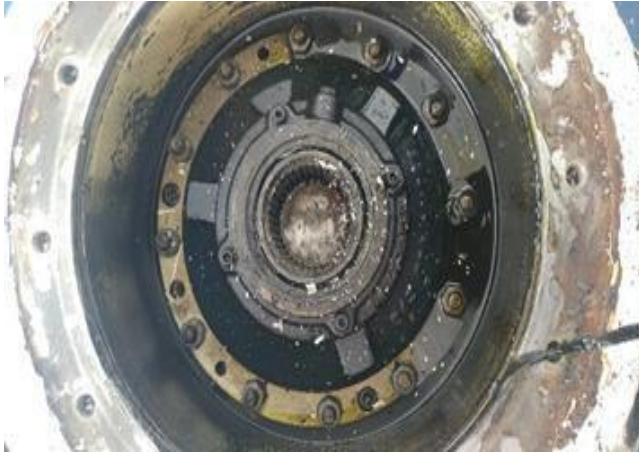
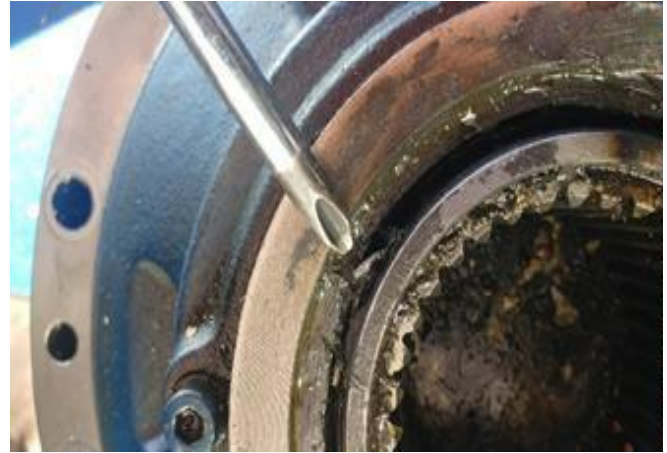
Failure of the Planetary Gear/Reduction Gear will result in the winch losing the capability to control the descent of the lifeboat/rescue boat causing the boat to descend rapidly and uncontrollably. If this happens it will cause the Planetary Gear/Reduction gear in the winch drum to operate at speeds far higher than it was designed for, subjecting the parts to tremendous fiction which may cause the gear box to rupture. Such failure may occur within seconds of overspeed operation.

**Figs. 5 and 6: Interior of above reduction gears after running in a dry condition leading to overspeed damage**
