# Deck Water Spray Systems on Liquefied Gas Carriers

Sector Houston-Galveston

## Deck Water Spray Failures

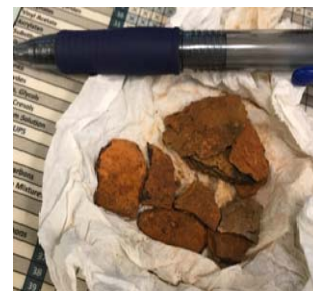
Figure 1 - a very small sample of debris from 2 and half year old VLGC Deck Water Spray system. Total volume of debris cleared after temporary removal of 4 orifice plates could have nearly filled a five gallon bucket. Also cleared from the system were 3- 3inch x 1 inch bolts with nuts on obviously in the piping system since construction.

Ineffective operation of the deck water spray appears easily managed by periodic removal of the installed orifice plates & piping end caps and then flushing the debris from the system. Failure to do this allows for the rapid and substantial build up of debris behind each orifice plate. This situation, like plaque in an artery, has gone undiagnosed for decades as vessel crews endlessly poke at the clogged nozzles in futile attempts to cure a more severe and untreated issue.

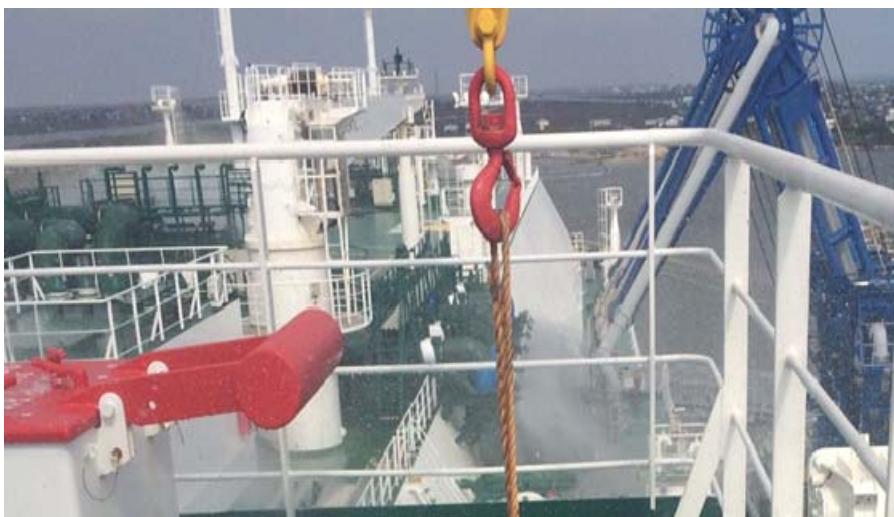
Figure 2 – Deck Water Spray coverage of starboard cargo manifold on a LNG Carrier Photo Credit (Mr. Jamie Wilson, USCG Sector Houston-Galveston)

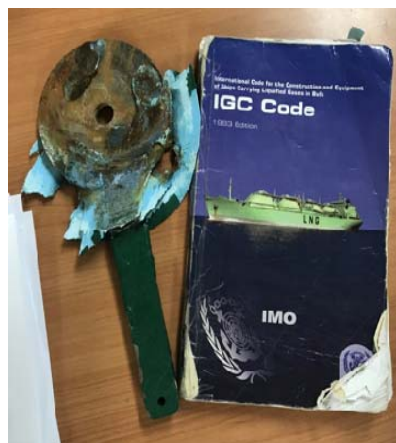
Figure 3 – (left) Orifice plate temporarily removed to clear debris from deck water spray system. Note approx 2 inch internal diameter of pipe reduced to 1/2 inch trapping most debris behind each plate. At least 9 orifice plates were identified on this VLGC. Photo Credit – Mr. Jamie Wilson USCG Sector Houston-Galveston

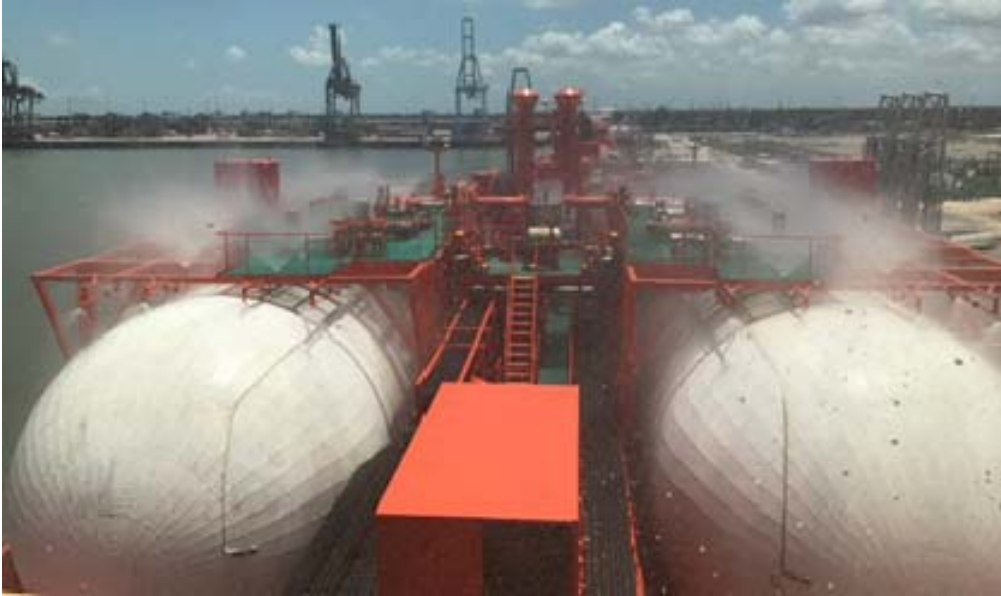
Figure 5 – Excellent deck water spray coverage of deck tanks as viewed from bridge. Good example of why not to only test from the bridge, is there adequate coverage on the other cargo tank tops, manifolds, etc.? Something to think about.

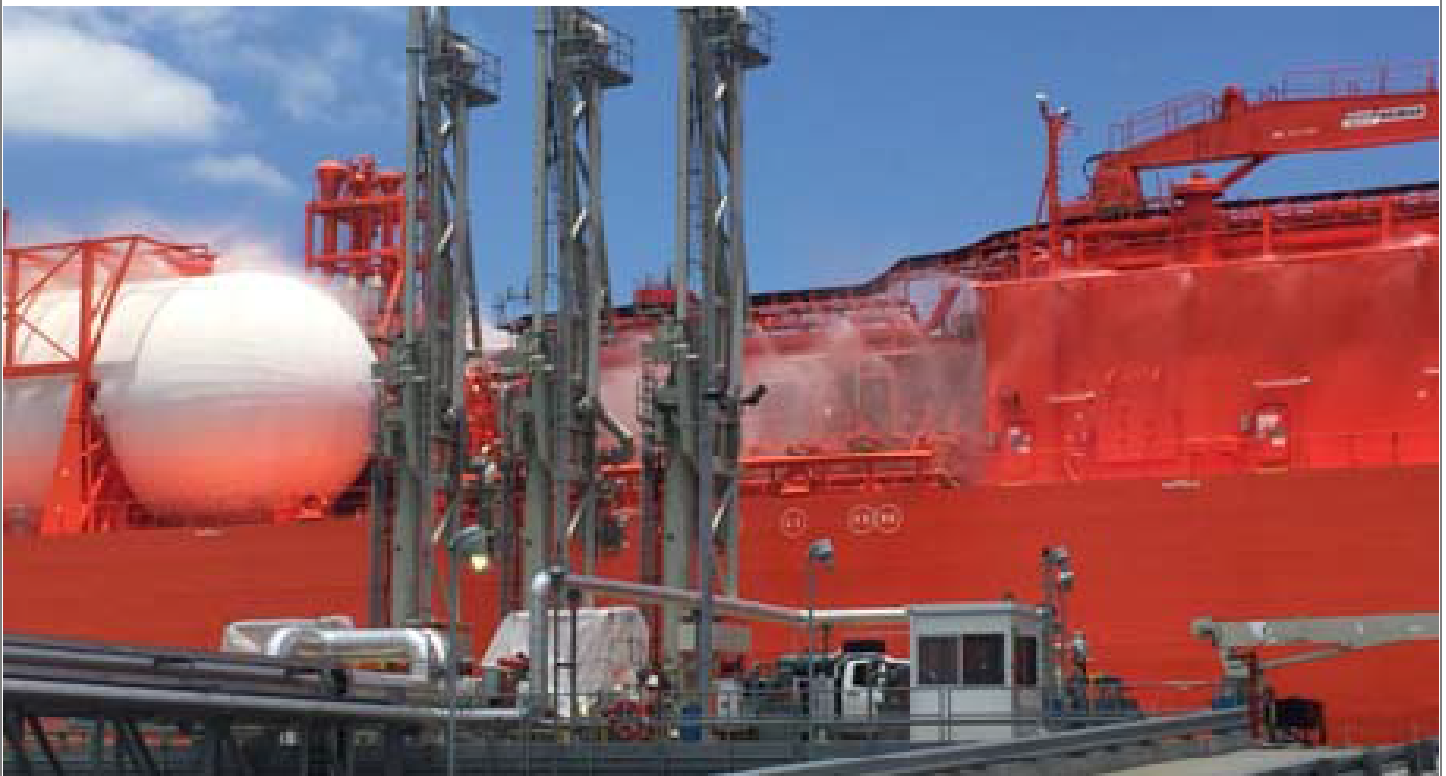
Figure 6 – Testing of deck water spray during an initial COC-Gas Exam conducted in Houston, Texas.
