## MEASUREMENT ORGANIZATION INFORMATIONAL NOTES - 09/16/2021

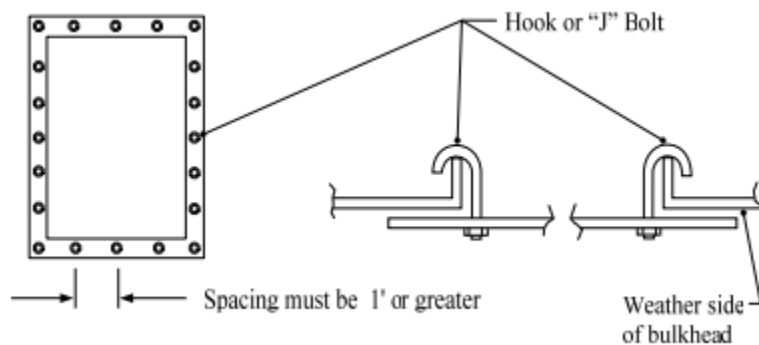
**TEMPORARY COVERS** During recent oversight activities, the Marine Safety Center identified multiple temporary cover configurations not authorized under § 69.117(d) of MTN 01-99 CH-10 that are considered a means of closing otherwise qualifying openings, and preclude progression of open space. One configuration involved a cover plate secured by hook bolts that were not spaced at least one foot apart as required under § 69.117(d)(5)(i). Another had alternate covers (e.g., sliding doors, hinged doors, or expandable partitions) prohibited under § 69.117(d)(6')(v). As a reminder, tonnage openings and associated tonnage opening cover plates are required to be verified during an onboard survey in accordance with § 1.4(e) of MTN 01-98 CH-13. This includes verification that covers meet configuration requirements and that no battening, caulking, seals or gaskets of any material are present. Additionally, anything affixed to a temporary cover – such as excess paint – must not hinder the removal of the cover; and removal of fasteners used to hold a cover in place must result in the cover “falling free”.
