NAVIGATION AND VESSEL INSPECTION CIRCULAR NO. 7-56

Subj: Manned LSTs; structural reinforcement and drydocking; hull inspection requirements

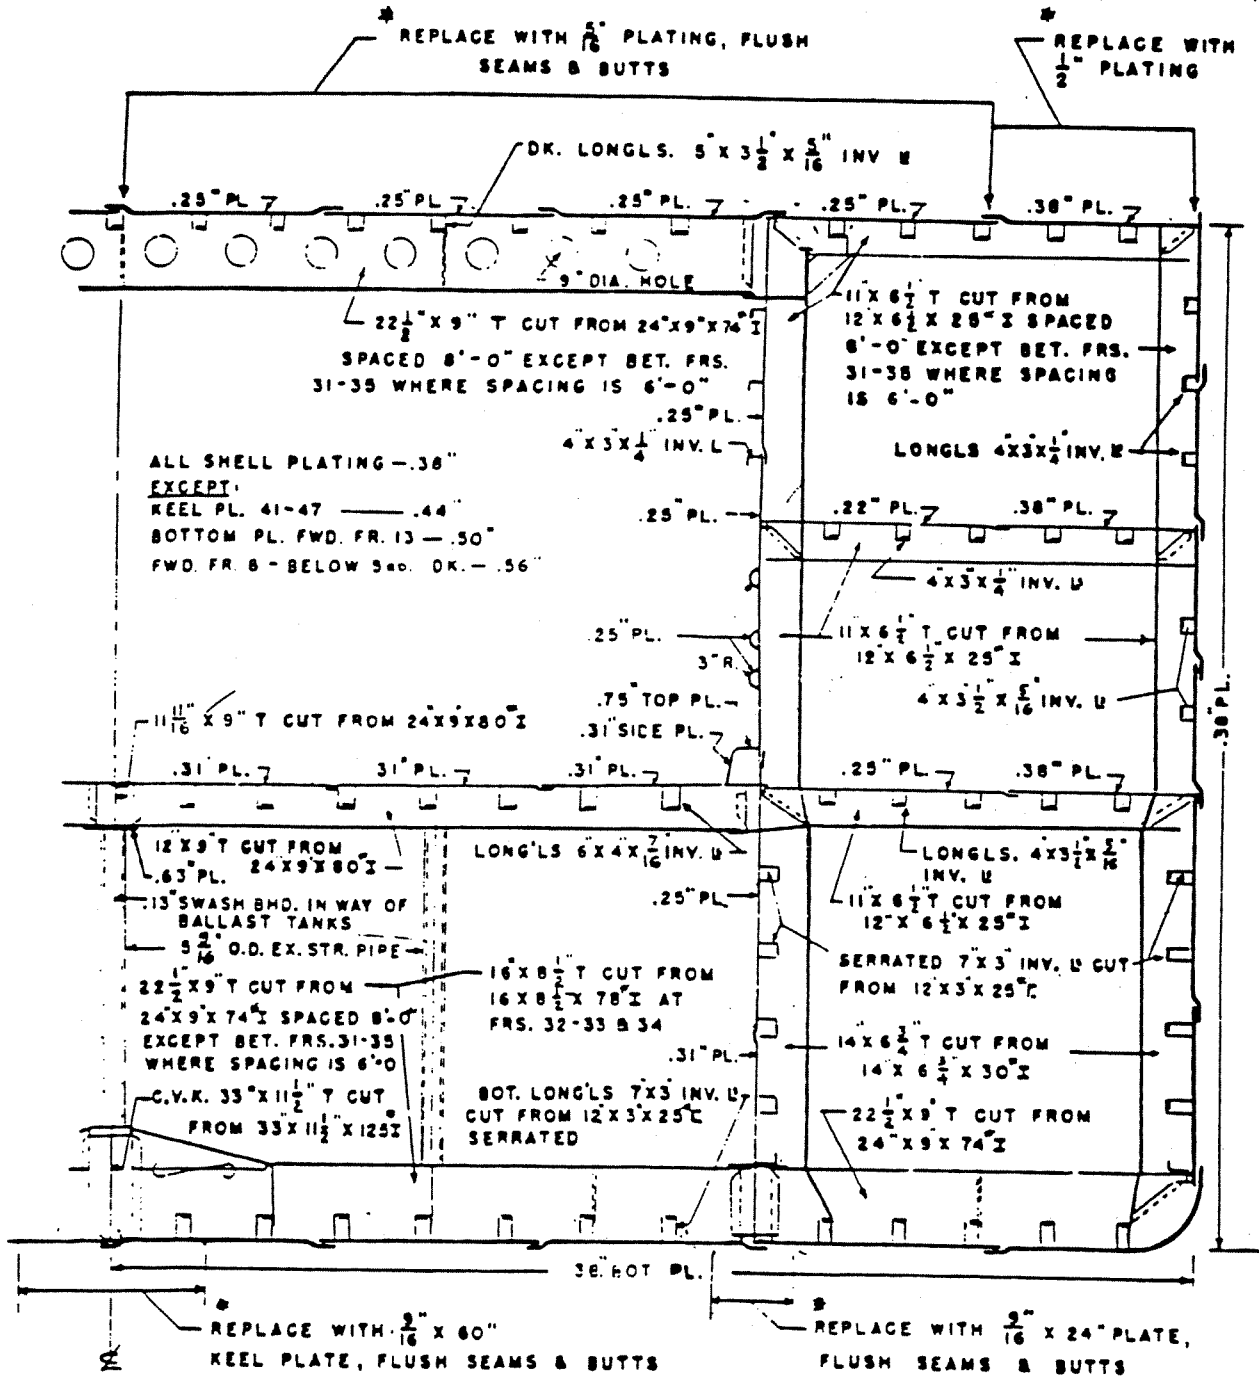
FIG. 1

\* INDICATES REQUIRED CHANGES.  
ALL OTHER SCANTLINGS ARE EXISTING

- (1) Existing  $\frac{1}{4}$ " deck plating between frames  $12\frac{1}{2}$  -  $35\frac{1}{2}$  inclusive shall be replaced with  $5/16$ " plating, with all seams and butts flush and butt-welded in lieu of the present joggled laps.

- (2) Existing  $3/8$ " stringer plate between frames  $11\frac{1}{2}$  -  $36\frac{1}{2}$  inclusive shall be replaced with  $\frac{1}{2}$ " plate, with flush butts and seams.

- (3) Bottom plating for a 60" width in way of the keel and for not less than a 24" width in way of the longitudinal bulkheads shall be replaced by new strakes of  $9/16$ " thickness fitted with flush butts and seams. New plating in way of keel shall extend between frames  $12\frac{1}{2}$  -  $35\frac{1}{2}$ . New plating in way of longitudinal bulkheads shall extend between frames  $13\frac{1}{2}$  -  $34\frac{1}{2}$ .

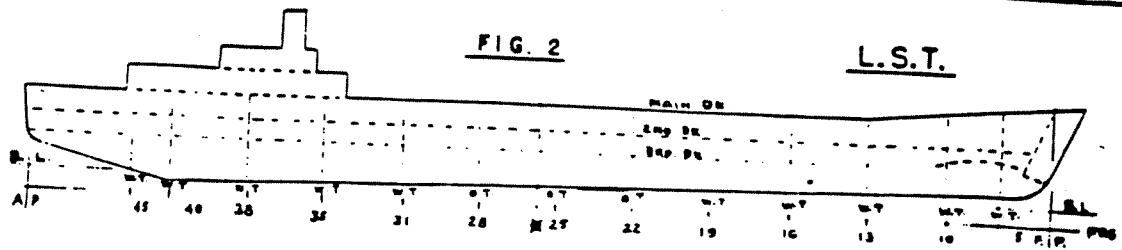
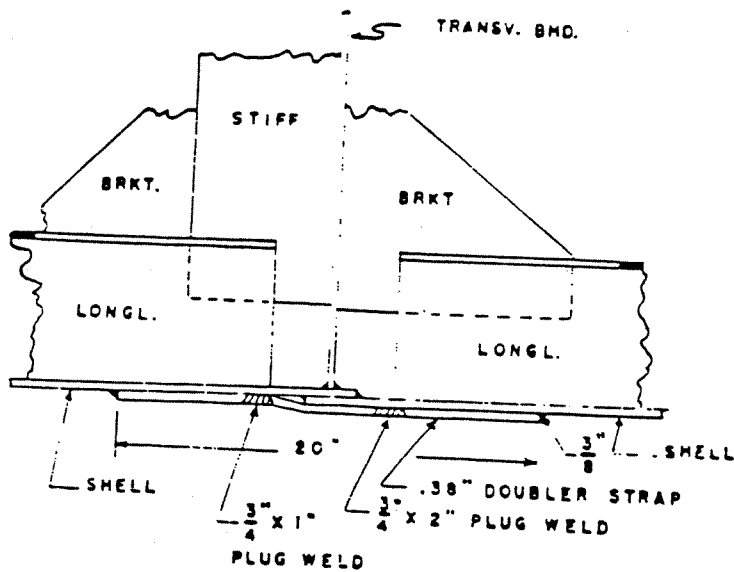
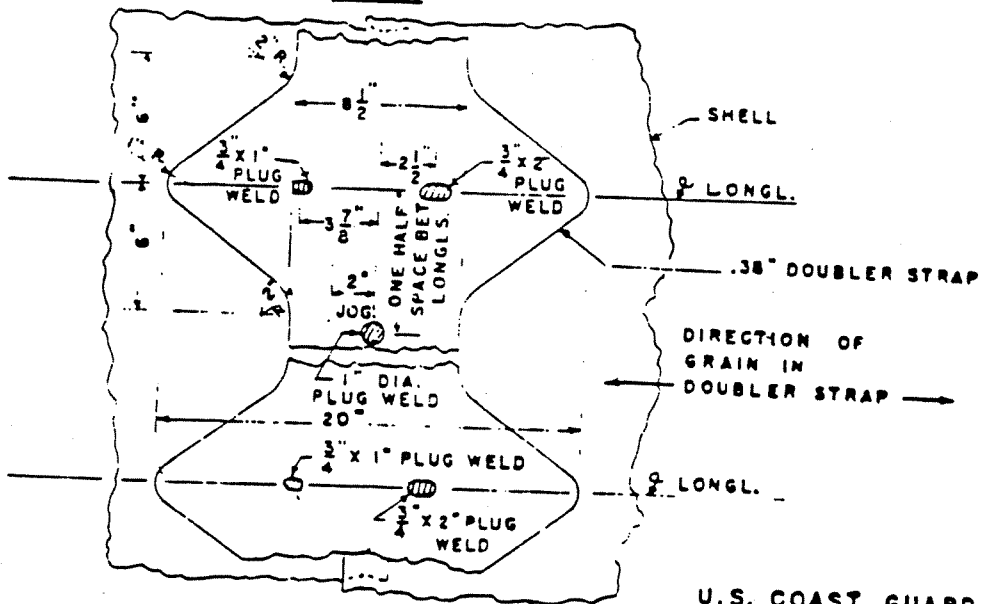
FIG. 3  
 ELEVATION

- e. Implementing the first consideration, shell and deck plating butts were made as joggled laps at bulkheads, and joggle laps were used for seams, including the critical connection of the garboard strakes under the center vertical keel (no flat plate keel being fitted), and the also critical bottom

seams under the longitudinal bulkheads. These points proved adequate to the short-time military purpose, but on a long-time basis are susceptible to accelerated corrosion and to possible metal fatigue. The possible seriousness of these occurrences is aggravated by the fact that the plating concerned is generally thinner than would be required in a normal merchant vessel of the same size.

- (5) Existing lapped butts in shell plating at frames 13 - 35 inclusive shall either be reinforced by the fitting of scalloped doubler straps as shown by Fig. 3, or the modified reconstruction shown by Fig. 4 shall be used. Where the reinforcement shown by Fig. 3 is used, it is necessary that all existing faulty welds, both external and internal be corrected before straps are fitted. Use of the construction shown by Fig. 4 eliminates the existing fillet welded lapped butts, and consequent need for any repair work thereon.
