**TREASURY DEPARTMENT
UNITED STATES COAST GUARD**

NAVIGATION AND VESSEL INSPECTION CIRCULAR NO. 11-63

Subj: LSTs as unmanned barges; structural reinforcement and drydocking; hull inspection requirements

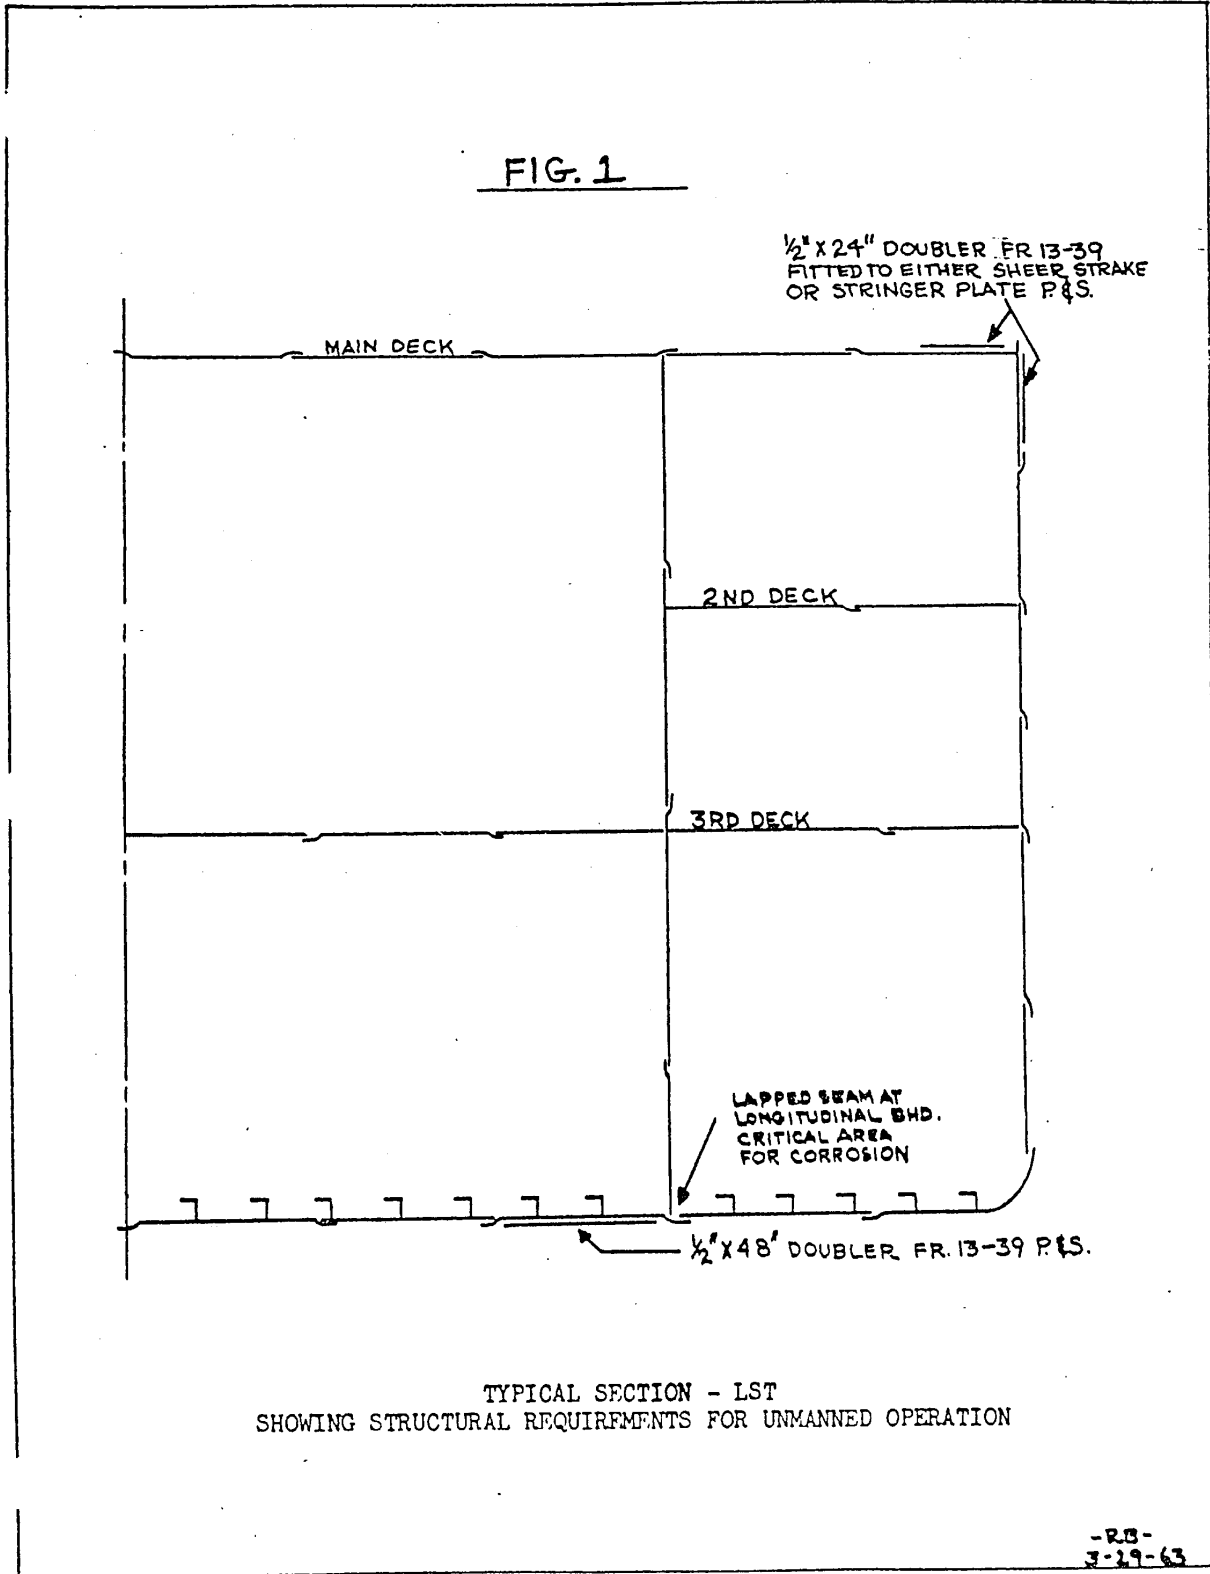
ENCLOSURE (1) NAVIGATION AND VESSEL ENGINEERING

- (2) Continuous longitudinal bottom doublers ½ " x 48" shall be fitted port and starboard on the bottom shell as shown in Figure 1. These doublers shall extend from Frame 13 to Frame 39. The lapped seams in way of the longitudinal bulkheads shall be sound with no significant localized wastage in the plating adjacent to the welds (Fig. 5). Where such wastage is apparent the lapped seam shall be removed and the required doubler shall be centered on the longitudinal bulkhead as shown in Figure 6.

- (3) A continuous longitudinal sheer strake or stringer plate doubler ½ " x 24" shall be fitted port and starboard as shown in Figure r. These doublers shall extend from Frame 13 to Frame 39. If the mean operating draft of the vessel is to be 12' or less, consideration may be given by the Commandant to omit these doublers depending upon the nature and severity of the intended service.

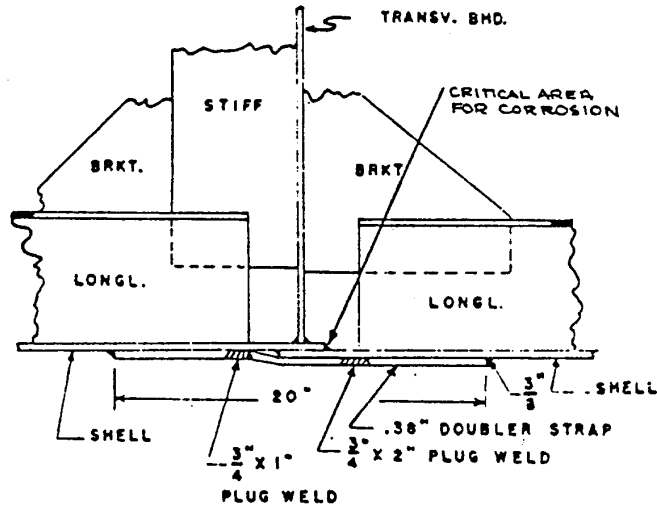
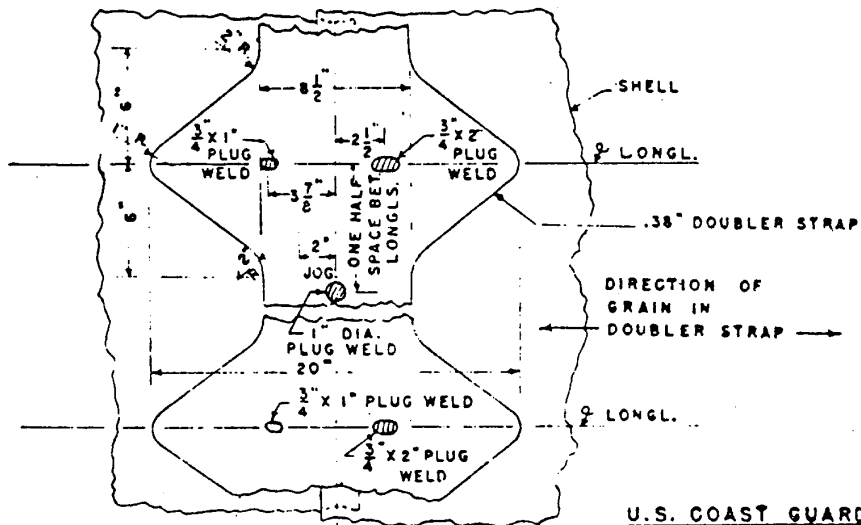
FIG. 3
ELEVATION

STRAP REINFORCEMENT OF SHELL LAPPED BUTTS, FRS. 13-35 INCL.

- (1) Existing lapped butts in shell and deck plating at Frames 13-35 inclusive shall either be reinforced by the fitting of scalloped doubler straps as shown in Fig. 3, or be modified as shown in Fig. 4. Where the reinforcement shown in Fig. 3 is used, existing welds in the lapped butts, both internal and external, must be sound with no significant localized wastage in the plating adjacent to the welds. This is especially important at the internal welds of the butts in the bottom plating (Fig. 3). Where such wastage is apparent the bottom butts shall be reworked in accordance with the method shown in Fig. 4.

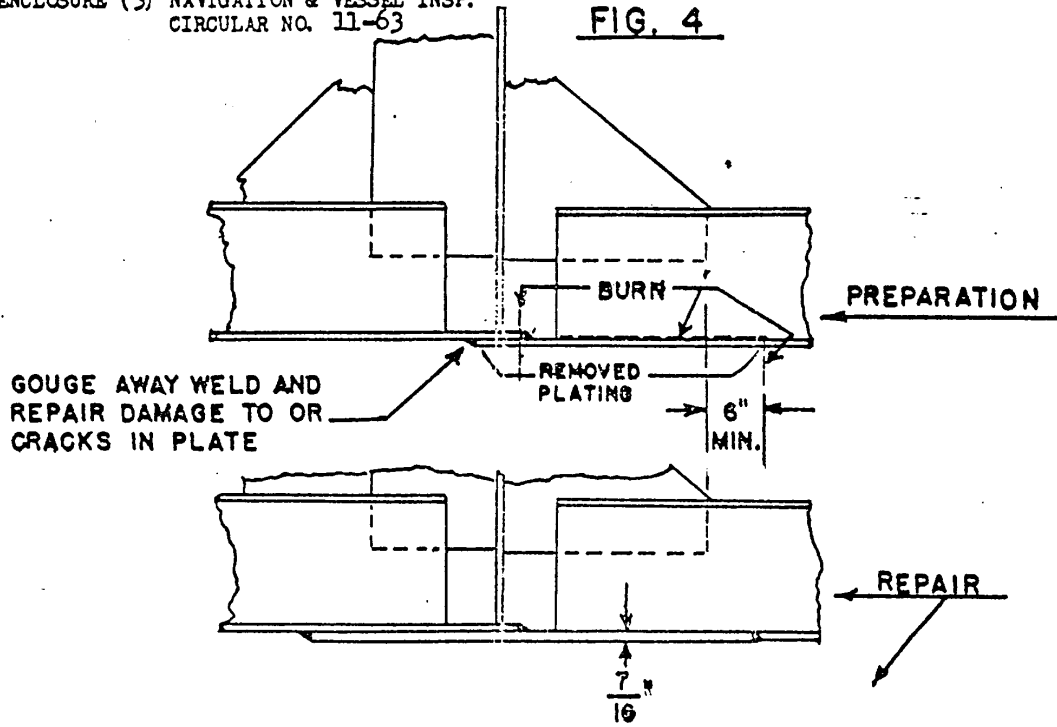
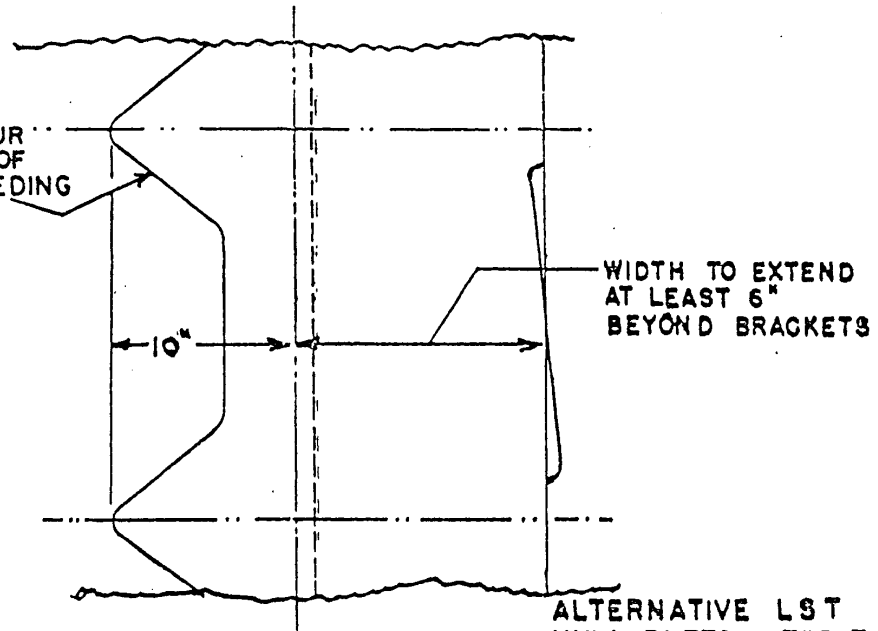
FIG. 4

ALTERNATIVE LST
HULL BUTTS ALTERATION
U.S. COAST GUARD
M.M.T. 9 MARCH 1956
ALT. 16 AUG. 1956

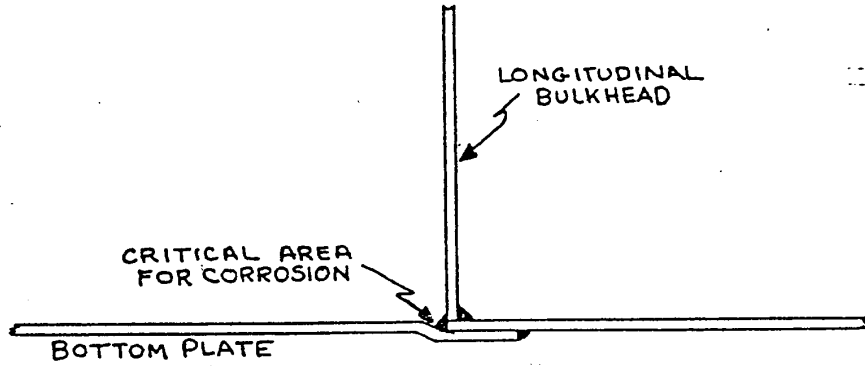
FIG. 5

- b. In LST hulls built during World War II shell and deck plating butts were made as laps at bulkheads, and joggled laps were used for seams, including the critical connection of the garboard strakes under the center vertical keel (no flat plate -keel being fitted)) and the critical bottom -seams under the longitudinal bulkheads. These points are susceptible to accelerated corrosion and to possible metal fatigue (figures 1, 3 and 5). Furthermore, the plating concerned is generally thinner than that of a normal merchant vessel of the same size.

TYPICAL LAPPED SEAM AT LONGITUDINAL BULKHEAD
ORIGINAL CONSTRUCTION

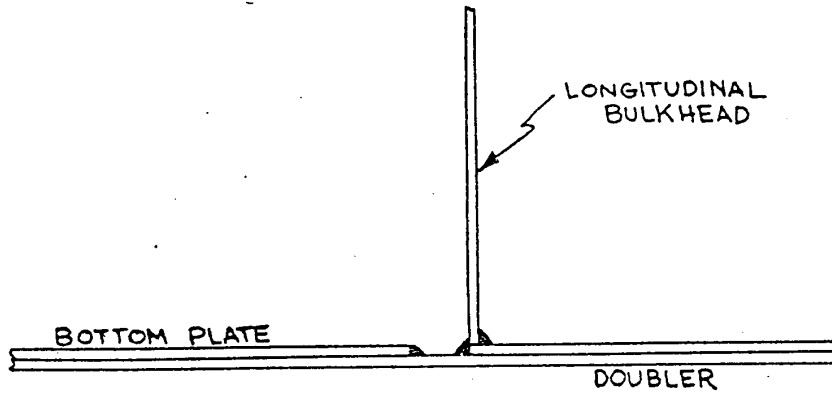
FIG. 6

ALTERNATE METHOD OF INSTALLING BOTTOM DOUBLER
IN WAY OF LONGITUDINAL BULKHEAD
