NVIC 1-84
3 APR 1984

NAVIGATION AND VESSEL INSPECTION CIRCULAR NO. 1-84
Electronic Version for Distribution Via the World Wide Web

Subj: Lack of Topstitching on Some Type I Personal Flotation Devices (PFDs) Ref : (a) 46 CFR
160.006-2

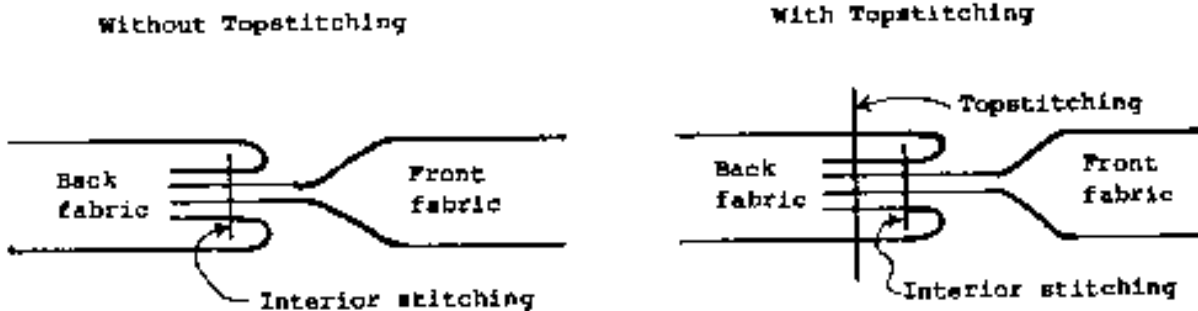
2. **BACKGROUND.** We have received several failure reports concerning Gladding Corporation (now Paris Southern Corporation) AF 500, Model 3, Type I PFDs, approval number 160.002/78/0. After examining these PFDs, we found that the required topstitching was omitted from the shoulder seams. This severely weakens the shoulder of the device, allowing the shoulder seams to be pulled apart rather easily. To date, the problem has been detected in Lots 9, 10, 16, 17, 24, 25, 28, and 32. Therefore, all Lots initially inspected between approximately September 1980 and March 1982 should be identified as possibly having the defect. Illustrations of the construction of the shoulder seam with and without topstitching are shown below:

3. DISCUSSION. The manufacturer has agreed to repair the devices or provide instructions on how to repair the devices. If a device is returned to them, the manufacturer will add the topstitching and return the device to the owner, free of charge. If the owner wants to repair the devices without returning them to the manufacturer, the owner must notify the Officer in Charge, Marine Inspection prior to making the repairs as specified in reference (a). Instructions for making the repair will be provided free by the manufacturer. The manufacturer's address is:

4. ACTION.
 - a. Vessel owners/operators and Coast Guard personnel should closely check any Gladding Corporation (now Paris Southern) AF 500, Model 3, Type I PFDs, approval number 160.002/78/0 manufactured between approximately September 1980 and March 1982 to see if the topstitching has been omitted. If there is no topstitching, the problem should be corrected as discussed in Paragraph 3.
 - b. Officers in Charge, Marine Inspection should normally allow the repairs to be made provided the owner has appropriate equipment and thread and agrees to follow the manufacturer's instructions.

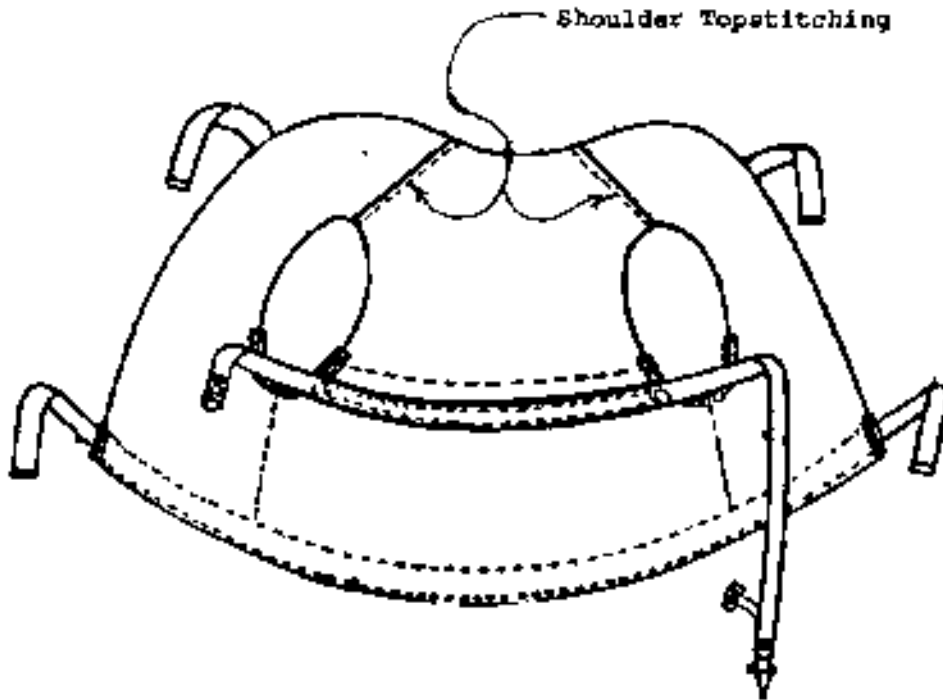
The locations of the seams in question are shown in the following illustration:
