NVIC 4-85 CH-1
20 FEB 1986

NAVIGATION AND VESSEL INSPECTION CIRCULAR NO. 4-85 CHANGE 1

**Subj: Change 1 to NVIC 4-85 of 29 May 1985, Subj: Recalls and Other
Corrective Measures for Lifesaving and Fire Protection Equipment**

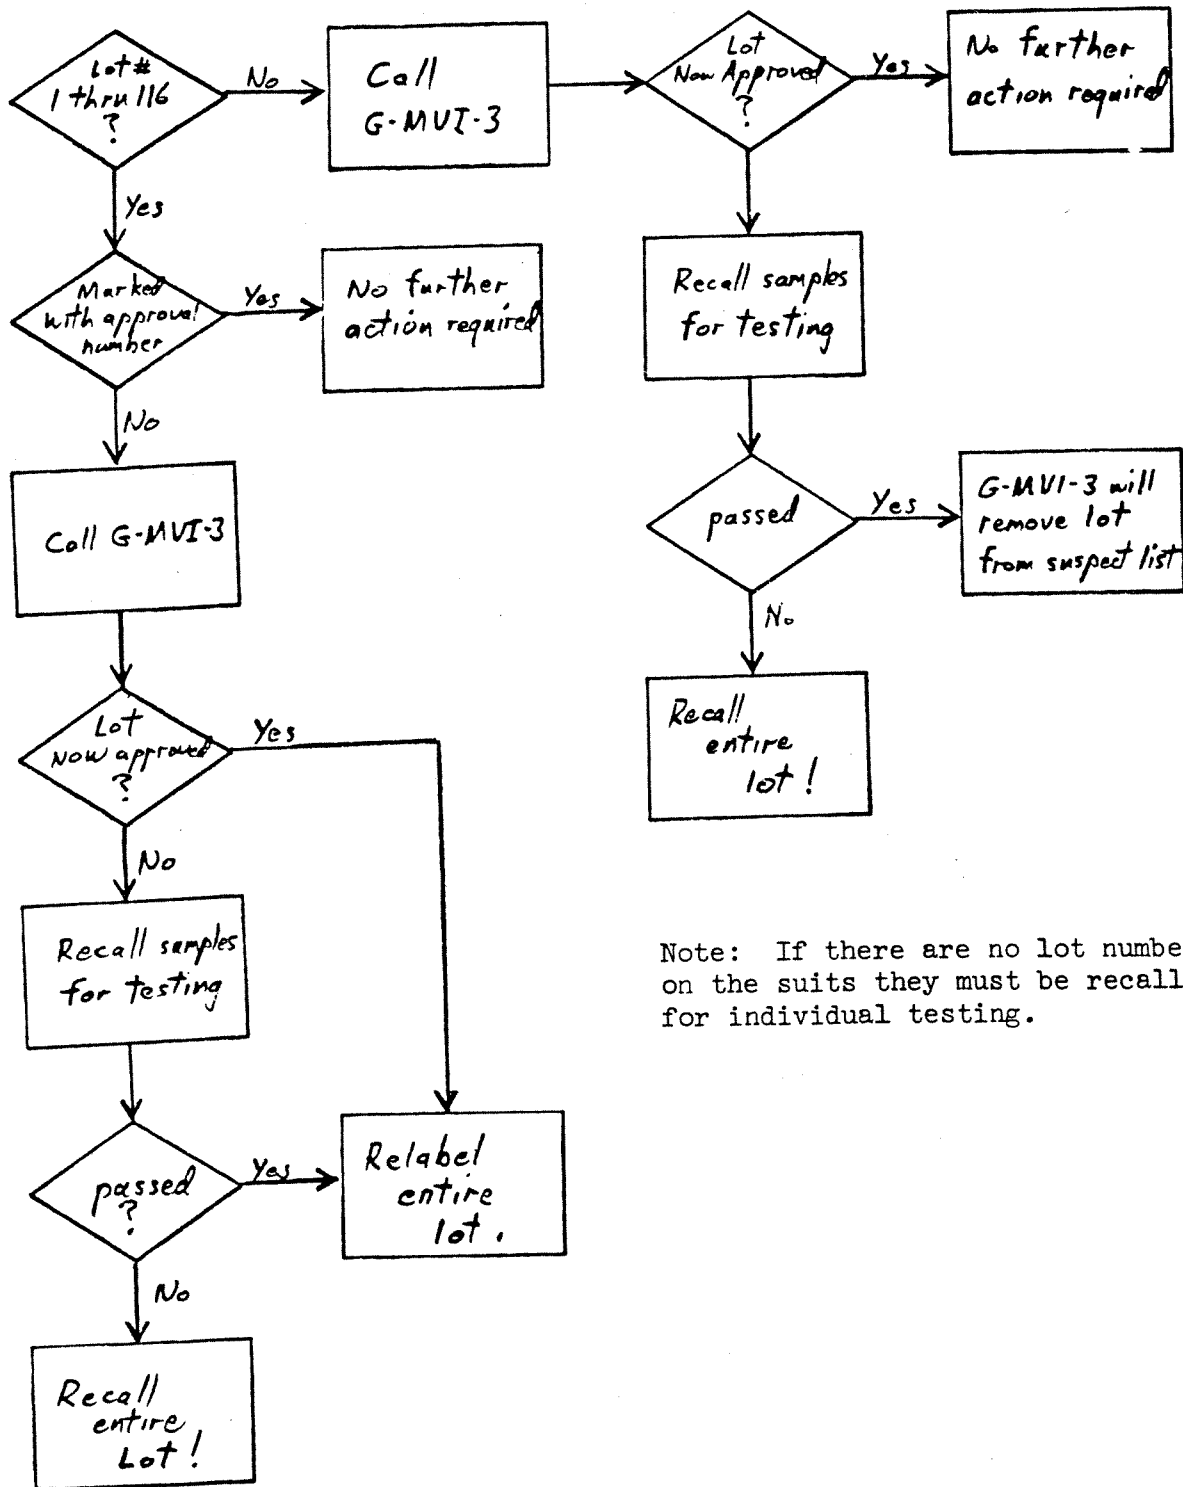
FITZ-WRIGHT SUITS RECALL PROCESS

- a. Fitz-Wright exposure suits up to and including Lot 116 were inspected and tested for Coast Guard approval by Warnock Hersey Professional Services but were not marked with an approval number on the suit.
- b. Production inspection has since been taken over by Underwriters Laboratories (UL), but suits from lot numbers 117-132, 134, and 136-137 may have been labeled as Coast Guard approved even though they were not inspected and tested at the factory by Warnock Hersey or UL.
- c. Some Fitz-Wright suits have been found to have no lot numbers, and their factory inspection status can not be determined.

- a. Where records in the custody of Underwriters Laboratories indicate that a lot numbered 116 or lower was inspected by Warnock Hersey Professional Services, the suits may be relabeled in the presence of a UL inspector.
- b. Where the records indicate that any lot was not inspected by an independent laboratory, representative samples of the lot must be returned to Fitz-Wright for testing by a UL inspector. Fitz-Wright will provide replacements for the samples recalled for testing. After samples of a lot have been tested and inspected, the lot will be approved and all suits of that lot may be relabeled in the presence of a UL inspector.
- c. Any suit which does not bear a lot number can not be considered Coast Guard approved.

- c. The flow chart on the following page is provided to guide decisions on testing and relabeling.

Note: If there are no lot numbers on the suits they must be recalled for individual testing.

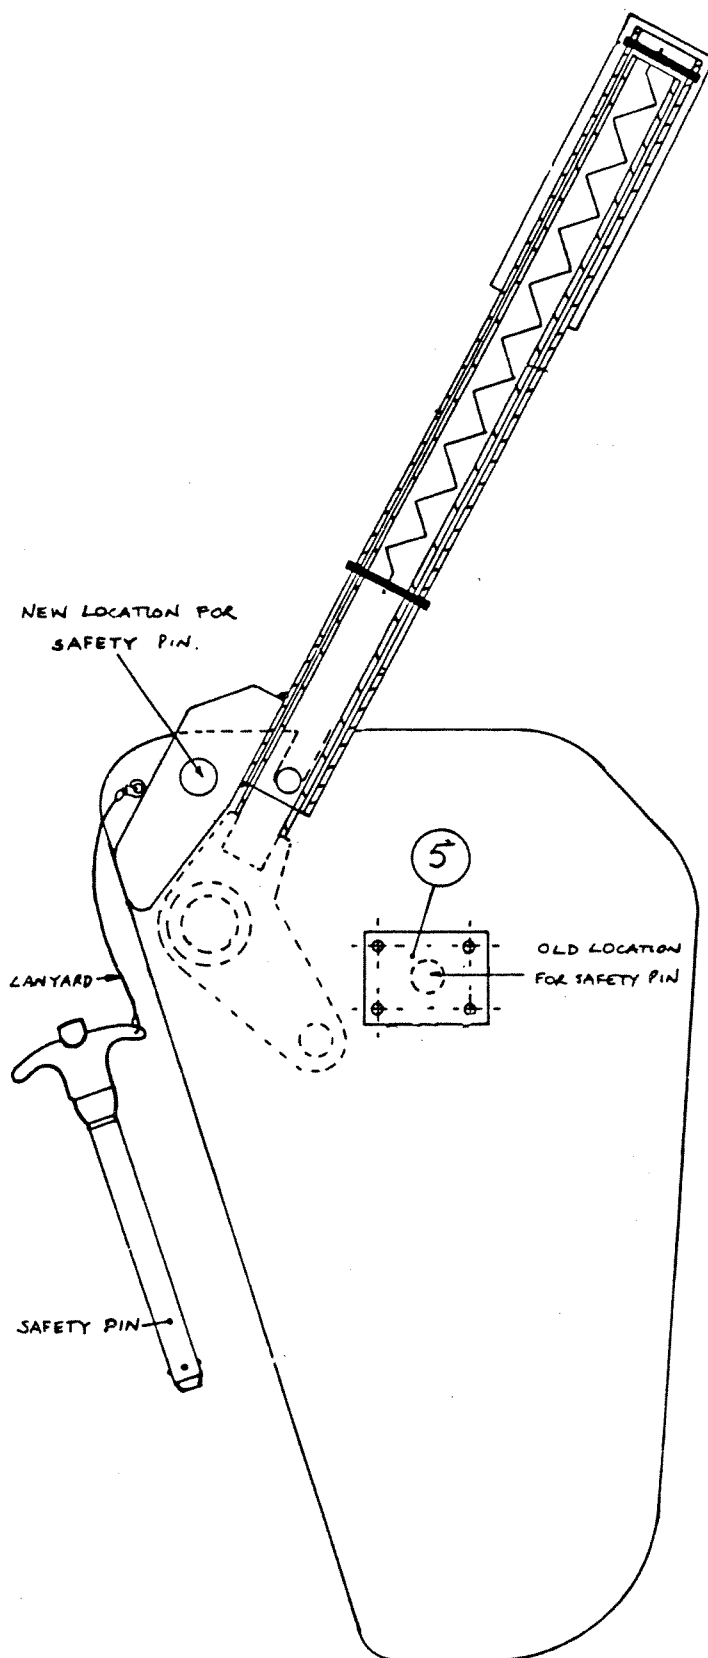
1. PROBLEM. The safety pin on the Titan release gear operating handle used in certain Watercraft America lifeboats, can be inserted before the handle is in the safe, fully closed position. In this condition, the release hooks may appear to be fully closed, but may unexpectedly open when a load is applied.

- a. Titan release gear with approval number 160.033/69/0 must be modified. Titan gear that has been modified can be identified by the cover plate over the old safety pin hole (item 5 on the drawing on the following page), and by the plate added to the release gear handle to accommodate the new safety pin location (see "NEW LOCATION FOR SAFETY PIN" on the drawing).

3. ACTION.
 - a. Vessel and MODU operators having Watercraft America lifeboats equipped with Titan gear having approval number 160.033/69/0 shall make sure the release gear is modified in accordance with Watercraft America drawing SP-201 and Engineering Instruction P-131, both dated 28 October 1985. The Coast Guard Officer in Charge of Marine Inspection shall be notified before the modification work begins. The drawing and instruction may be obtained from:

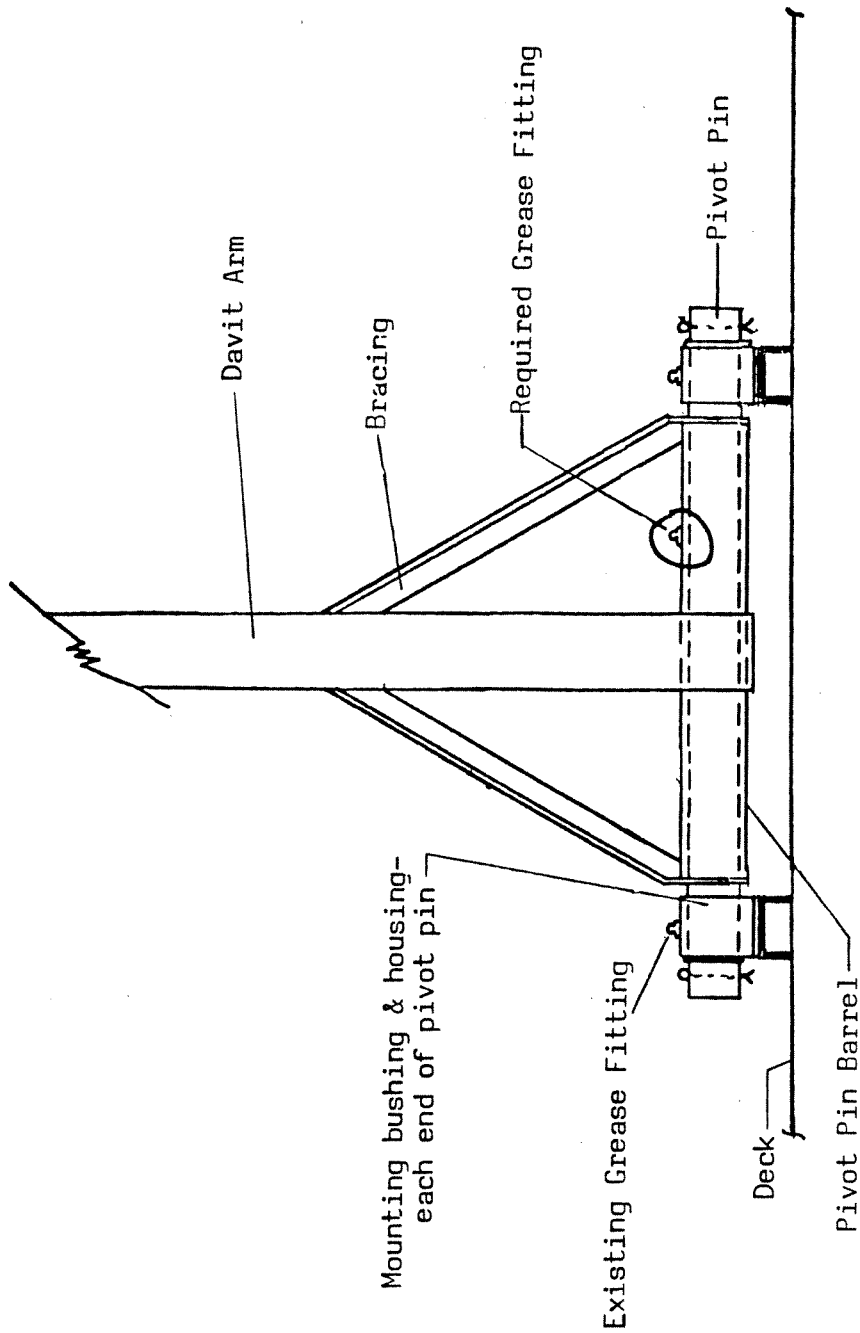
Looking Inboard at Davit Arm Base

1. PROBLEM: The pivot pins of certain mechanical davits arranged as shown in the figure on the following page, are subject to corrosion and seizure, due to water accumulation inside the pivot pin barrel.
2. ACTION: To prevent corrosion and seizure of the pivot pin, the pivot pin barrel should be equipped with a lubrication fitting as shown in the figure. Grease should be applied to this fitting regularly to exclude accumulated water in the barrel in order to permit easy operation of the davit.
 - a. Modification of mechanical davits to add this lubrication fitting is authorized. The Coast Guard Officer in Charge of Marine Inspection shall be notified before the modification work begins.
 - b. Coast Guard inspectors will require the addition of lubrication fittings to the pivot pins of mechanical davits where it is evident that water accumulation and corrosion is a problem.

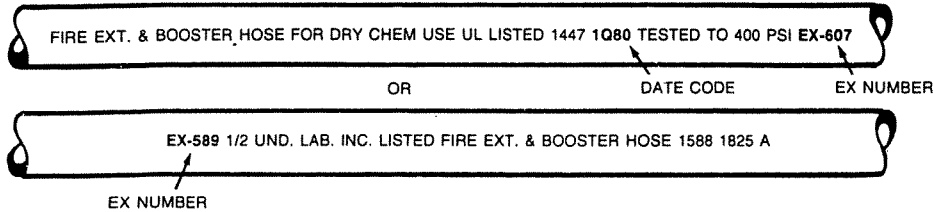
**ILLUSTRATION 1**

1. If extinguisher has a yellow "Inspected" sticker on the front, go to step 9.
2. Find U.L. Listing information printed on hose (either white print or molded on hose cover). (See illustration 1 below.)

3. If there is no printing, or printing is unreadable, replace hose assembly and destroy old hose.
4. Refer to **EX** number on hose, if it is **NOT** EX-607 or EX-589, hose is good, do **NOT** replace.
5. If EX-607
