N-CFSAC

Supporting Documentation Package 1

**INVESTIGATION INTO THE CIRCUMSTANCES
SURROUNDING THE FIRE ONBOARD AND
SUBSEQUENT TOTAL CONSTRUCTIVE LOSS
OF**

**COMMERCIAL FISHING VESSEL
MISS DOLORES
(O.N. 938108)**

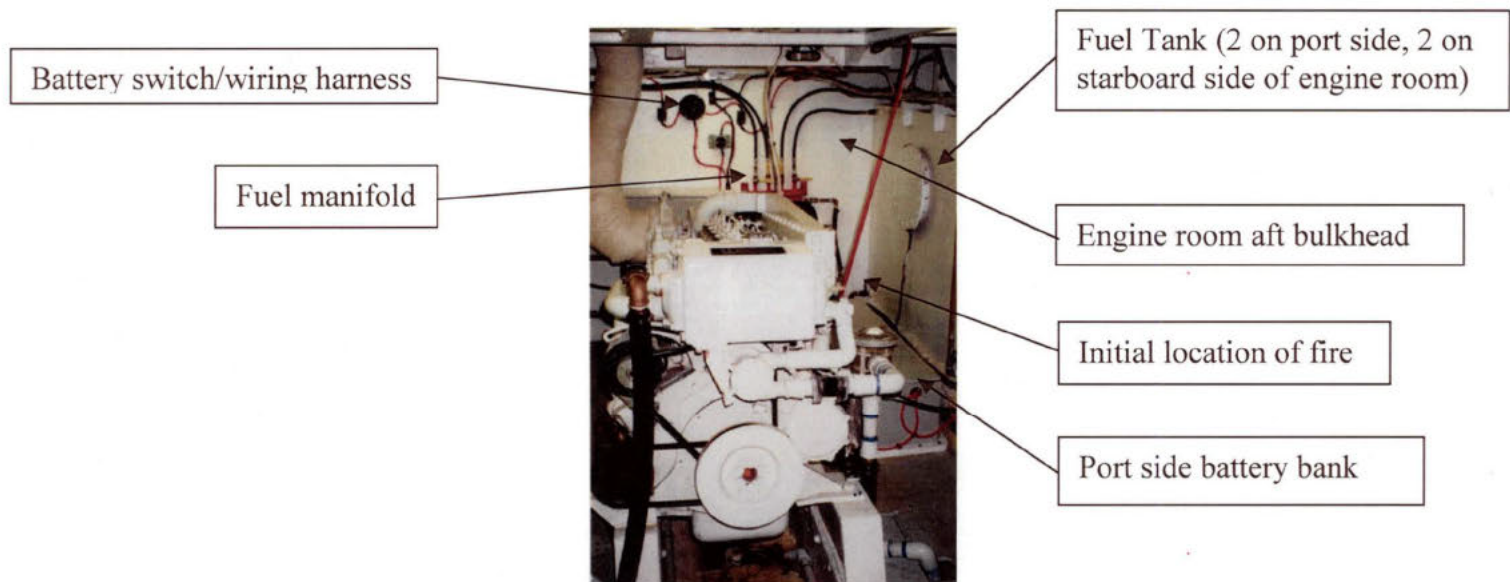
Port aft corner of MISS DOLORES engine room; taken after construction

- l. The MISS DOLORES was insured for \$210,000.
- m. Electrical wiring in the port aft corner of the engine room, which originally led from the port battery bank to the wiring harness on the aft bulkhead, was fused solid in two locations near the battery terminal end.

6. **Conclusions:** The fire is believed to have started in the port aft corner of the engine room, most likely initially as an electrical fire. Due to the close proximity of the electrical and fuel components, the fire quickly spread to the fuel lines. The fire spread through the forward cabin area burning two thirds of the vessel to the waterline. Earlier detection of the fire may have allowed the fire to be successfully extinguished.

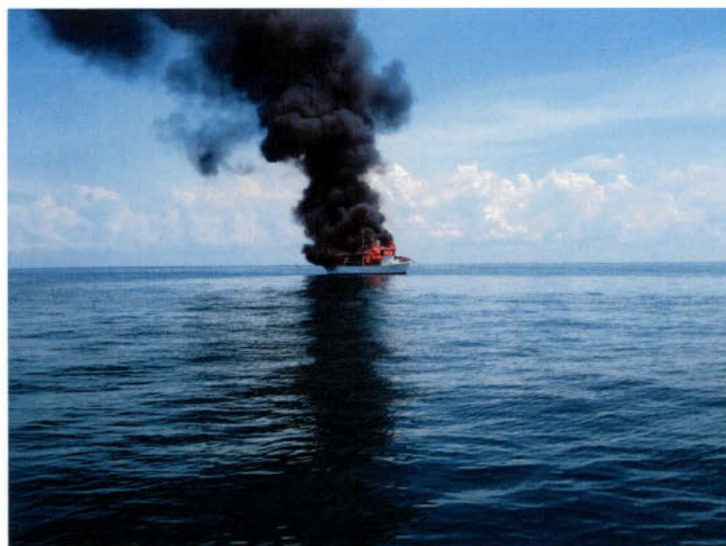
MISS DOLORES at 1253 local time

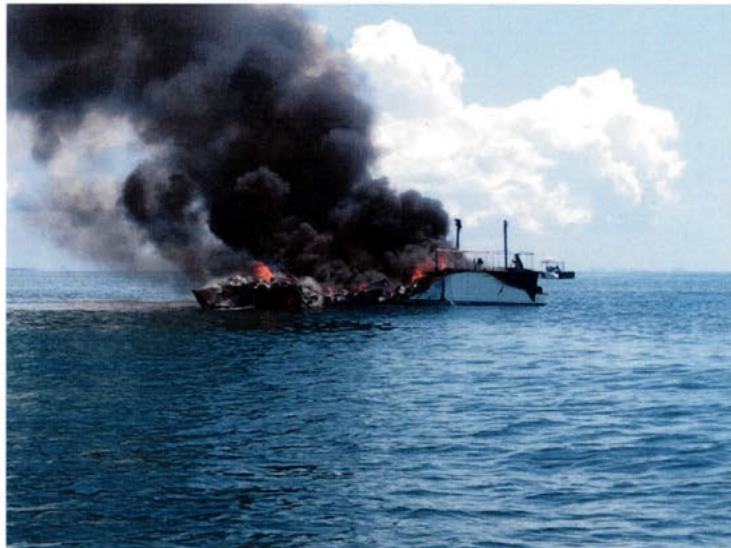
MISS DOLORES at 1420 local time

- i. At approximately 1440, the MISS DOLORES began flooding and eventually capsized and then sank by the bow. The stern remained afloat due to reserve buoyancy.

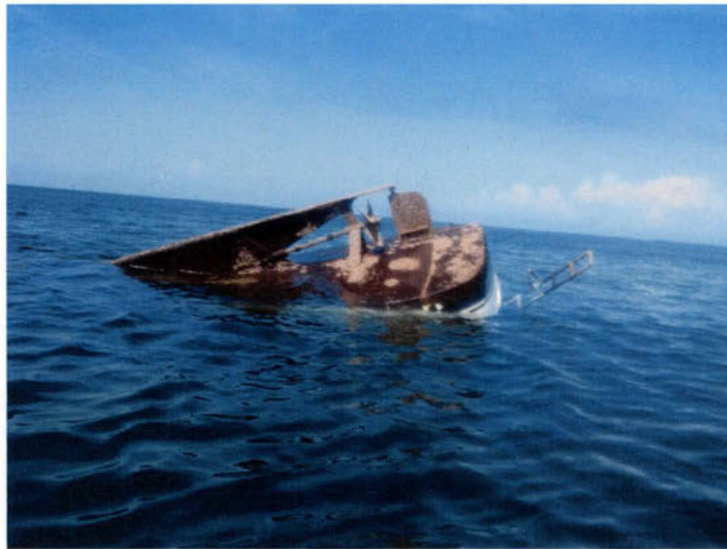
MISS DOLORES stern remained afloat

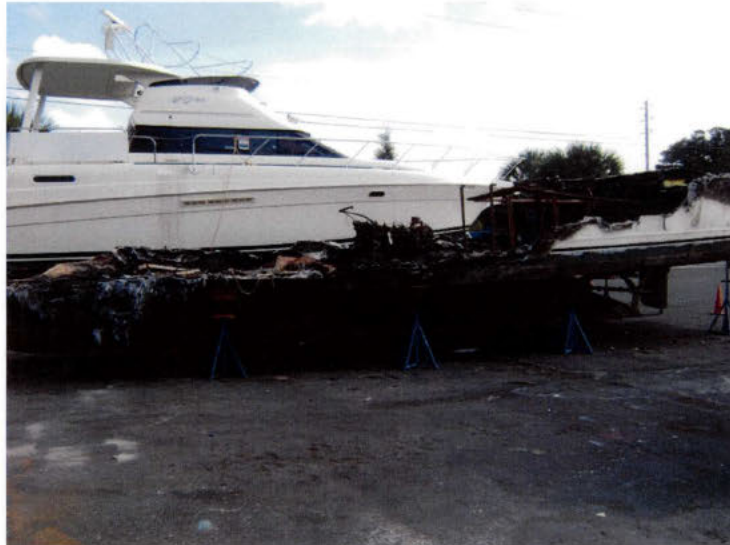
- k. On September 20, 2010, the remaining hull of the MISS DOLORES was salvaged and taken to Tarpon Springs, FL. Vessel was determined to be a total constructive loss.

MISS DOLORES on September 23, 2010, after salvage

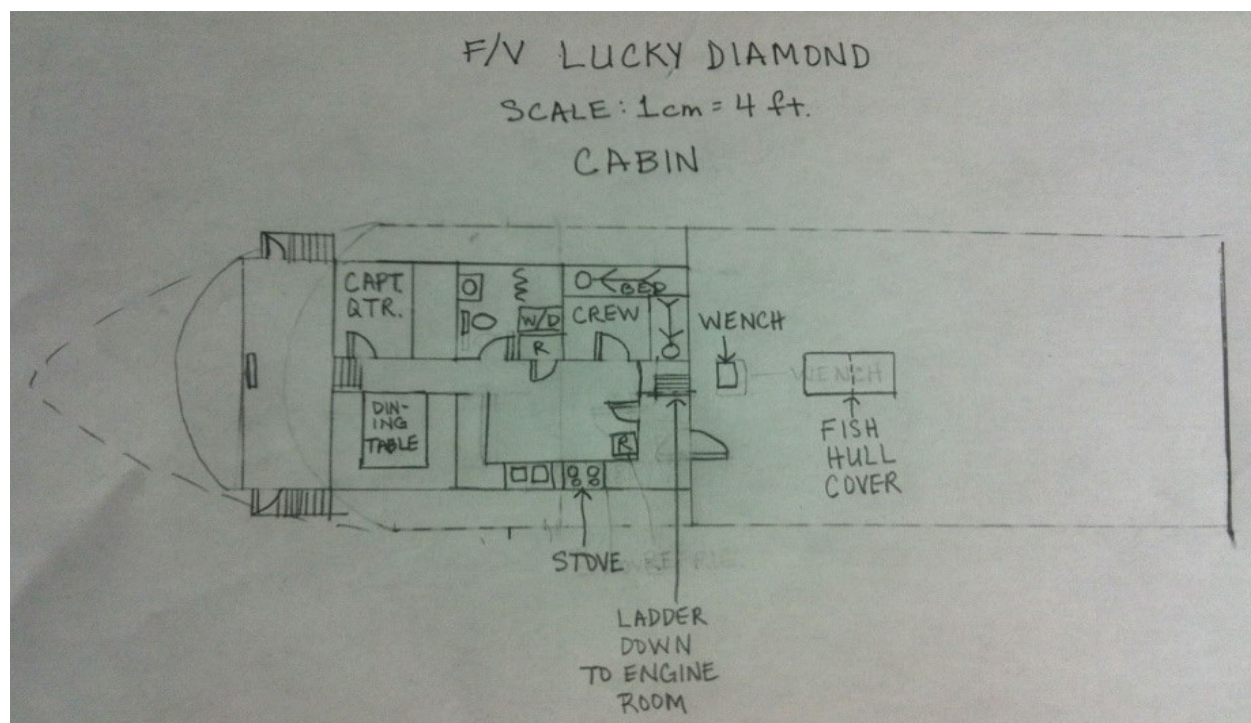
Sketch of *Lucky Diamond's* Main Deck

9. At 2200, Master [REDACTED] woke up to the smell of smoke. A smoke detection system was located outside the Master's cabin, but it did not sound. The smoke detector was not required but since it was installed it should have been in working order.

2. *System defenses were present, but did not work:* One smoke detection system was installed on the vessel located in the dining area just outside of the Master's stateroom. Master [REDACTED] indicated he woke up to the smell of smoke and at no time did he hear the smoke detection system. Although not required, safety equipment was installed, but was not properly maintained or in good working condition. If the smoke detection system were operational, the crew could have been alerted sooner to the presence of smoke and given the opportunity to

1. It is recommended that the Commandant initiate a regulation change requiring commercial fishing vessels 50 feet or over to have a minimum of one (1) smoke detector in the Galley and in each accommodation space or have it located in an area that is audible from each accommodation space. Early detection is vital during a fire, hence, implementing this change would provide an early warning system and allow crewmembers to fight a fire before it spreads. Additionally, commercial fishing vessels do not have a 24-hour watch standing requirement; all crewmembers could be asleep at the same time as in the case of the *Lucky Diamond*. Installing a smoke detector is an easy and cost effective tool that could save lives.

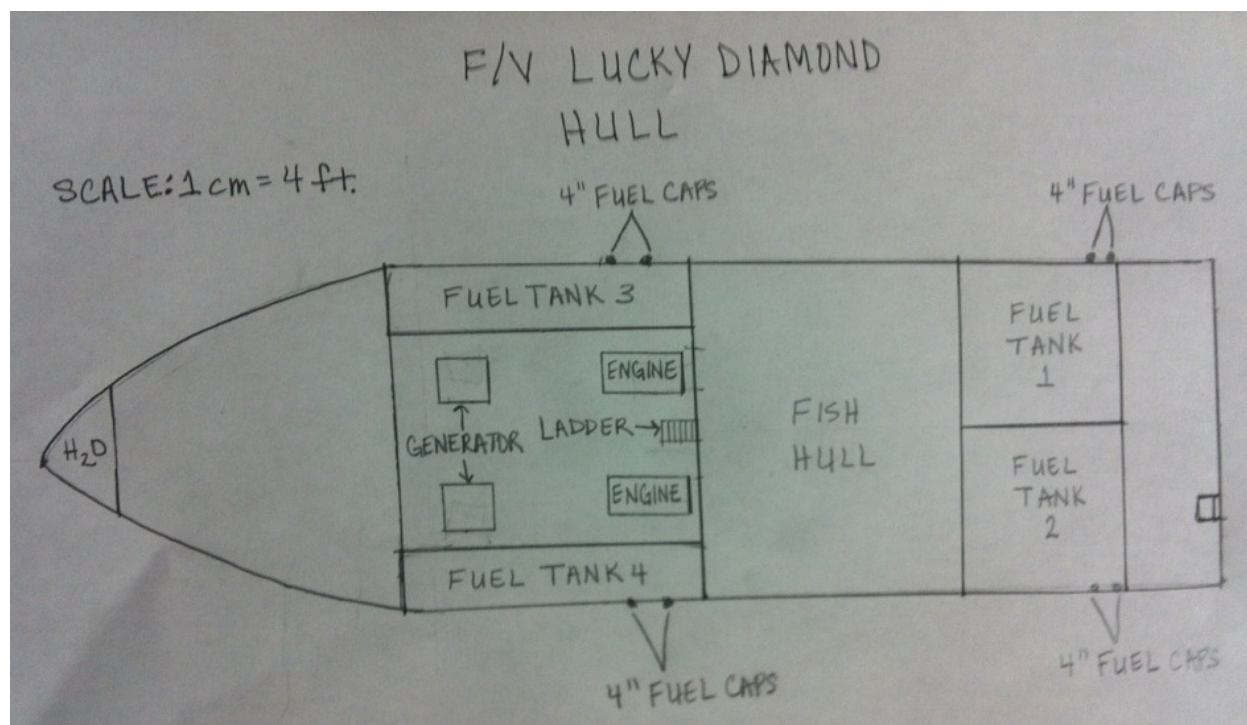
Sketch of *Lucky Diamond's* Engine Deck

1. *Fire:* Master [REDACTED] saw a small fire coming up from the deck near the crew's cabin door and noticed smoke outside of the crew's cabin, located aft. The source of the fire is unknown, but the Master believes the fire originated from frayed electrical cables that were affixed overhead in the engine room and located just below the crew's cabin space. If the wires were exposed, as indicated by the Master's statement, then it creates an unsafe condition. The protective exterior to the wires were missing and the wires could have heated to a point of ignition. As a reference, the electrical cables powered the wheelhouse, stove, lights, etc. and came from the generators located forward of the engine room. The vessel was powered by two (2) Caterpillar (CAT) 3412 diesel engines and two (2) Perkin 60K generators.
