N-CFSAC

Supporting Documentation Package 3

MISLE Incident Investigation Report For F/V PACIFIC RANGER; Collision with a Helicopter

MISLE Incident Investigation Report For MAKAH MAID Loss of Propulsion

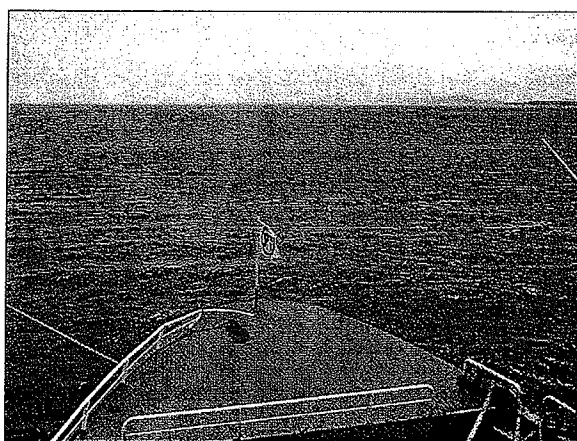
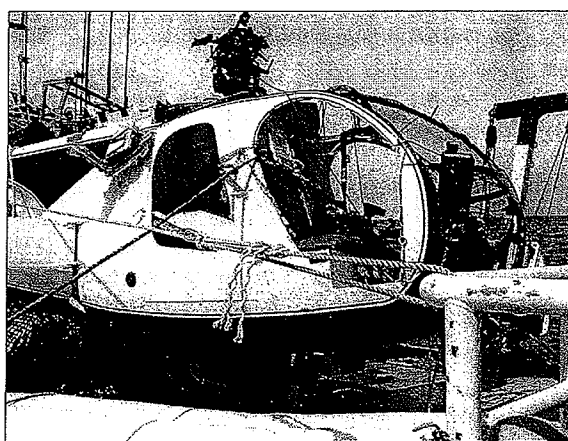
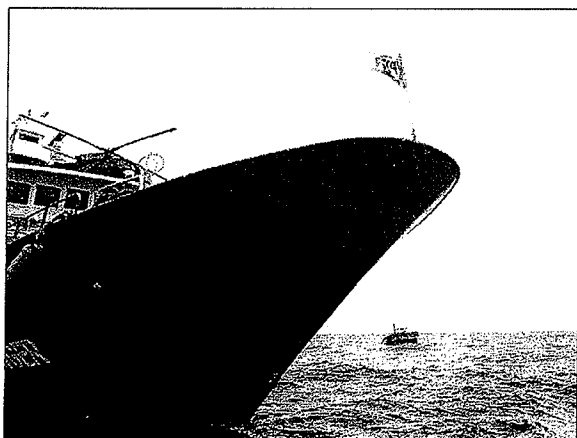
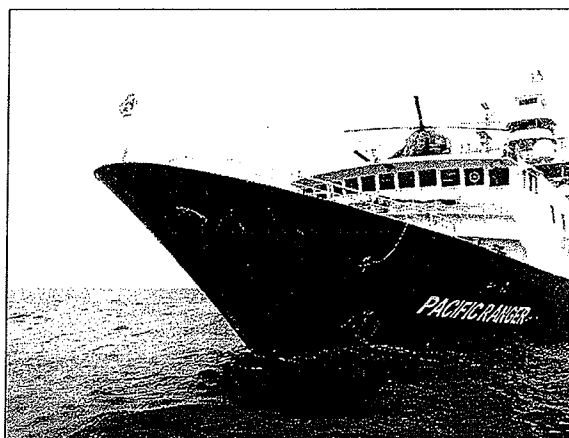
On 02 March 2013, at approximately 1350 hrs, the F/V PACIFIC RANGER was underway in the Pacific Ocean approximately 500 nautical miles south of Pohnpei, Federated States of Micronesia. While approaching a Fish Aggregating Device (FAD), the helicopter N471M "buzzed" the F/V PACIFIC RANGER and proceeded to a hover above the FAD in an effort to claim it for their fishing vessel, the F/V FONG KUO #869. Subsequently, the F/V PACIFIC RANGER collided with the tail rotor of the helicopter N471M, which resulted in the helicopter crashing into the ocean and resting inverted in the water. Accordingly, the pilot was injured and was able to emergency egress from the inverted wreckage; however, the spotter was killed. The helicopter's inflatable pontoons kept the wreckage afloat.

Once the F/V PACIFIC RANGER stopped, a full rescue effort was initiated by launching the vessel's small boats. As the small boats arrived at the helicopter wreckage, numerous crewmembers from the F/V PACIFIC RANGER jumped into the water to assist in the rescue. As a result, one of the F/V PACIFIC RANGER's crewmembers was injured. The other crewmembers found the pilot and assisted him onto one of the small boats; however, the spotter was submerged and still tethered to the helicopter. The spotter was unconscious after being brought to the surface and did not appear to be breathing. Attempts to revive the spotter using CPR were unsuccessful and he died as a result of the crash.
