N-CFSAC

Supporting Documentation Package 3

REPORT OF INVESTIGATION
INTO THE
COMMERCIAL FISHING VESSEL (CFV)

COASTAL REIGN Capsizing & Loss of Life

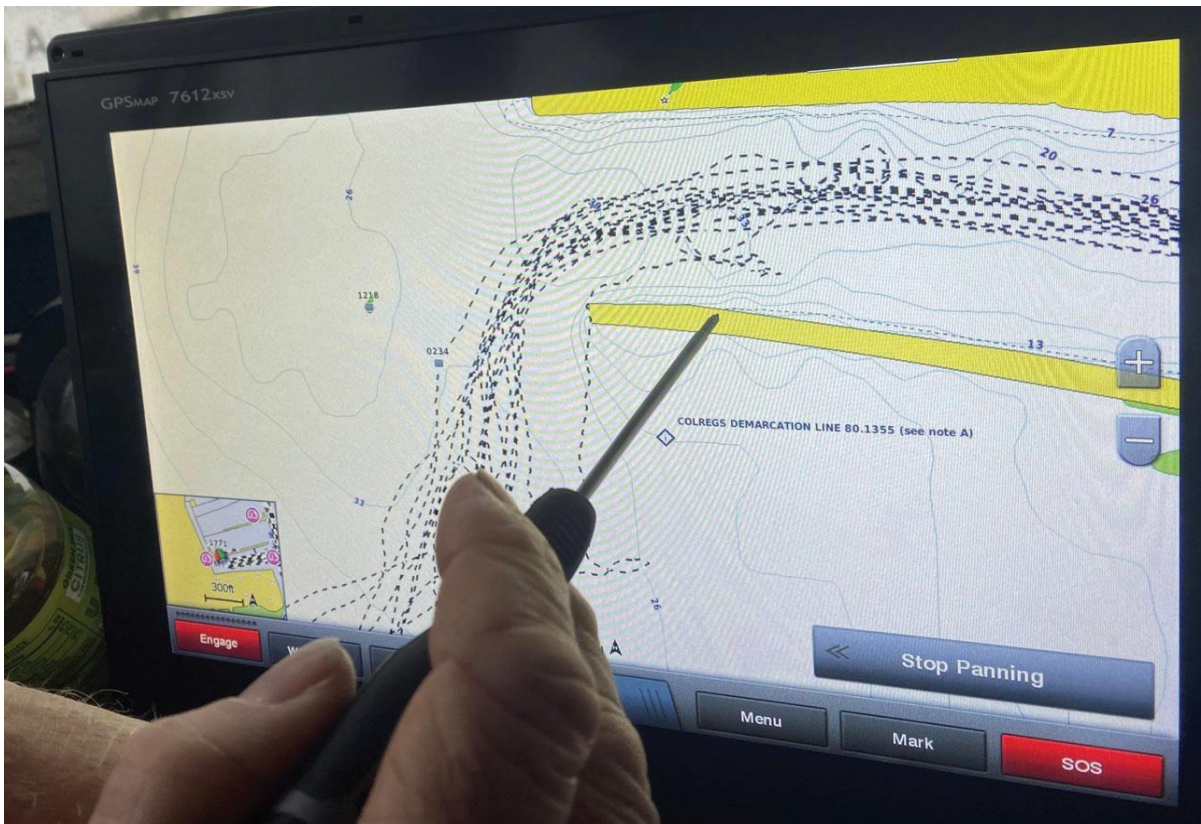
The approximate end of the submerged jetty, showing that the electronic chart portrays an image of the as-built jetty.

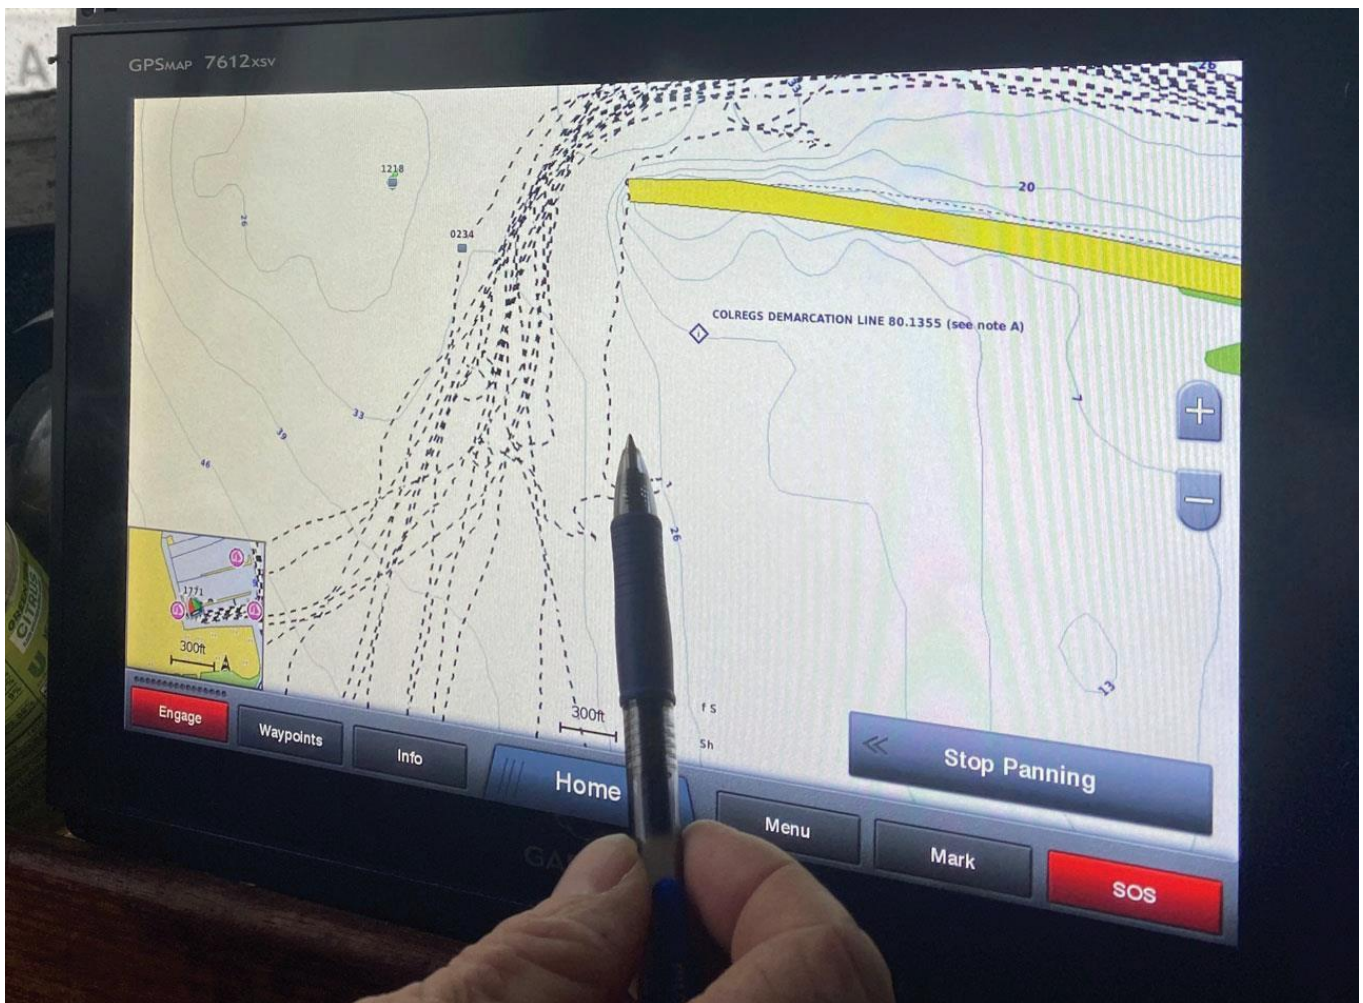
Owner/operator of CFV LADY LEE pointing to the location where the CFV COASTAL REIGN was set up prior to beginning its approach from the south, approximately 600 feet east of the CFV LADY LEE’s starting position.

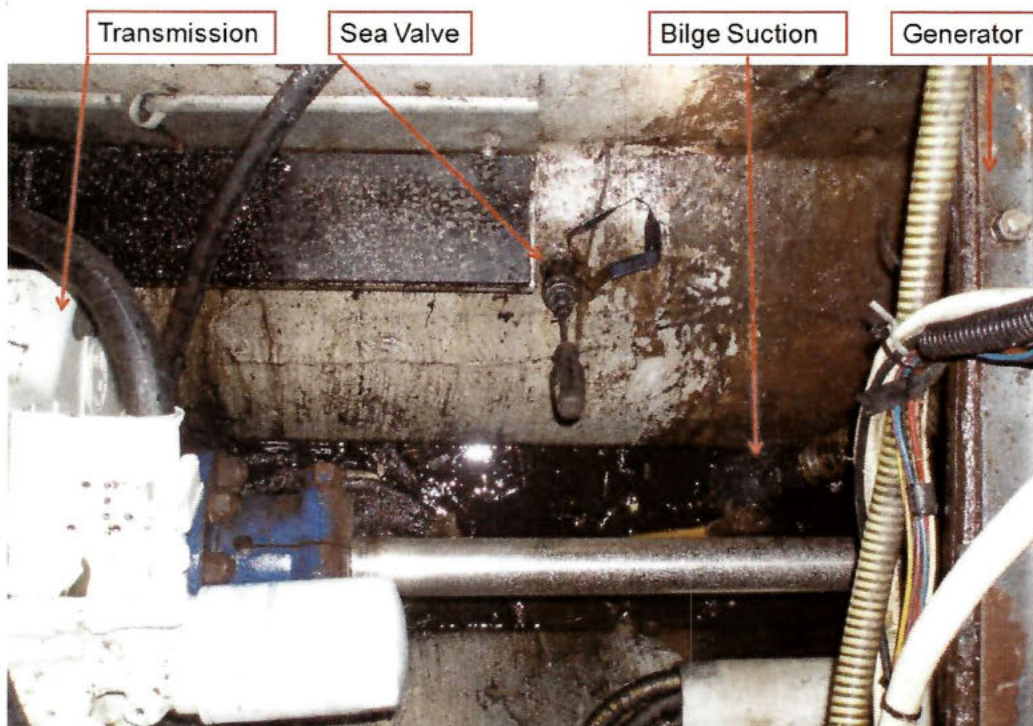
Figure 3: Engine room shaft and bilge area

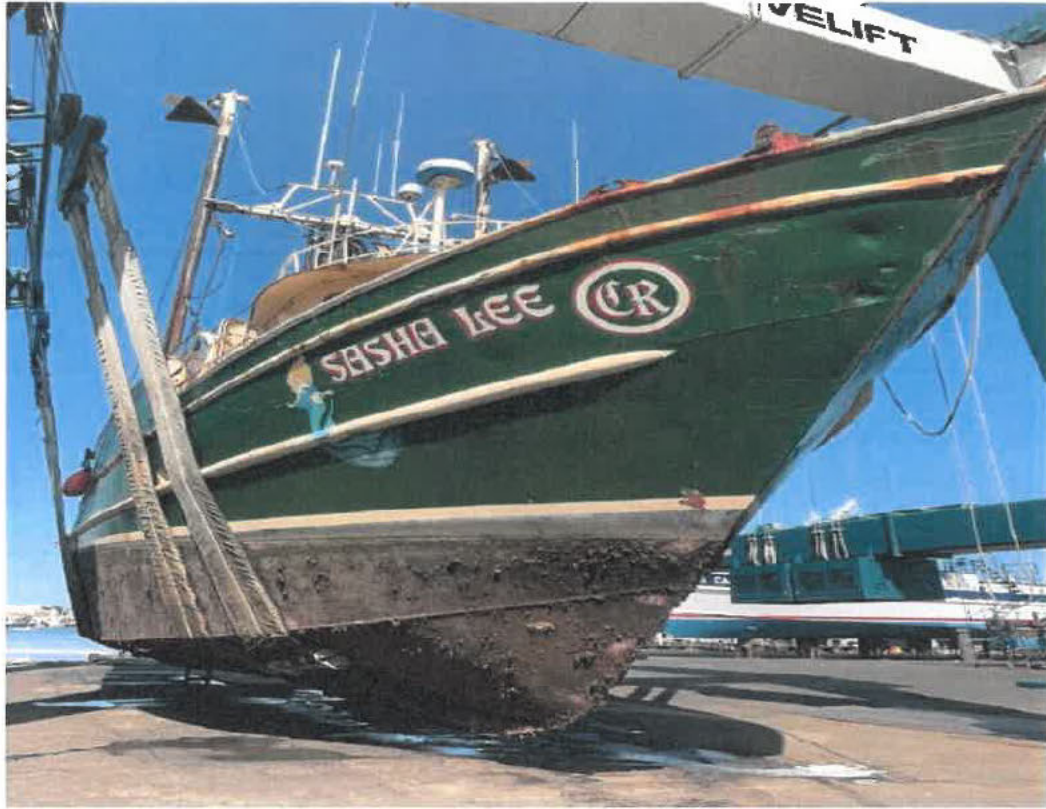
Figure 9: SASHA LEE hull during haul out, August 2019. Image courtesy of Marine Safety Consultants.

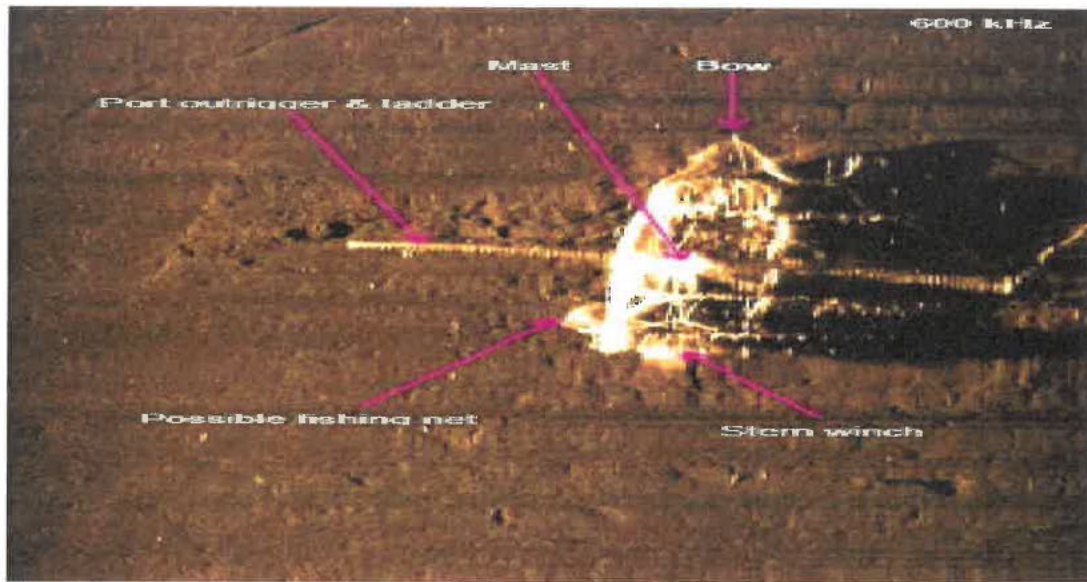
Figure 40: Prototype Klein 4K-SVY 600 kHz (75 m scan range) imagery of the FV EMMY ROSE lying upright on the seafloor with the port and starboard outriggers deployed. No vessel damage is visible. Image courtesy of MIND Technology, 2021.

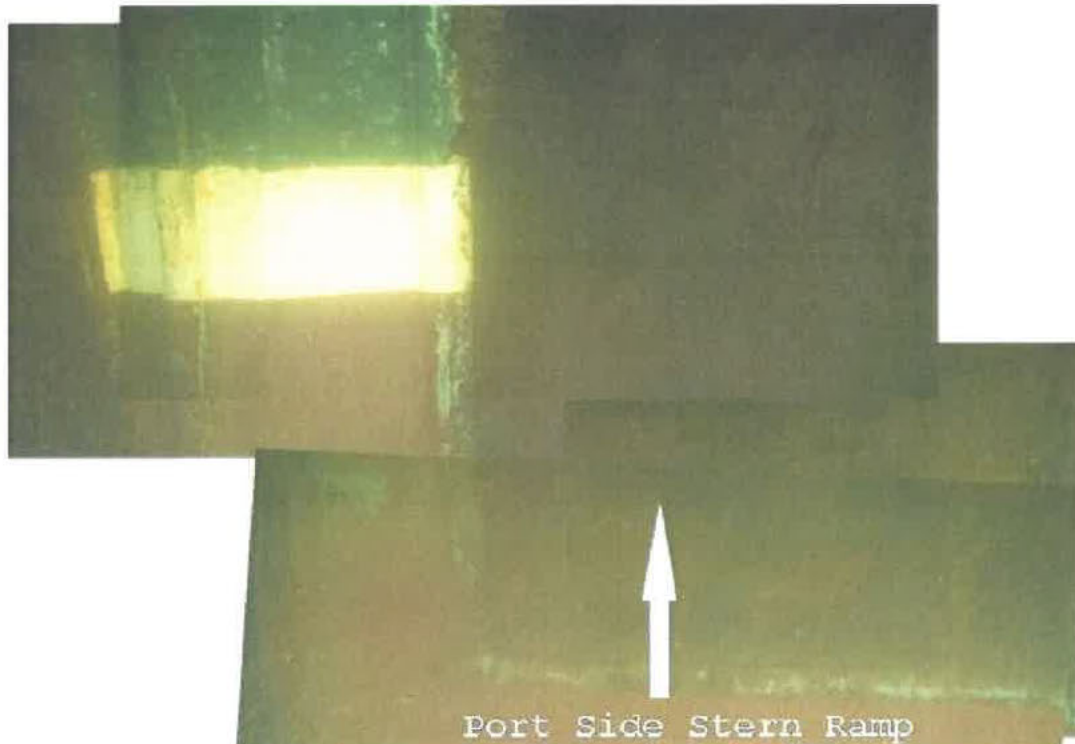
Figure 47: Port quarter of the EMMY ROSE. Image courtesy of WHOI, 2021.

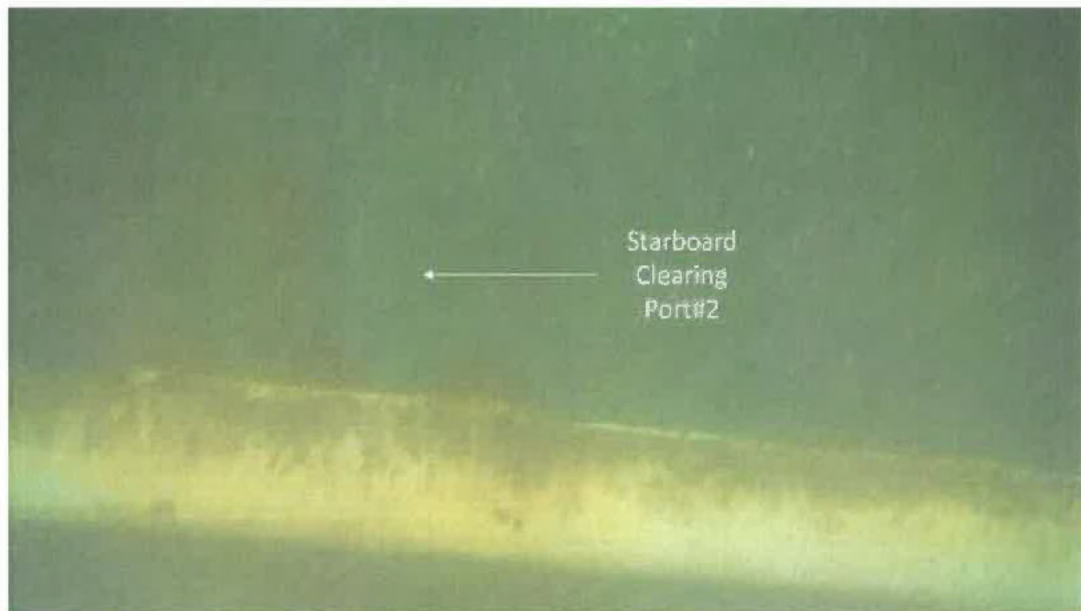
Figure 54: Starboard clearing (freeing) port #2. Image courtesy of WHOI, 2021.

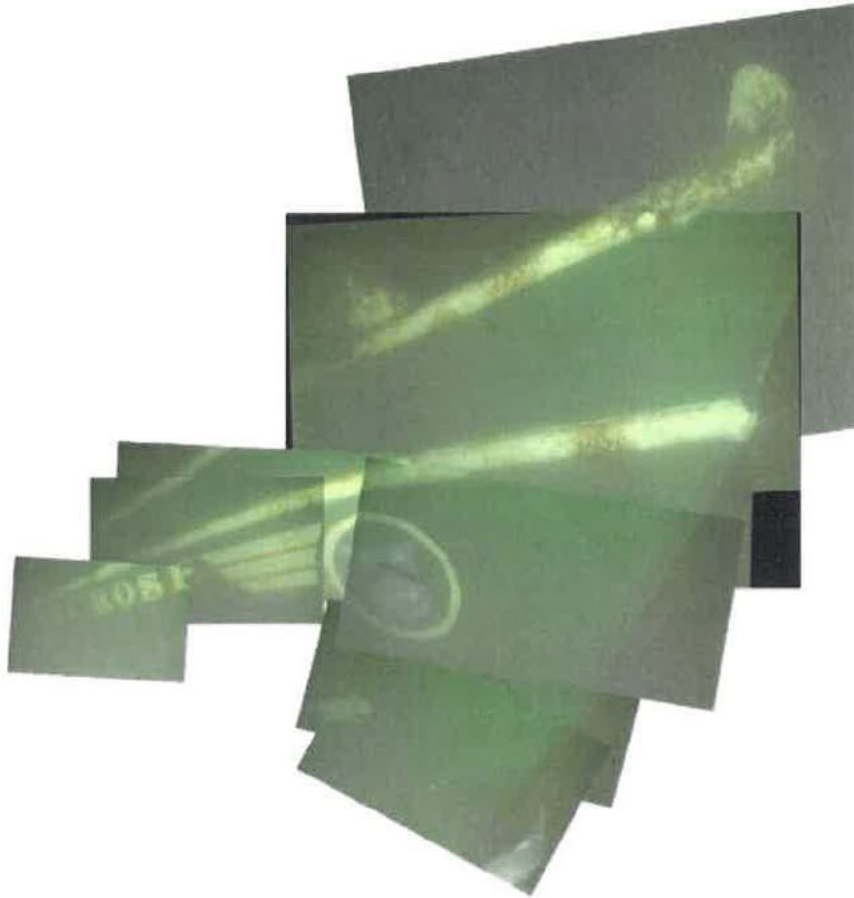
Figure 61: Starboard side bow of the EMMY ROSE. Image courtesy of WHOI, 2021.

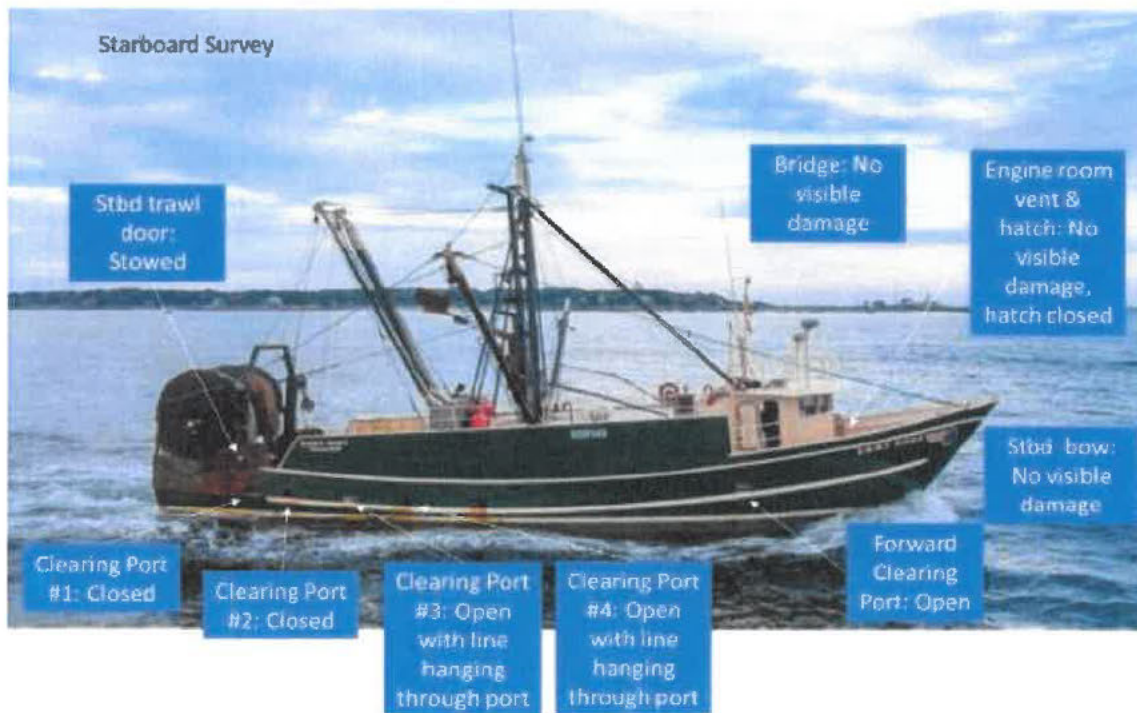
Figure 68: Starboard side ROV survey results of the EMMY ROSE. Image courtesy of WHOI, 2021.

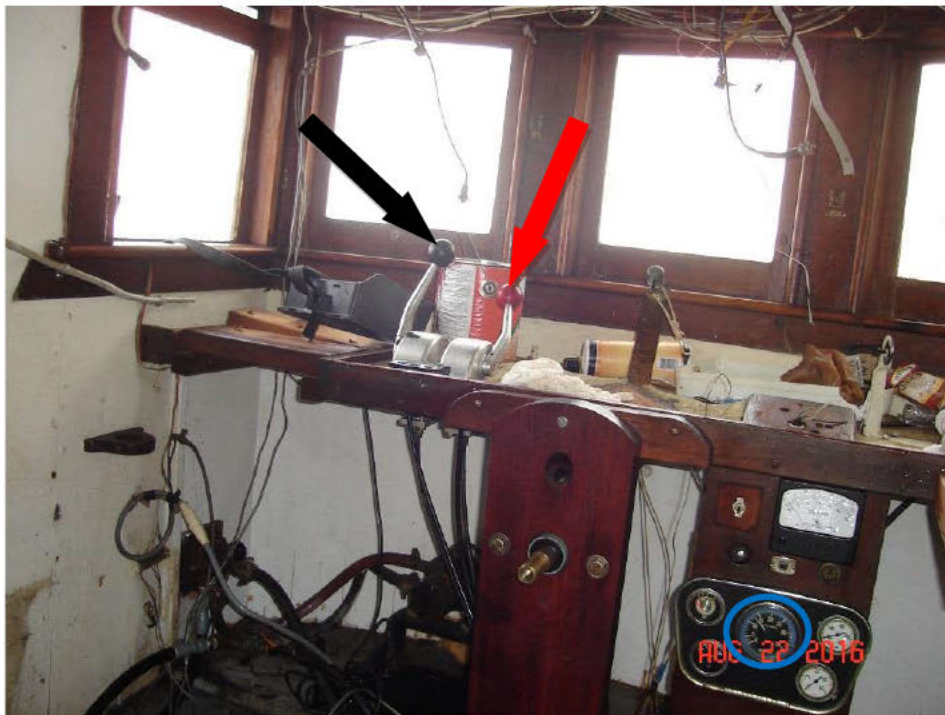
August 22nd photo of the wheelhouse of the ILA showing engine controls (gear control indicated by black arrow; throttle indicated by red arrow) and engine tachometer (circled in blue at lower right).

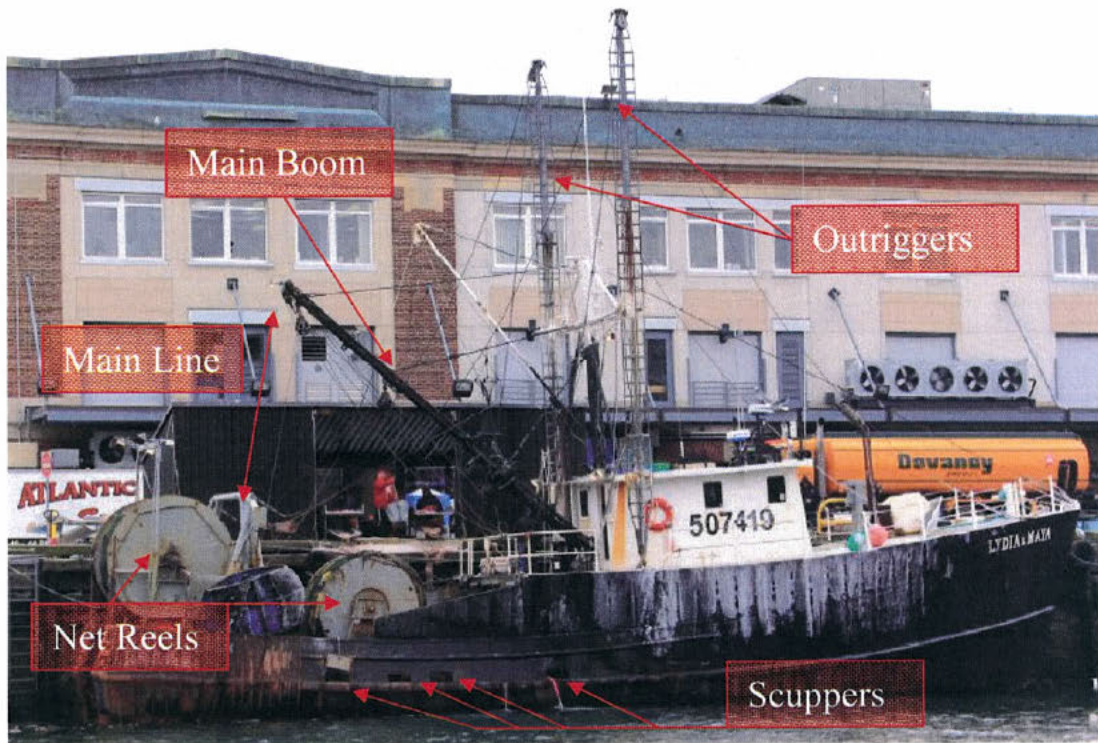
Figure 2 – Starboard profile of the F/V LYDIA & MAYA. The furthest two scuppers (also known as freeing ports) aft were reported plugged on both the port & starboard side. This inhibited the drainage of water from the vessel’s deck (courtesy of USCG Sector Boston).

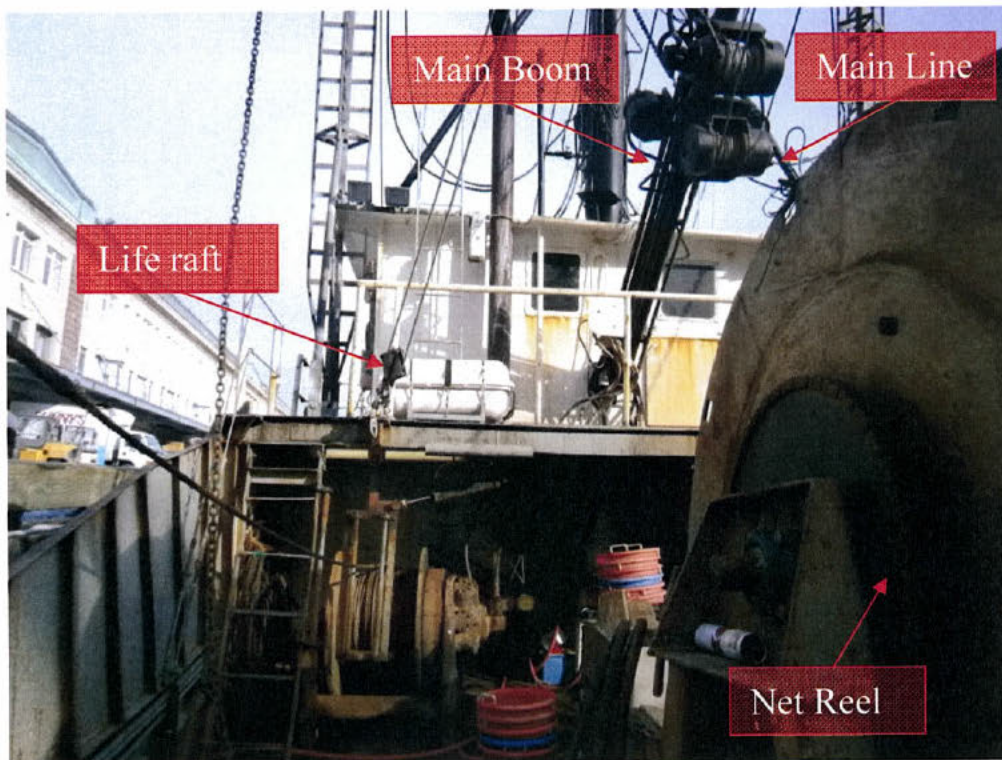
Figure 5 – The inflatable six-person life raft was located behind the pilot house the port of centerline (courtesy of USCG Sector Boston).

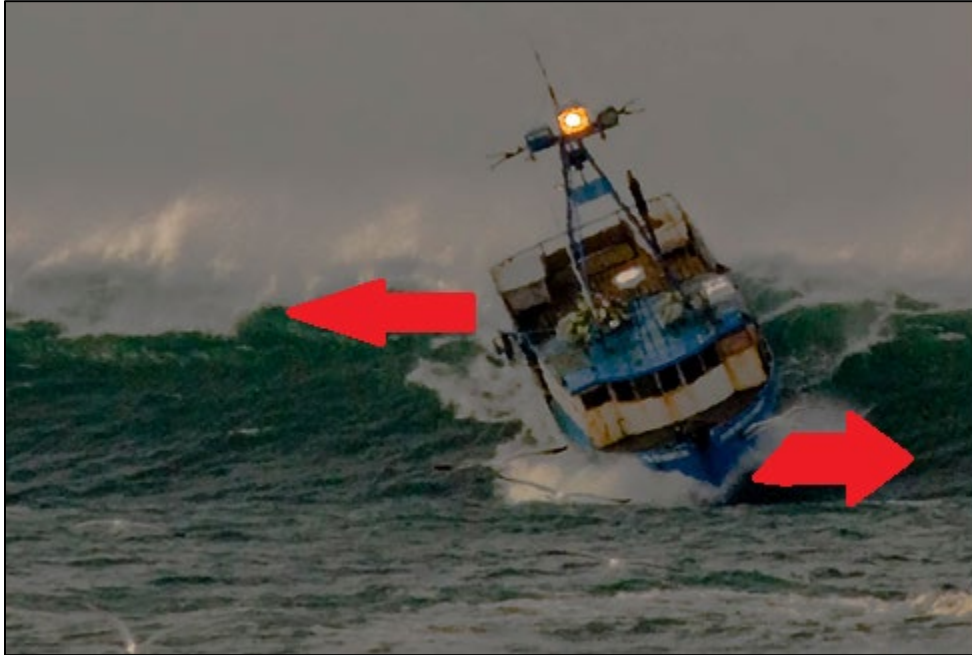
Figure 75. Labeled image of the F/V NORSKEN FISHER entering Yaquina Bay Bar in surf on an unknown date. The red arrows, which have been placed on the image, indicates the dangerous potential for movement of the vessel. Than can lead to broaching if there is a loss of control or an overpowering by the following wave without sufficient power and control to swiftly counteract this momentum. This broaching would result in the vessel laying sideways in the trough of the wave, which most likely lead to a capsizing of the vessel. (Source - Mr. and Mrs. [REDACTED] ©)

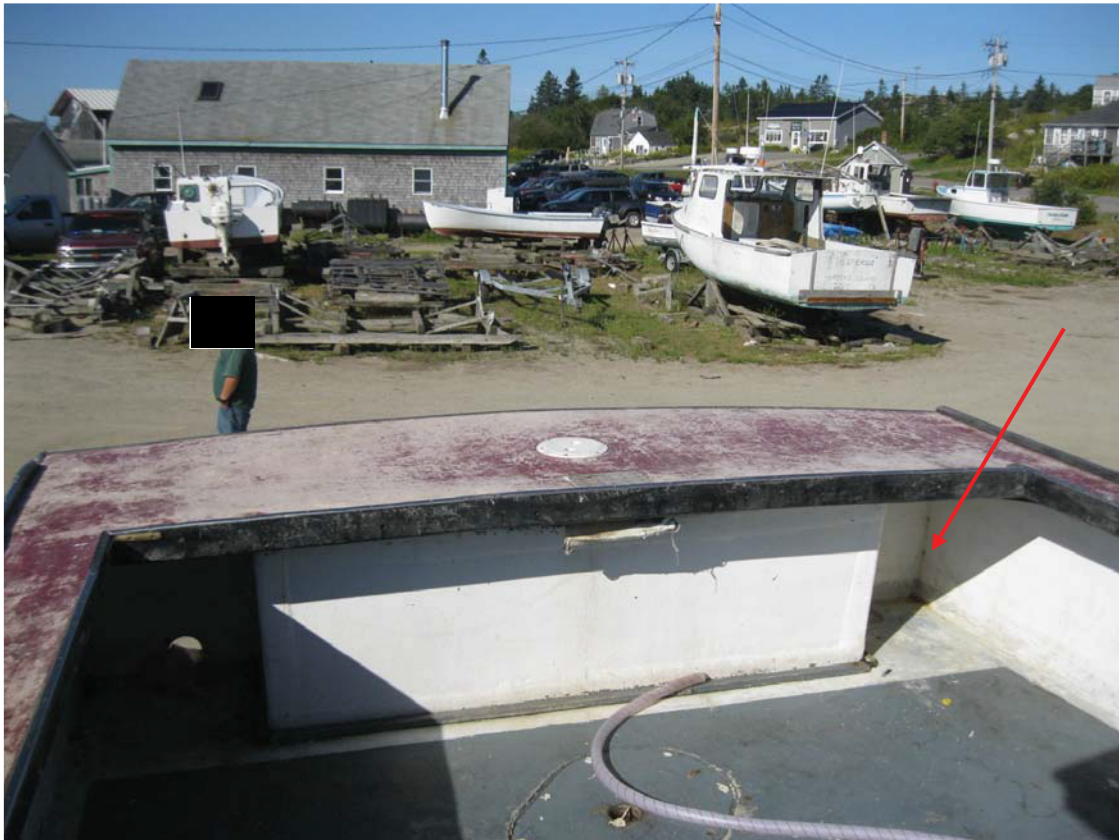
Figure 7- Aft deck gunwale of the OUTNUMBERED showing where Mr. Philbrook's pot buoy was trapped (red arrow), picture taken by [REDACTED].

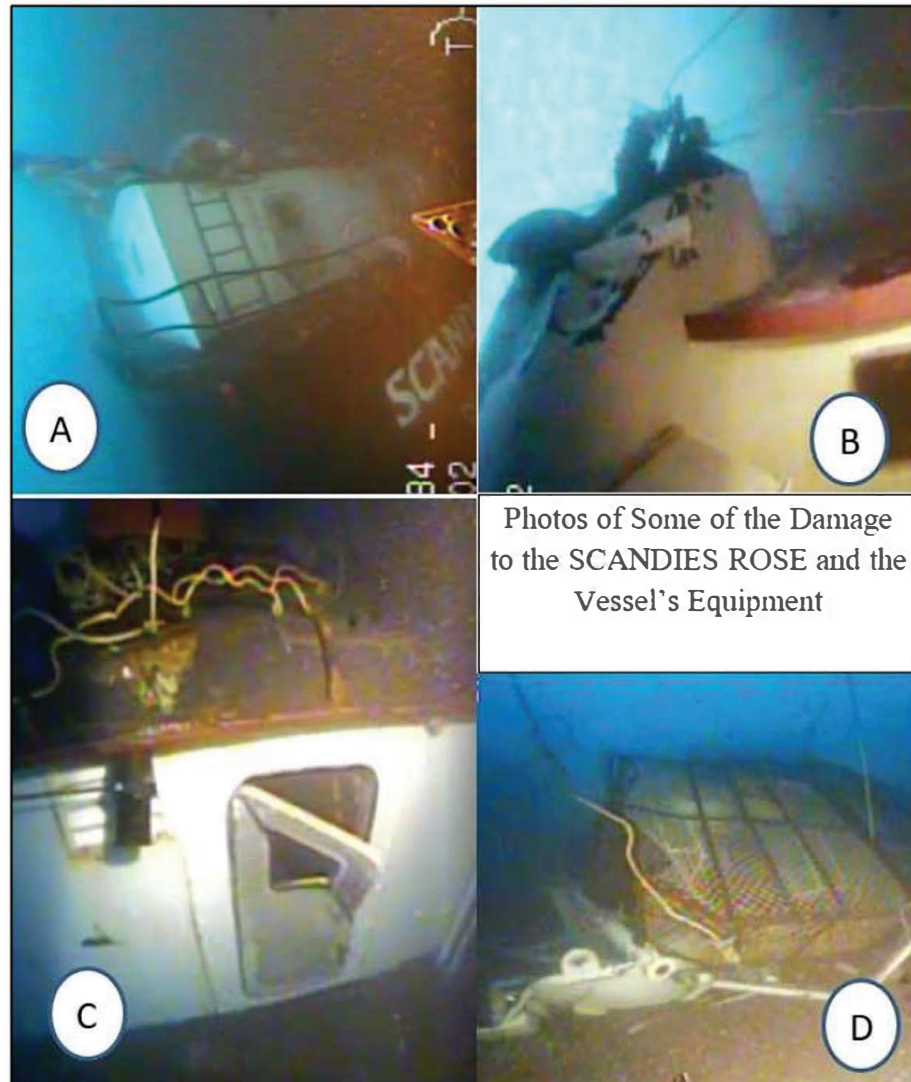
Figure 26 – Images of the damage sustained to the SCANDIES ROSE and her equipment as the vessel settled on the seabed. Image “A” shows the damage to the railings that run across the stern of the vessel. “B” indicates the damage to the top of the exhaust stack while “C” shows the damage to an external door aft from the superstructure. Finally, image “D” shows the mast and one of the large crab traps on the sea floor near the SCANDIES ROSE. (Source CG Exhibit 009 still frames, with markup)

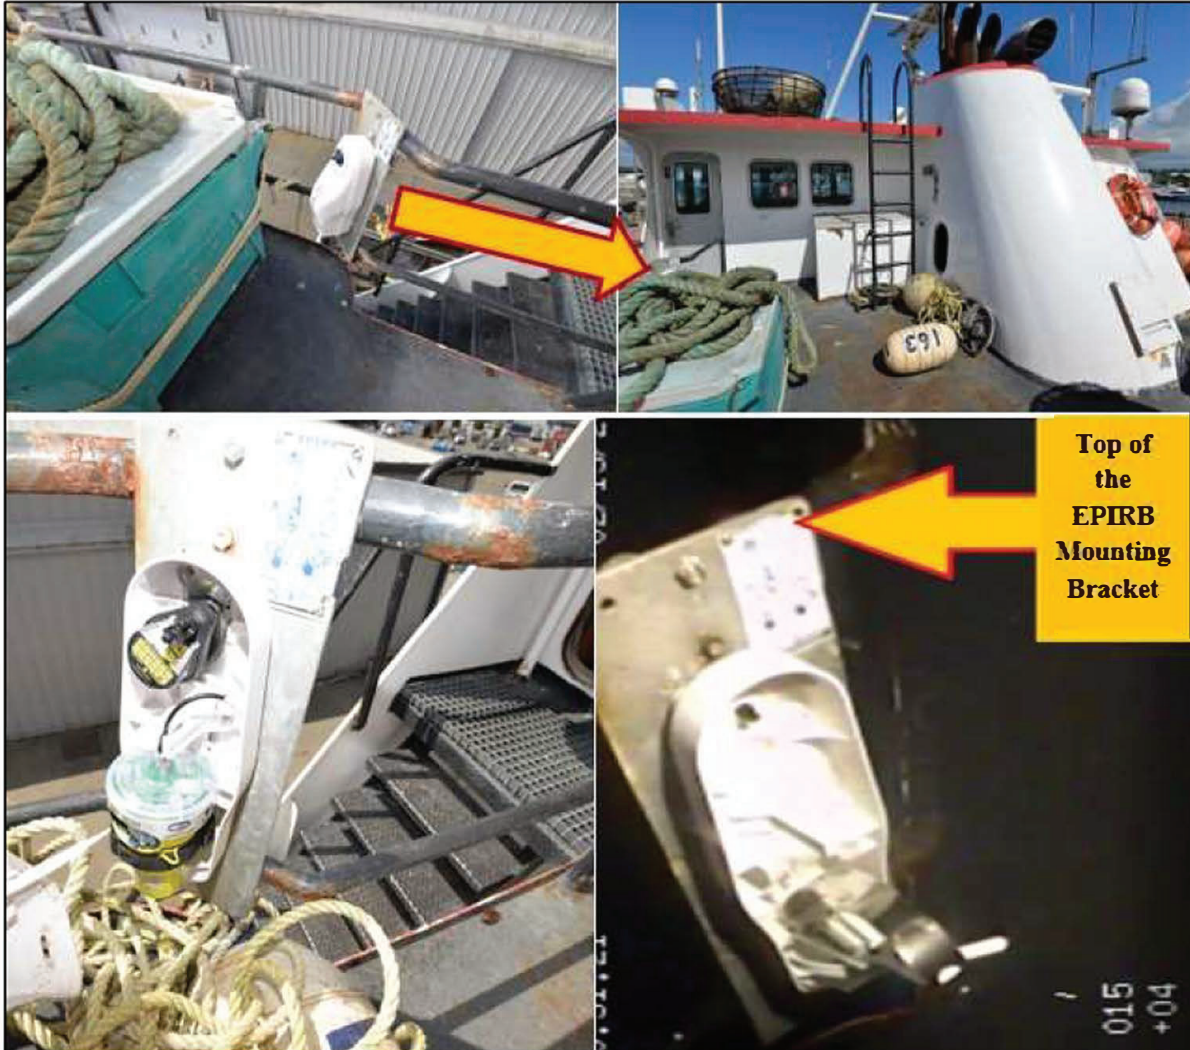
Figure 44 – Composite of photomontage of the SCANDIES ROSE EPIRB. Top left, EPIRB in housing on the inside of top rail aft of the wheelhouse. Top, right is the location shown with the yellow arrow in reference to the position in relationship to the port wheelhouse door. Bottom left, the open EPIRB housing during inspection for 2019 Valuation and Condition Survey. Bottom right, the empty housing as seen during underwater ROV site survey February 2020. (Source – [redacted] photos for 2019 Valuation Survey and bottom right, CG Exhibit 008)

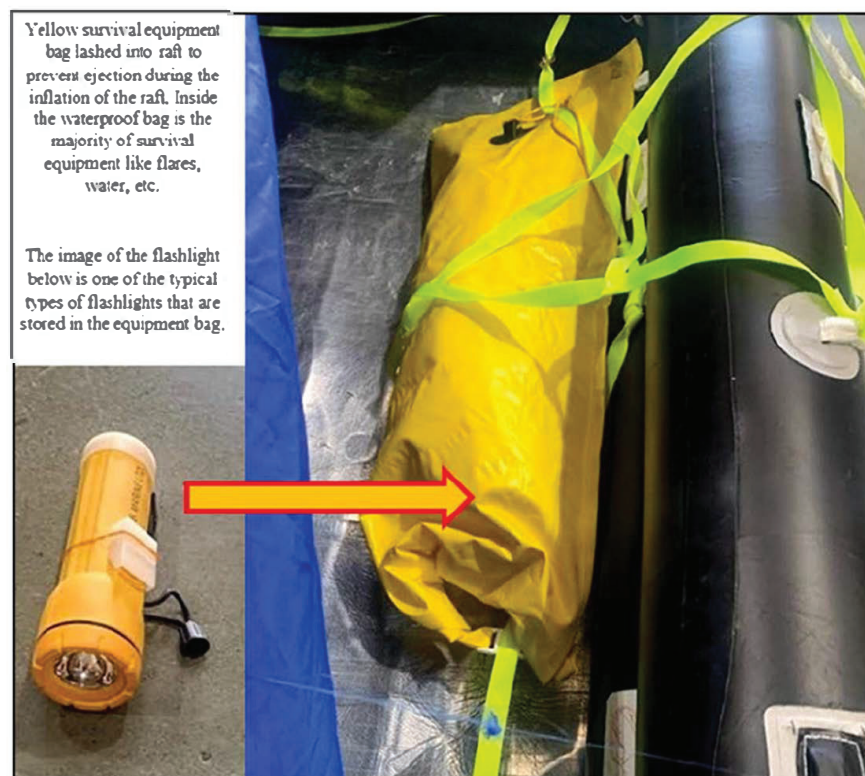
Figure 99 – Image showing the raft equipment bag, indicated by the yellow arrow that is lashed to the floor of the raft near the boarding area. On the left side of the figure there is an example of a D-cell flashlight stored in an equipment bag. (Source Marine Safety Services, Inc.)

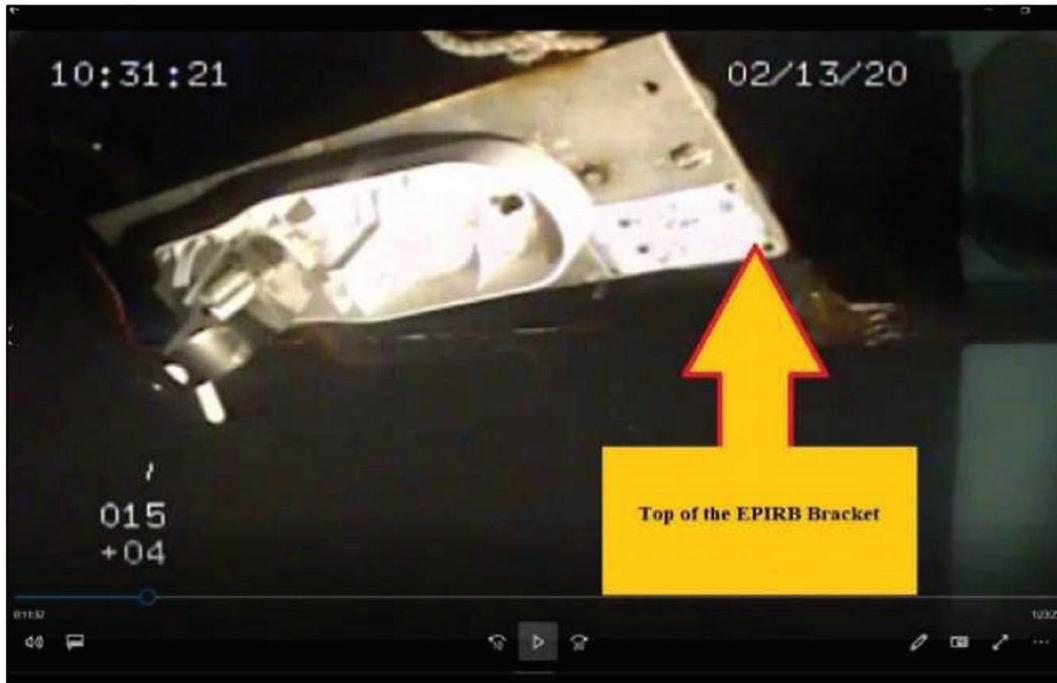
Figure 103 – Image of the empty EPIRB housing mounted inside the top rail on the port side behind the wheelhouse of the SCANDIES ROSE taken during the ROV underwater survey mission and photographed at the angle the EPIRB bracket was found on the seafloor. (Source CG Exhibit 008)
