**United States Coast Guard**  
**Office of Investigations and Casualty Analysis**  
**Safety Alerts, Safety Advisories, Lessons Learned**  
**2008-2012**

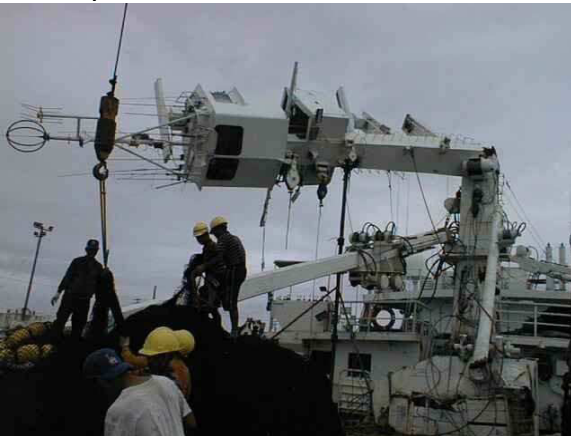
Recently, several catastrophic failures of masts, booms, and lift cables have occurred on purse seine fishing vessels that have resulted in loss of life and severe injuries. Over the years many casualties have occurred onboard all types of fishing vessels attempting to haul in catches that exceeded the capacity of their winches, hoists, and associated equipment. These types of casualties are not unusual. This alert serves to remind all purse seine fishing vessel owners/operators and other fishing segments to ensure safe use of the haul equipment particularly matching the size and the capacity of the nets to the rated size and capacity of the winch/haul/hoist equipment, taking into account safety factors for various species, and other concerns such as the variable platform that a rolling fishing vessel and variable catch presents.

- Know the design limits of load bearing structures and winches, hoist, and haul components;
- Ensure they are not modified by crew members; properly maintained; and are inspected and tested on a regular basis. Repair/replace components immediately when deficiencies are discovered;
- Evaluate and revise operational procedures as needed.

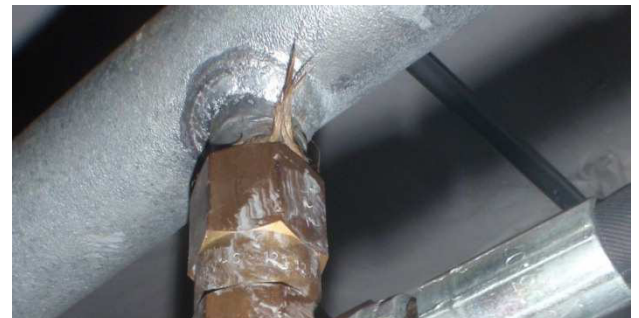
- Hemp type pipe sealant was used extensively on pipe threads throughout the system and in some instances seems to have entered the system. (Photograph at right.)

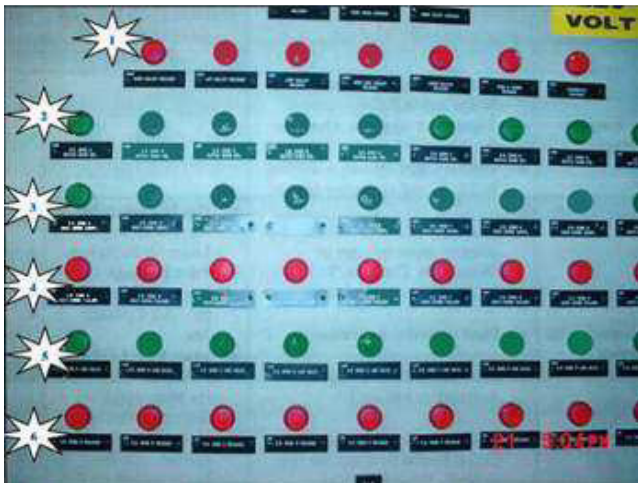
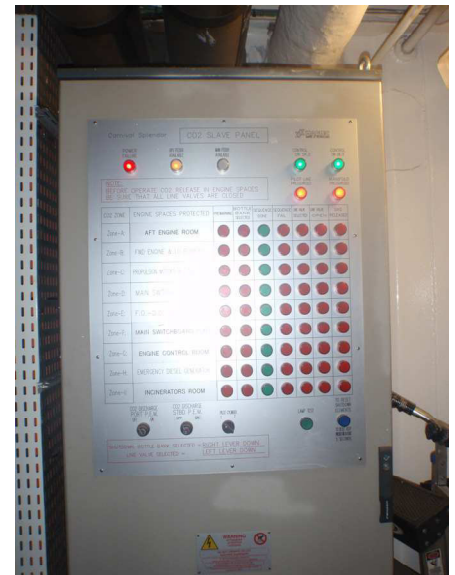
- Shipyard commissioning test procedures appear to differ from procedures documented in the vessel's Firefighting Instruction Manual (FIM). Commissioning procedures indicate that the discharge line selection to a specific protected zone should be made prior to releasing the gas contrary to the directions in the FIM.
- The FIM refers extensively to a Control Panel (left following image) that differs vastly from the one onboard the vessel (right following image).

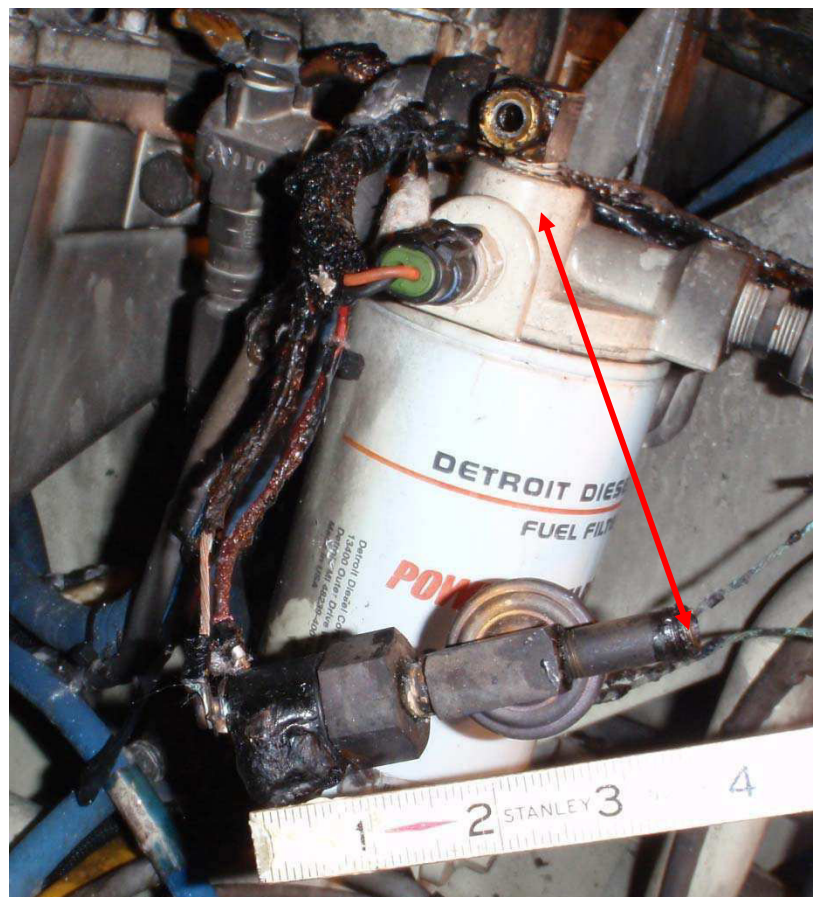
As stated previously, the investigation into this casualty is not yet complete. The components of the pipe fitting which failed are currently being examined by NTSB metallurgists. It is suspected however that the failed fittings may have been subjected to excessive vibration which could have caused the fracture. The original configuration was modified by adding a fitting that attached two additional sensors (for a total of four) to the fuel filter assembly and was subject to pressures up to 65 psig or greater. The assembly weighed 6.3 ounces and extended about 4 inches out of a reducing bushing that was threaded into the inlet fitting of the filter. Because of the location of the fire and oil soaked insulation it is

suspected that the fitting leaked first and did not immediately shear as shown in the photo at the right.
