MARINE INVESTIGATIONS LESSONS LEARNED

Lessons Learned 01-09

SMALL FIRE / IMPORTANT LESSONS

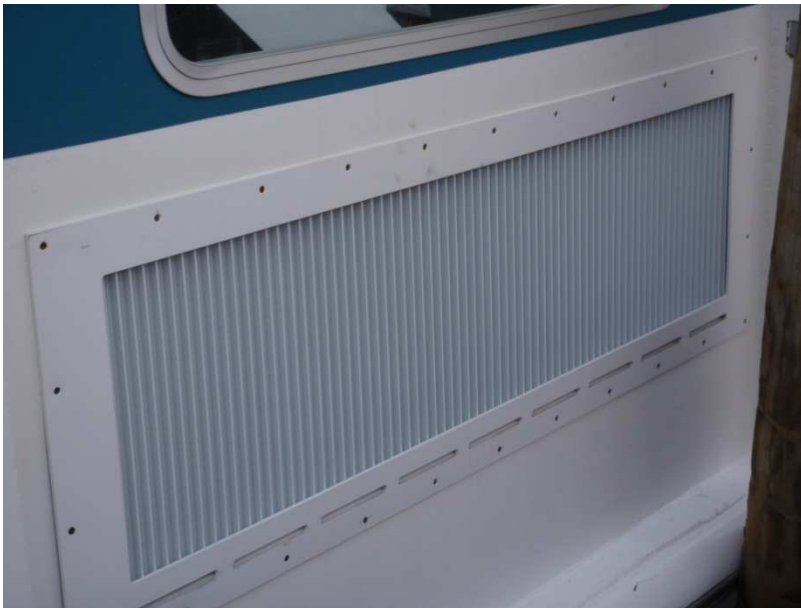
When the extinguishing system was activated, all the dampers closed properly. However, after the fire it was noted that several external moisture eliminator filters were extremely damaged. The photo above shows an undamaged moisture eliminating filter. The actual size of this filter is about five feet by fifteen inches.

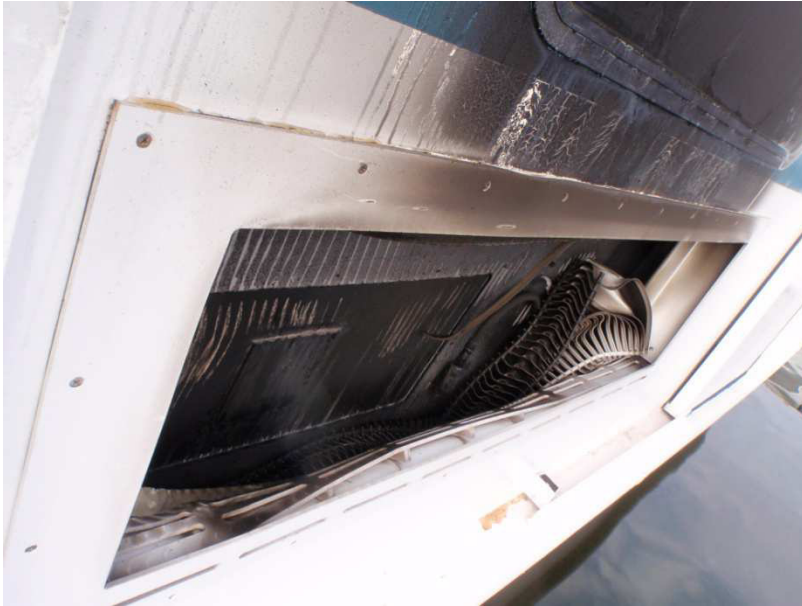
The following photo shows the melted moisture eliminating filter from the opposite side of the vessel. High temperature gases flowed through it during the fire causing it to overheat and deform prior to its respective damper closing. It fell on top of the damper after the damper had closed. The small fire in the engine room was about nineteen feet away on the other side of the vessel and aft. Investigators

noted that *if* the filter had melted and fallen on or into the slot of the duct before the damper closed, it is likely to have interfered with the damper operation and possibly have reduced the effectiveness of the CO2 system.

46 CFR 116.610 (b) applicable to this vessel, states that “a ventilation duct, and materials incidental to installation must be made of noncombustible material.” 46 CFR 116.610(c) states that “combustibles and other foreign materials are not allowed within ventilation ducts. However metal piping and electrical wiring installed in a metal protective enclosure may be installed within ventilation ducts, provided that the piping or wiring does not interfere with the operation of fire dampers.” Owners and operators of any type vessel, as well as those persons involved with the inspection of vessels should be aware of the potential risks associated with this and similar installations and are reminded that

inspections of fire dampers should include observation of all related structure near dampers to ensure that the dampers will operate under fire conditions. These structures and any incidental materials should not be made of combustible material. On vessels with manual extinguishing systems, or those with manual dampers whereby when securing the ventilation time is of the essence, consideration needs to be given regarding the materials used should it be subjected to excessive heat carried by high temperature gases.

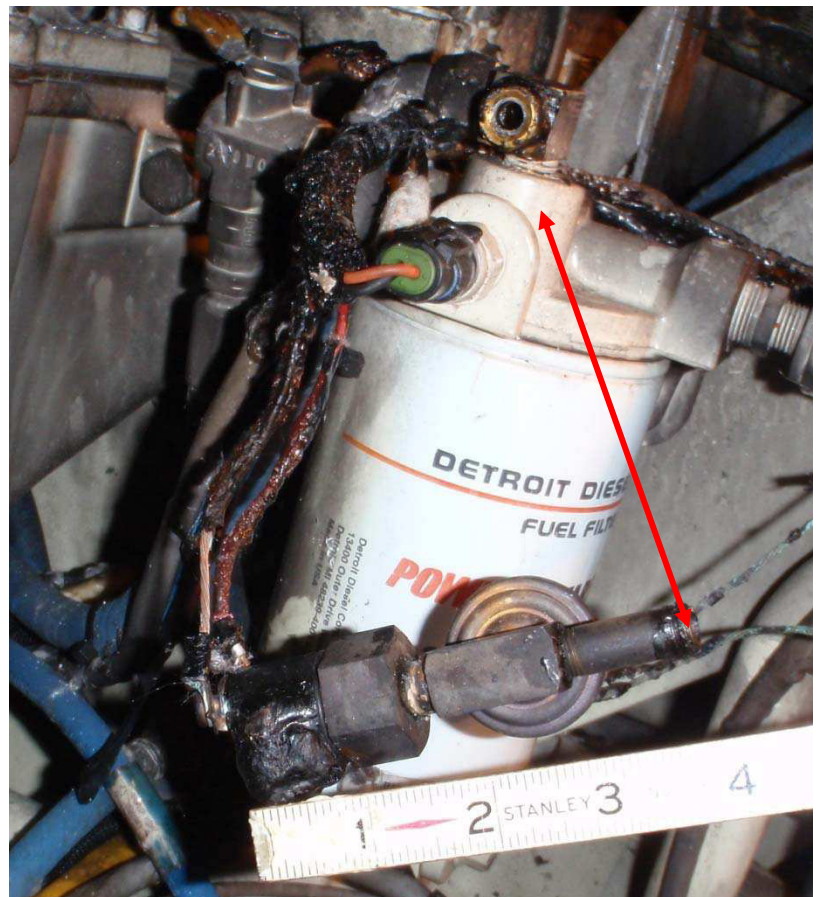
As stated previously, the investigation into this casualty is not yet complete. The components of the pipe fitting which failed are currently being examined by NTSB metallurgists. It is suspected however that the failed fittings may have been subjected to excessive vibration which could have caused the fracture. The original configuration was modified by adding a fitting that attached two additional sensors (for a total of four) to the fuel filter assembly and was subject to pressures up to 65 psig or greater. The assembly weighed 6.3 ounces and extended about 4 inches out of a reducing bushing that was threaded into the inlet fitting of the filter. Because of the location of the fire and oil soaked insulation it is

suspected that the fitting leaked first and did not immediately shear as shown in the photo at the right.

Owners and operators of any type vessel, as well as those persons involved with the inspection of vessels should be aware of the potential risks associated by adding components to an engine assembly and must take into account the effect of vibration on those components. If add-on components are discovered effort should be made to verify the adequacy and safety of the installation by consulting the engine manufacturers and designers.

In this instance an improved installation may have involved mounting the sensors directly to a stable surface and attaching the sensors to the filter inlet using a flexible hose.

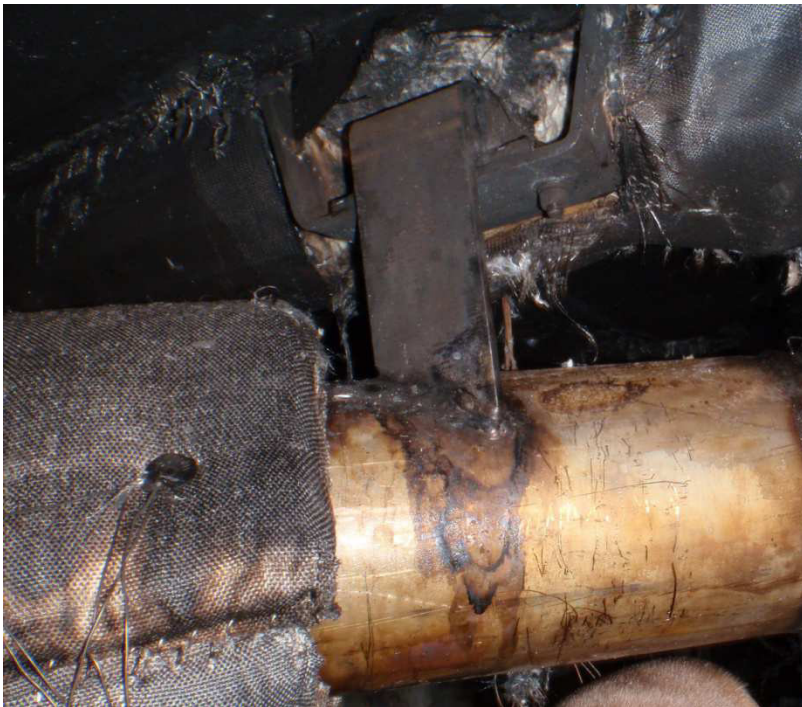
In a small engine room containing several engines and having a low overhead there are a number of locations that present enough heat to cause a fuel to flash and ignite other components. Turbocharger and exhaust piping insulation while serving to reduce heating of external areas also helps reduce the immediate availability of ignition hot spots. Care should be taken to ensure insulation wraps and blankets are kept tight and fastened in a manner to prevent dripping or spraying fluids from traveling to an exposed hot spot. Insulation seams should be made tight and where possible aligned in a manner to prevent pooling of fluid and to repel dripping. Likewise good marine practice may also dictate and ensure that braces which are welded directly to the exhaust pipe which serve as hangers or supports

also be insulated. Heat conducting from the exhaust pipe to the brace could be substantial allowing the exposed bracket to become nearly as hot as the exhaust pipe. The brace in the photo above was only partially covered with the insulation that was wrapped around the exhaust pipe. As with the other concerns in this document, owners and operators of any type vessel, as well as those persons involved with the inspection of vessels should be aware of the potential risks associated with improper or inadequate installation of insulation.
