MARINE SAFETY ALERT

Safety Alert 01-18

A Delayed Repair Can Bite You in the Derriere **Performing prompt maintenance is critical!**

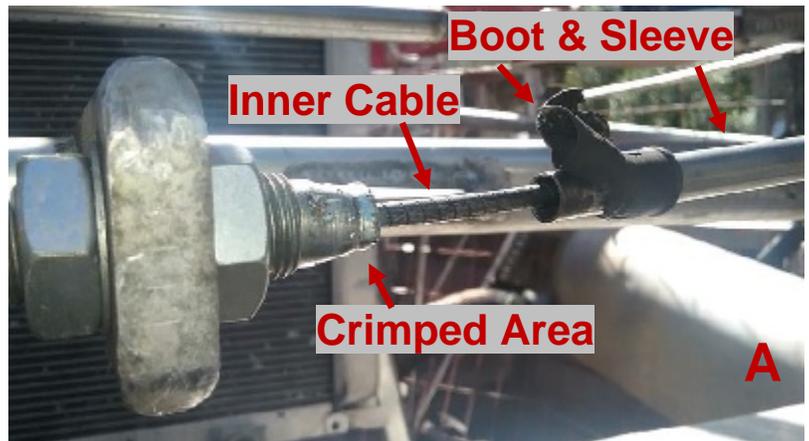
Recently, several passengers onboard a commercial airboat tour were injured when the boat lost steering and hit a tree. Fortunately, there were only a few serious injuries because the boat was not underway at full speed when the accident occurred. This Safety Alert serves as a reminder to vessel owners, operators and those who repair these vessels of the importance of recognizing risks and ensuring proper maintenance and repairs are made to minimize risk.

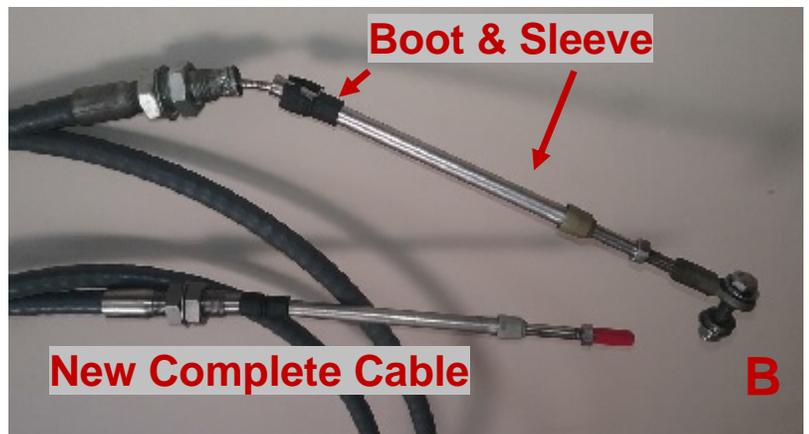
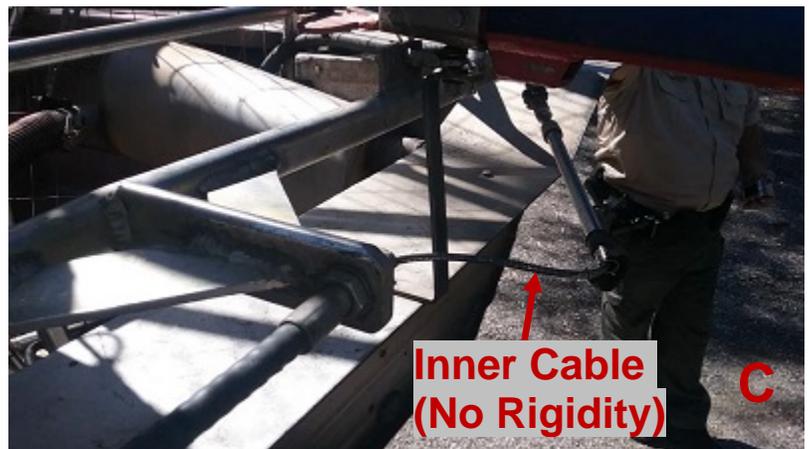
On some airboats, steering is achieved by directing the flow of (propulsion) fan air across two vertically placed rudder foils. As the foil position is changed the directional thrust acting on the stern of the vessel varies. The foils move in tandem because of a linkage between the two foils. The steering cable is typically only connected to one of them. The end of the body of the steering cable is secured to the vessel and locked in place by two nuts. (Image A) Attached near this fitting is a sleeve which covers the final end of the enclosed cable. The end of the sleeve is bellowed outwards and inserted into the end of the main cable body which is then crimped inward. (Image A) This joint is covered by a rubber boot to prevent dirt and debris from entering into the cable body and interfering with the enclosed cable's movement. The crimped connection allows for some angular movement at the end of the cable.

Over time, the crimped connection can become deformed due to the stresses occurring at the joint. Ultimately, in this case, the parts separated and the end of the cable lost its linear rigidity, putting slack into the control cable and causing a loss of control of the steering foils. (Image C) In this instance, the rubber boot covering the joint was found to be damaged and there appeared to be tool marks at the location of the joint. It's likely that in the past the joint was held compressed together by the use of Vice-grip type pliers. The person who may have placed the Vice-grips on the connections failed to recognize the potential risk of a loss of steering should the connection fail. It was not proper to make repairs in this instance and the cable should have been completely replaced.

- To develop an operational paradigm where maintenance and repair items are evaluated carefully, recognizing the potentials risks associated with their operation should the repair or maintenance item not be properly performed or achieved in a timely manner.
- **For airboat operators specifically:** Owners and operators of airboats that use flexible type steering control cables are reminded of the need to thoroughly inspect cables before use, including areas under the dust boots. Due to the forces encountered on airboat applications, owners are also encouraged to ensure these cables are properly maintained and to immediately replace a worn cable. Owners are discouraged from attempting to repair a factory crimp.

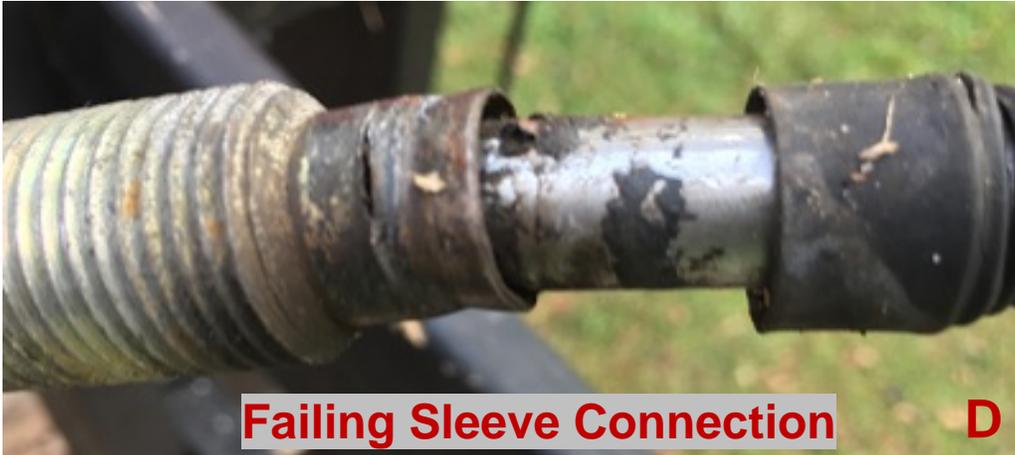
The following image shows a Morse/Teleflex/Cablecraft "type" push-pull control cable assembly sleeve connection point that was fatigued and had begun to fail.
