MARINE SAFETY ALERT

Safety Alert 01-98

REPOWERING WOOD BOATS

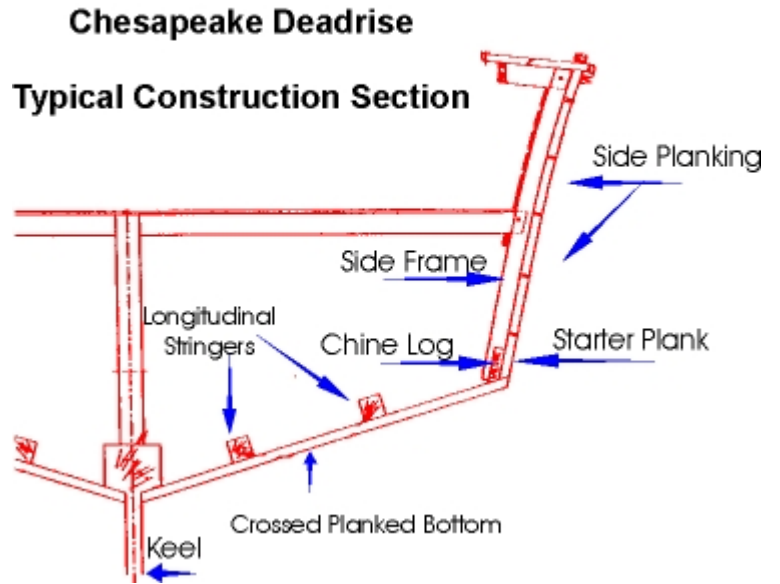
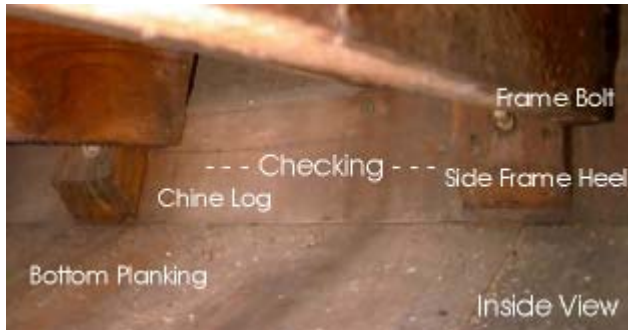
Initial indications include shallow checking of the face of the chine log on the inside or on the face of the starter plank on the outside "bolt to bolt."

The chine log and starter planks on all cross-planked hulls should be inspected closely at each scheduled drydock inspection for early signs of deterioration. When inspected underway, leakage on the top of the chine log may indicate a split starter plank, versus leakage on the bottom of the chine which is an indication of the condition of the bottom planking to chine connection. These areas should be looked at closely before re-powering schemes are approved, so that any preliminary indications can be fully documented and watched over time

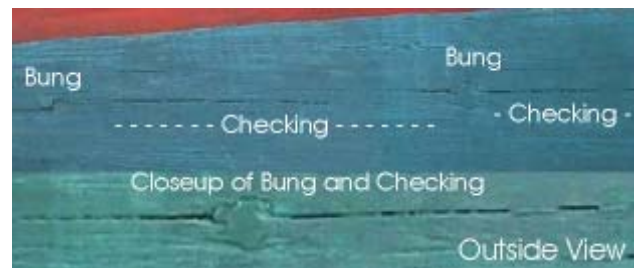
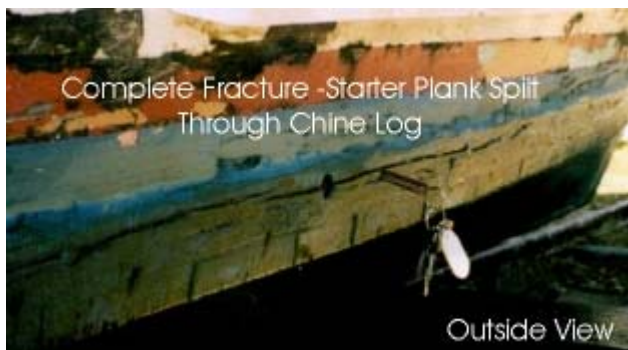
As the hull continues to work, these checks can widen into fractures, with the worst case of both the chine log and the outside starter plank fracturing all the way through.
