U.S. Coast Guard Safety Alert

Alert 2-06

STAR PRINCESS Cruise Ship Fire

MAIB SAFETY BULLETIN 1/2006

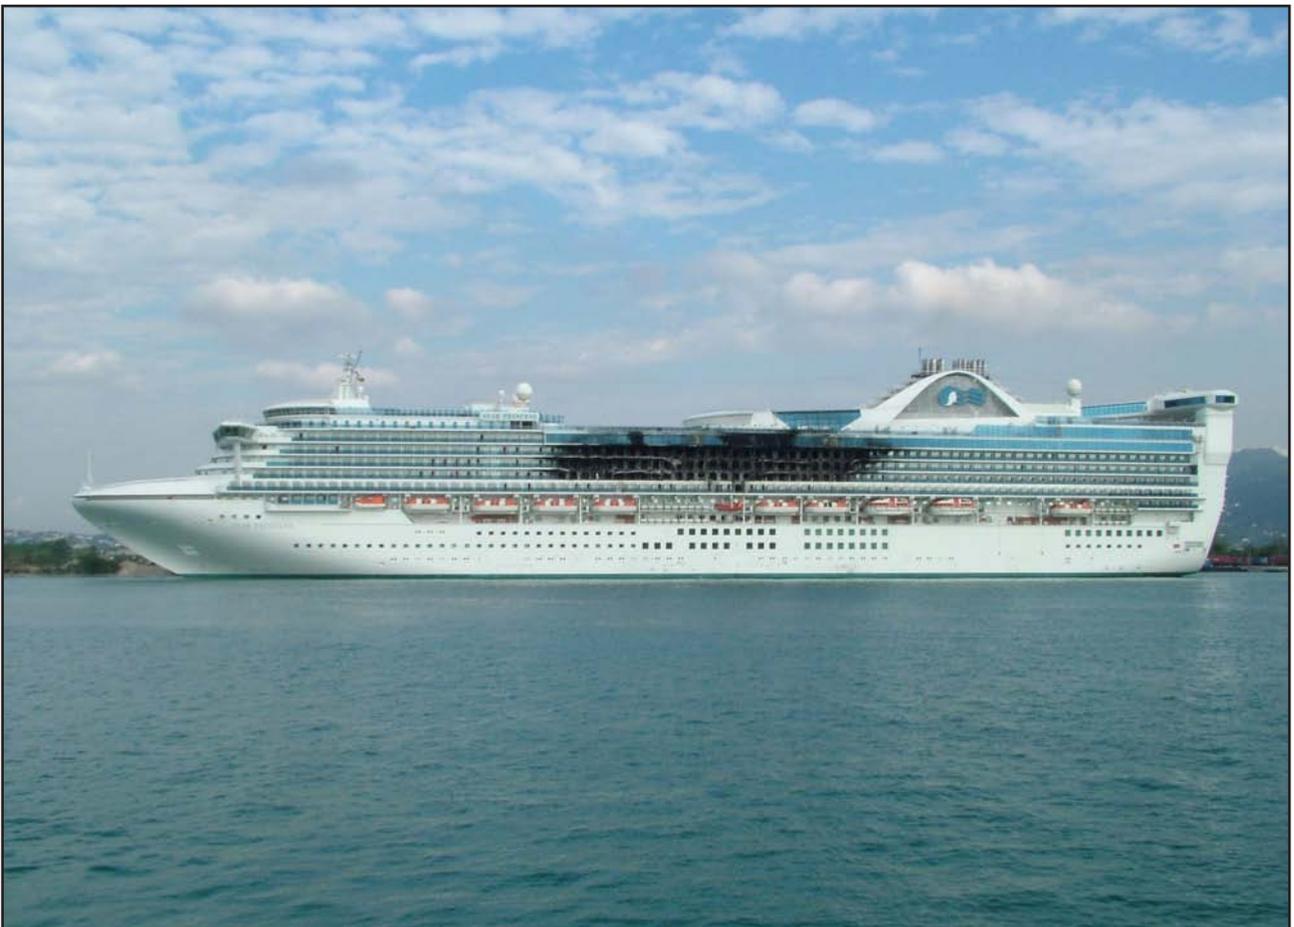
Figure 1

The fire was extinguished about 1.5 hours after it had started. The crew fought the fire with water hoses from adjacent external areas, and from internal alleyways. Difficulty was experienced in reaching the fire due to the construction and partitioning of the balcony areas. A total of 79 cabins were condemned after the fire, and a further 204 were either water or smoke damaged. The damaged area covered 3 vertical fire zones on 5 decks (**Figures 1, 2 and 3**).

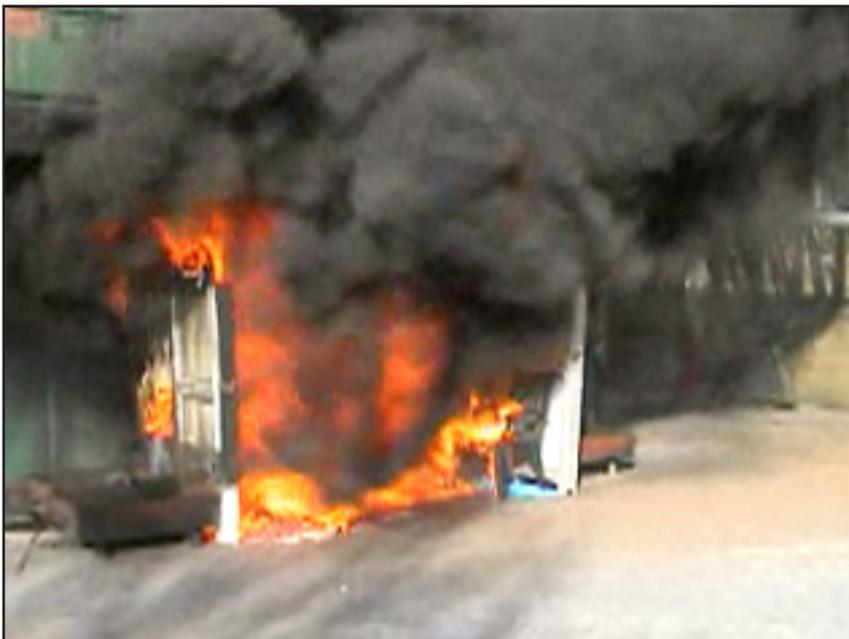
Figure 4

Following the accident, it has been determined by practical tests that the materials at the seat of the fire were readily ignitable, and that the polycarbonate balcony divisions generated intense heat and copious amounts of dense black smoke as they burned (**Figure 4**).

combustible balcony dividers on a priority basis and as soon as possible with dividers that are of non-combustible material.
