MARINE SAFETY ALERT

Safety Alert 3-15

LIQUEFIED PETROLEUM GAS (LPG) Cargo and Hydrate Handling Risks

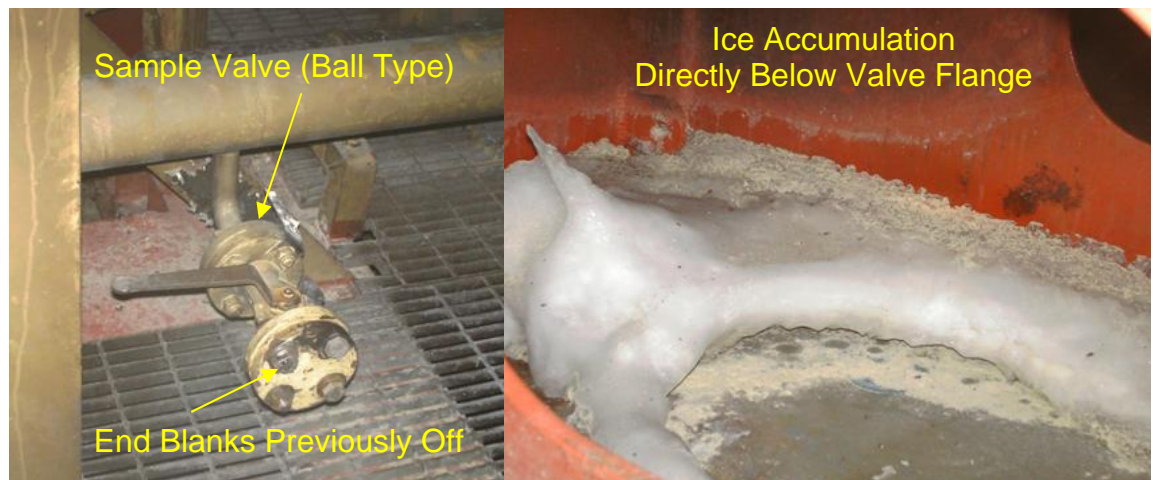
Crewmembers reported that a ball valve at a sample point in a condenser outlet piping was opened on occasion to drain the hydrates into a modified bucket. It was also learned that flanges on the outlet piping of the ball valve had

been removed and left off. Investigators were told that the Cargo Engineer regularly made rounds to manually drain the hydrates to the bucket in order to prevent the freezing of the expansion valve. However, no buckets were found and significant accumulations of ice were noted in the bilge areas below the same sample point for two of the three liquid line drains.

Whether or not buckets were used to capture the hydrates, along with escaping liquid propane, and then later allowed to boil off as stated by the crew, or if the drains were left cracked on or just leaking, as they were found, may never be exactly determined. However, the ice formation in the bilge seems to indicate the latter was the more prevalent condition. Regardless of either initial condition, a hazardous flammable atmosphere developed. With the doors of the compressor room clearly labeled to be kept closed, but latched open, it is likely that proper air flow and volumetric air changes in the space did not occur. It is speculated by crewmembers that a fallen flange blank may have provided the initial spark that ignited the gas. A fire subsequently developed and destroyed electrical cabling and gaskets associated with the condenser. It was extinguished quickly by a crewmember who was in the space at the time, using handheld dry chemical extinguishers.

- Senior shore side operating company personnel provide extensive technical support when a vessel is required to load cargo at higher temperatures and when substantial hydrates quantities are known to be contained within;

- Shipboard Safety Management Systems and Operational Manuals be inclusive of all procedures to be expected and performed onboard. In the incident under investigation a procedure for removal of hydrates was unavailable;

- Methods to inspect and identify leaks throughout the cargo system, and corrective actions to take when leaks are identified;
 - Ways to manage and minimize the negative effects of hydrates throughout the entire cargo system;
