MARINE SAFETY ALERT
Inspections and Compliance Directorate

Safety Alert 05-19

MAN OVERBOARD!
An unusual fatality calls for reassessment of hazards & risks.

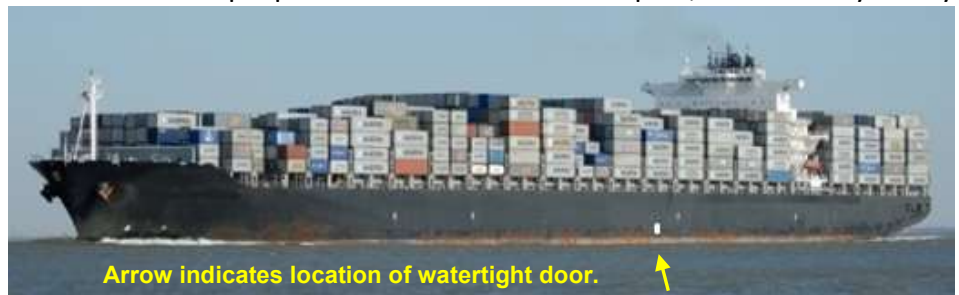
Last fall a very large 1,100 foot container ship was arriving the Port of New York/New Jersey in heavy weather with about 40 knot winds, 13 foot swells and 60 °F seawater temperatures. As the vessel maneuvered at about 10 knots to make a lee in preparation to embark a ship's pilot via a side shell access port, it was hit by heavy seas that forced the side shell hatch door open resulting in flooding of the embarkation space, sweeping one crewman out to sea and injuring another. At the time of the casualty, the vessel was on a west-northwesterly course with seas on the vessel's starboard quarter.

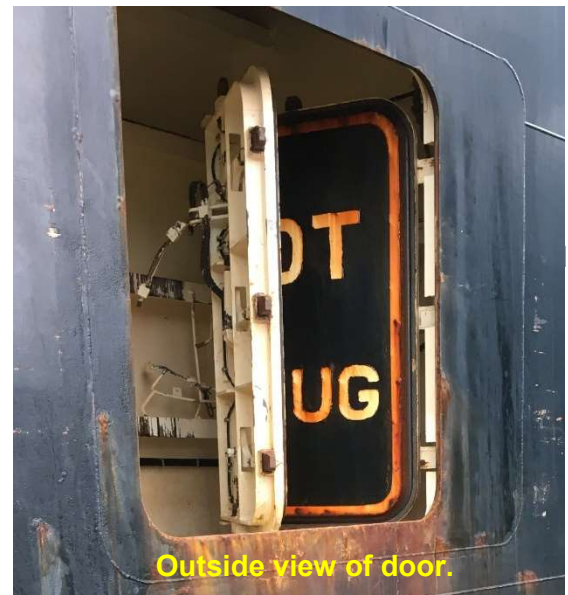
The ship's Boatswain and Ordinary Seaman (OS) were manning the port side shell access port and pilot embarkation space behind a hydraulically operated bi-fold hatch door, pictured below, and were preparing for the pilot's arrival. The port was located forward of the house and approximately 13 feet above the waterline. The Boatswain and OS were unable to monitor the seas from their position behind the hatch door. As the two crewmembers were in the process of opening the door, seas unexpectedly struck and violently forced it open, flooding the space. The OS was not wearing a harness or safety line nor a personal flotation device; he was subsequently swept out to sea. The Boatswain was forced onto the deck whereby the pilot ladder fell on him, fracturing his leg. The side shell door also suffered structural damage during the incident, again echoing the dangers of and power of the sea. Coast Guard Sector New York launched an extensive search and rescue mission that was terminated with no success after a 28 hour search. The OS was lost and was presumed dead.

This casualty reiterates the dangers of personnel exchanges at sea, especially in heavy weather conditions. Even though the side shell hatch door was located on the port side and was being brought onto the vessel's lee, the crew's inability to observe and assess the sea conditions combined with the ship's roll and sea state presented significant risks.

The Coast Guard **strongly recommends** owners and operators of deep draft vessels:

- Review vessel Safety Management Systems, procedural manuals and guidance that relate to pilot transfers and update as appropriate considering risks revealed by this casualty;
- Reinforce the importance for crewmembers to wear personal protection devices and safety lines when working over the side of a vessel, when exposed to the elements or when there is an absence of barrier that could prevent an accidental water entry;
- Ensure officers and crew identify potential hazards and conduct a risk assessment, to include a consideration of weather conditions, prior to opening the side shell port hatches;
- Ensure crew communications between Navigation Watch Officers and crew, in situations such as this, are clear and provide suitable supervision of activities, considering sea state and other changing conditions.
