## **MARINE SAFETY ALERT**

Safety Alert 07-97

### **PROPELLER CLEARING PORT HAZARD**

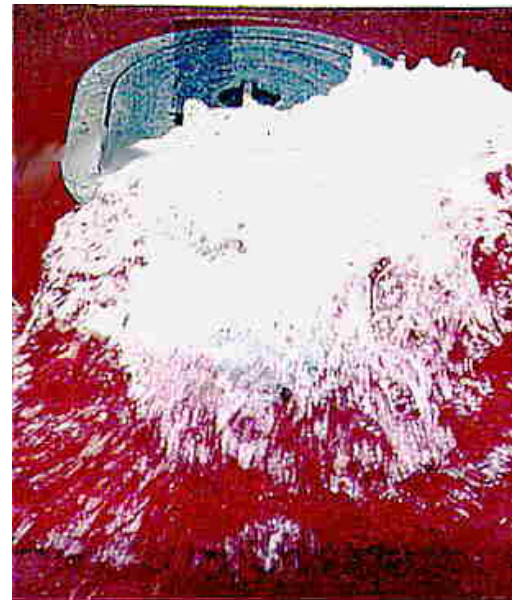
In this incident, the vessel's master had removed the propeller clearing port hatch cover the day prior to the accident to clear away a line that had become entangled in the propeller. Coast Guard investigators believe that this hatch was not properly secured after it had been opened and loosened at some point the following day which then led to the flooding of the vessel. The Coast Guard feels that propeller clearing ports such as this are becoming more popular on vessels constructed to tend stationary fishing gear because the gear itself is more likely to become fouled on the propeller. Stationary fishing gear includes lobster and hagfish traps, as well as gillnets and longlines. Because the hatches of the propeller clearing ports are typically placed above a vessel's waterline, some vessel operators may underestimate the risk of flooding associated with them. The assumption is that sea water will not rise up through a hatch opening that is above the waterline. However, because propeller clearing ports are placed in the same plane as the propeller in order that a fouled propeller can be easily cleared, any side wash from the vessel's propeller when it is operating will act like a pump and place considerable water pressure on the clearing port hatch opening. The pumping action of the propeller can, in some cases, be in excess of 1000 gallons per minute.

The photograph demonstrates what happens when a vessel is maneuvered with a loose clearing port hatch cover. This vessel's clearing port hatch is located on the weather deck, which makes flooding easy to detect. The Coast Guard advises fishermen considering the installation of propeller clearing ports to design the ports with the access hatch on the vessel's main deck. On vessels with access hatches placed below the main deck, a means should be provided to prevent the hatch from unintentional opening, such as the use of double nuts, safety wiring of the bolts, etc... The Coast Guard strongly advises against the installation of clearing ports below the main deck in hulls that are not fitted with watertight bulkheads.
