MARINE SAFETY ALERT

December 21, 2010
Washington, DC

Alert 10(a) -10

WRONG DIRECTIONS: A RECIPE FOR FAILURE

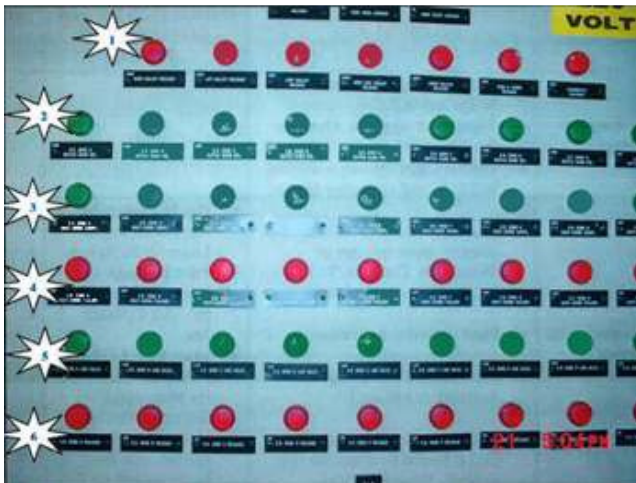
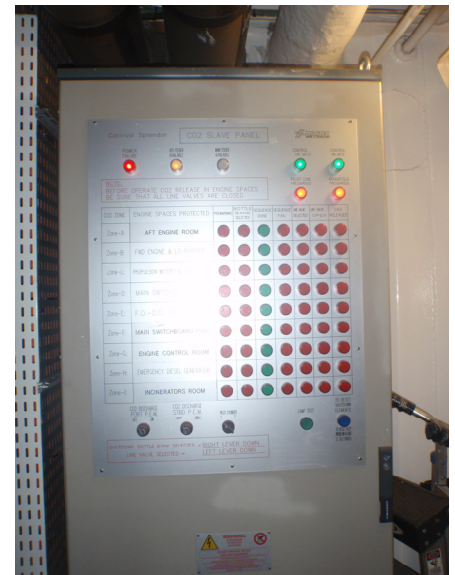
- Shipyard commissioning test procedures appear to differ from procedures documented in the vessel's Firefighting Instruction Manual (FIM). Commissioning procedures indicate that the discharge line selection to a specific protected zone should be made prior to releasing the gas contrary to the directions in the FIM.
- The FIM refers extensively to a Control Panel (left following image) that differs vastly from the one onboard the vessel (right following image).

- Ensure that all supporting documentation, piping schematics, plans, manuals, component labeling and instructions are consistent with each other and relevant to the systems, equipment, and components installed onboard the vessel.

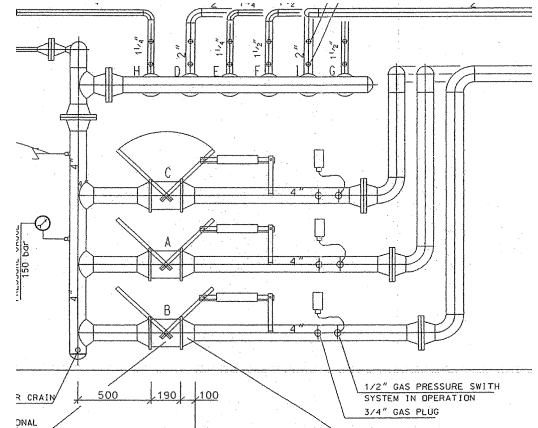
- Shipyard piping schematics and drawings do not appear to match the actual installation. The schematic at the right shows the “A valve” for the Aft Machinery Space in the center position vice the bottom position as it is installed on the vessel.
