MARINE SAFETY ALERT

Safety Alert 02-25

PILOTHOUSE ALERTER SYSTEM FAILS TO HELP AVERT DOCK ALLISION

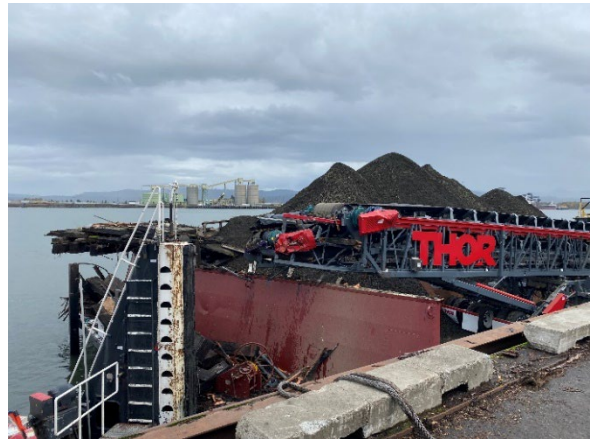
A towing vessel was pushing a barge loaded with aggregate when it allided with a bulk liquid transfer terminal pier on the Columbia River. The Coast Guard's marine casualty investigation determined that the operator fell asleep at the helm, resulting in more than \$1.5 million in property damage to the barge, handling equipment, and the facility. The incident occurred near a pipeline that could have discharged 25,000 gallons of synthetic diesel into the waterway.

Figure 1: Damage to fully loaded barge and towing vessel, after alliding with bulk liquid transfer terminal pier.

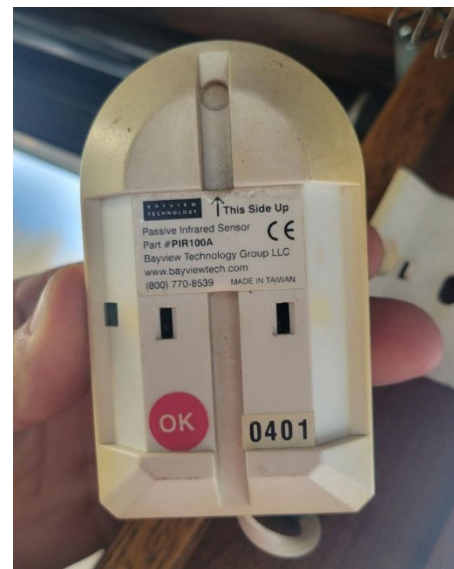
During this incident, the system's time interval was set to 10 minutes and relied on passive infrared (PIR) detectors to monitor motion in the pilothouse. However, PIR sensors, which detect motion, were influenced by non-human movements such as swinging cables and oscillating fans, causing the system to fail in detecting the operator's inactivity. The system used was not designed by a marine equipment manufacturer, which raises concerns about its reliability in marine environments.

Figure 2: Passive Infrared Sensor installed on the towing vessel.

- Ensure alarm intervals are appropriate for the vessel's route and conditions. Assess the impact of 10 minutes of unattended operation based on the current route (e.g., river versus open ocean routes).
- Consider replacing current systems with ones specifically designed by marine equipment manufacturers for marine environments.
- Update company safety policies for Pilothouse Alerter Systems to address required alarm intervals, proper training, and maintenance per the manufacturer's recommendations.

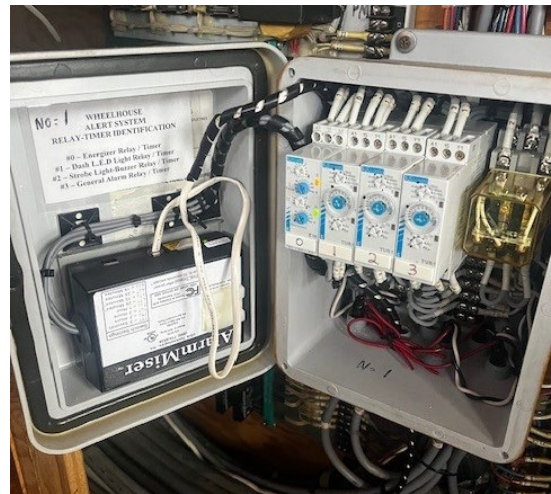
Figure 3: Pilothouse Alerter System Timer Adjustment Panel.

- Confirm the system functions as intended, without tampering. Ensure alarm resets are not bypassed with tape, and movement sensors are not circumvented by objects like oscillating fans with paper or ribbon streamers.
- Consider voluntarily installing marine-grade Pilothouse Alerter Systems on vessels under 65 feet, even though not required by regulation.
