MARINE SAFETY ALERT

Safety Alert 04-22-CH1

VERIFY GATEWAY HANDHOLD ARRANGEMENTS **Incorrect Terminations Can Lead to Marine Casualties**

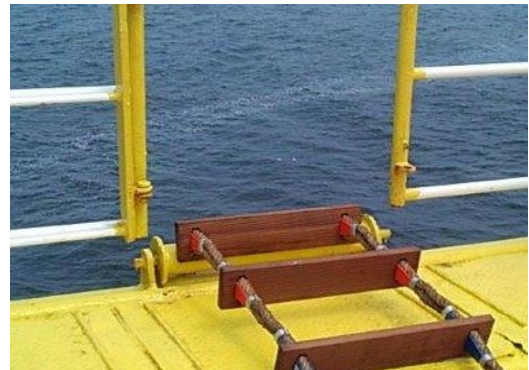
The Coast Guard is currently investigating a casualty involving a fall from a pilot ladder where the handholds in the gate arrangement aboard the vessel terminated without being rigidly secured to the vessel's structure. This termination left a gap in the handholds at the transition point at the head of the pilot ladder, where an embarking person might reach to pull themselves onto the vessel (Figure 1).

Figure 1: Handholds that terminate above the vessel structure.

- Ensure familiarity with applicable requirements pertaining to handholds in gateway embarkation arrangements aboard merchant vessels.
- Visually examine handholds in gateway embarkation arrangements for gaps, specifically at the lower terminations.
- Initiate rectification and issue outstanding conditions to meet regulatory intent for any non-conformities discovered.

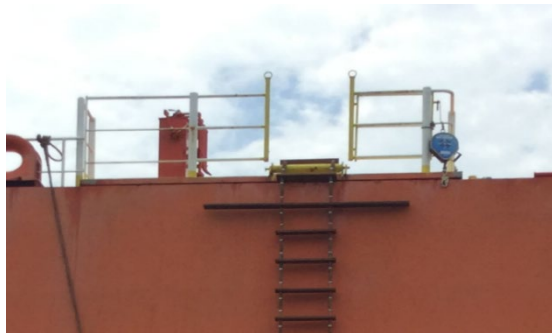
Figure 2: Gap in handholds appear to accommodate spreader.

The Coast Guard observed that the abrupt termination of the handholds above the vessel structure appeared to be a modification that was completed to accommodate the length of the pilot ladder spreader during deployment and retrieval of the pilot ladder. The modification made it possible to retrieve the pilot ladder without having to lift the spreader up and over the vessel's railings (Figure 2).

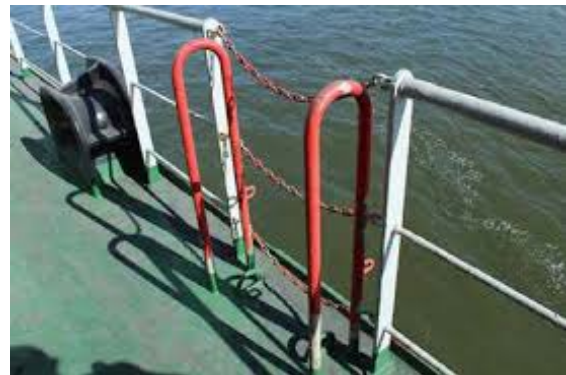
SOLAS 2020 (Consolidated) is clarified by IMO Resolution A.1045 (27), as amended by Resolution A.1108 (29), to indicate that each handhold in a gateway arrangement should be rigidly secured to the ship's structure at or near its base (Figure 3).

Figure 3: Handholds rigidly secured to the vessel structure at their base.
