MARINE SAFETY ALERT
Inspections and Compliance Directorate

Safety Alert 06-21

RISK OF STEERING LOSS FROM DEFECTIVE RAMS

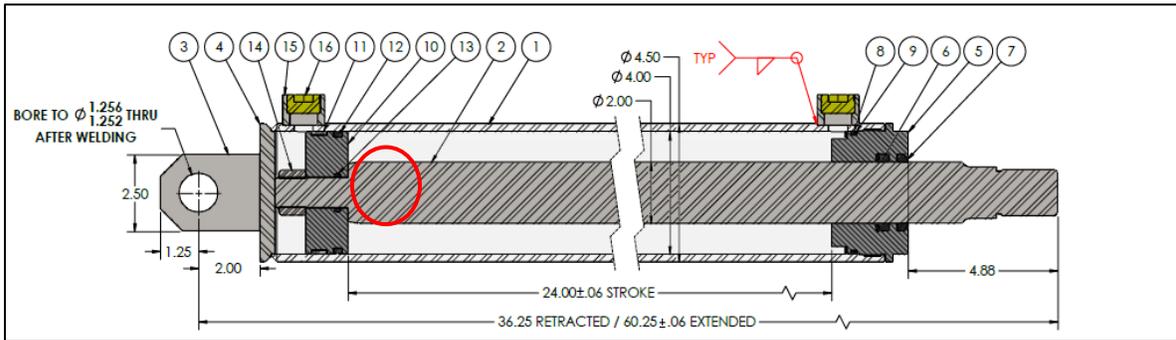
Schematic of ram assembly. Red circle indicates location of 1" stover (retaining) nut and stud location.

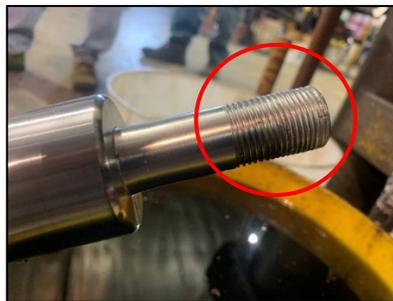
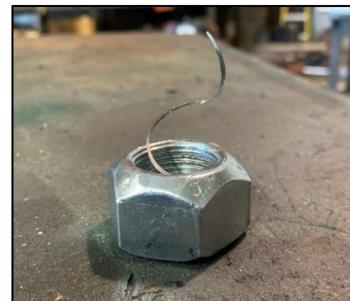
Recently, an inspected towing vessel experienced a reduction in steering when the port hydraulic steering ram failed. Technicians replaced the ram with a spare part located on-scene; however, the cause of the failure was undetermined. Within 24 hours, the vessel experienced a second steering reduction when the starboard ram failed. Due to the abnormal consecutive failures, the rams were sent to the manufacturer to undergo inspection. Testing revealed the threads on the rod studs for both rams were machined out of specifications. Specifically, the rod stud threads were not properly machined to measure the required 0.995 inch outside diameter (OD), but instead measured 0.950 inch OD. The rod stud is the portion of the rod that is turned down and threaded for the piston and retaining nut. The improperly sized threads reduced the surface contact with the lock-nut threads and the fastener's holding ability.

Photographs taken of disassembled ram showing rod stud threads and retaining nut.

- Periodically ensure set points are still within acceptable parameters for steering systems.
- Conduct checks of all installed and spare ram information for any of the manufacturer information listed in this alert.
- Regularly observe steering gear operation and inspect for signs of hydraulic oil leakage and excessive pump noise, which could indicate impending problems or failure.
- Contact the manufacturer for further guidance if any of the above referenced rams are identified. At this time, the manufacturer has not issued a recall.
