# UNITED STATES COAST GUARD

## MARINE SAFETY ALERT

Safety Alert 08-26

## MARINE BOILER BURNER INSPECTION AND OPERATIONAL SAFETY RECOMMENDATIONS

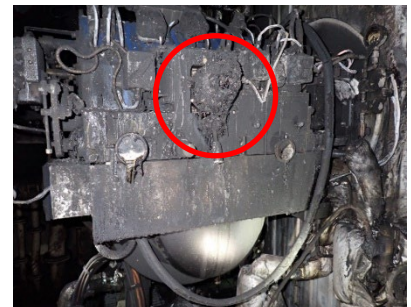
On January 4, 2025, while moored in the Port of Mobile, Alabama, a foreign-flagged cargo vessel equipped with a SAACKE Monoblock Rotary Cup Burner SKVJ-M 14 Mark I burner system on a marine boiler experienced a significant engine room fire. The incident began with a high-pressure fuel leak from the oil fittings block, which caused atomized marine diesel oil to ignite on the hot surface of a nearby auxiliary generator exhaust stack. The fire rapidly spread from the boiler flat through two upper deck levels, resulting in extensive structural and equipment damage, though no personnel were injured.

*Oil Fittings/Oil Flow Meter - Post Fire*

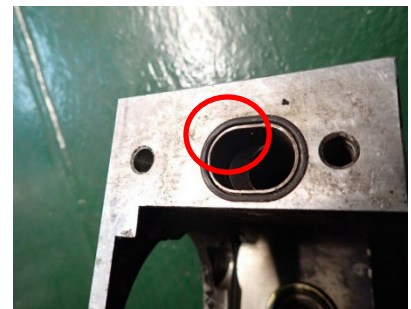
- **Seal Failure:** During assembly of the oil fittings block, an O-ring intended to seal the high-pressure fuel interface between the oil flow meter and the oil fittings block was improperly seated, resulting in a pinched seal. This improper installation compromised the seal's integrity, leading to material failure over time and the eventual high-pressure release of fuel.
- **Control System Misconfiguration:** A software configuration error was identified in the burner control system. Following a normal shutdown sequence, the external marine gas oil (MGO) fuel supply pumps feeding the burner unit were not de-energized. This failure to secure the fuel pumps kept the fuel lines pressurized up to the burner's internal rapid shut-off valves. The residual high-pressure was a significant contributing factor to the volume and velocity of the MGO fuel released when the O-ring failed.

*Pinched Seal on the Oil Flow Meter Block*

- Conduct periodic visual inspections of the burner's oil fittings block assembly for any indication of fuel leakage, paying attention to the oil flow meter and associated seals. O-rings and seals should be replaced at the manufacturer's recommended intervals and in accordance with the manufacturer's recommended procedures.

- If misalignment or damage to the oil fittings block or its seals is suspected, it is recommended to contact the manufacturer, SAACKE, for technical guidance.
