**UNITED STATES COAST GUARD**  
U.S. Department of Homeland Security

## **MARINE SAFETY ALERT**

Safety Alert 09-22

## **HIDDEN CORROSION ON DECK FITTINGS CAN CAUSE DANGEROUS FAILURES**

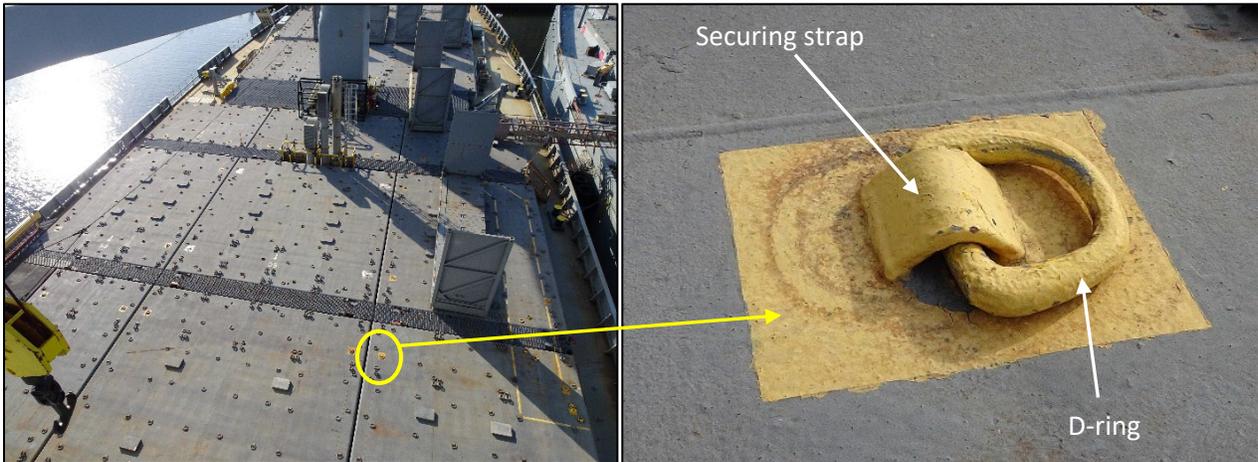
While positioning a removable hatch cover on the vessel (Figures 1 and 2), three of the four D-ring securing straps failed (Figures 3 and 4), causing an uncontrolled snap-back of the lifting sling assembly that struck the crewmember in the head. The three fractured securing straps showed similar failures with a significant amount of corrosion beneath the paint and on the underside of the straps. It is likely that just one D-ring failed initially, which would have instantly doubled the load on the two adjacent corner D-rings, both of which were apparently weakened and subsequently failed.

Figure 1. Deck Configuration

Figure 2. Example D-Ring Configuration

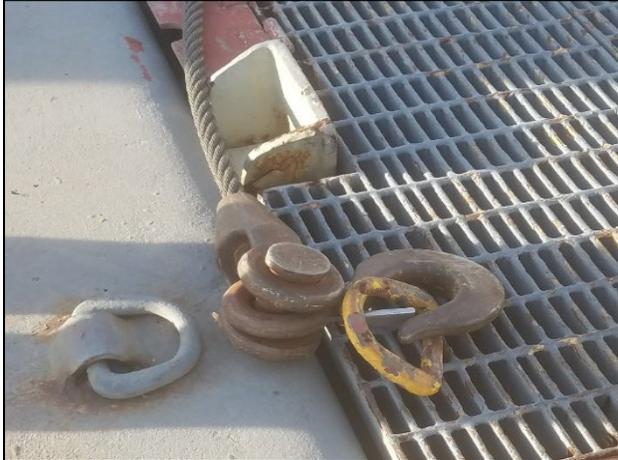
Figure 3. Separated D-Ring

The Coast Guard **strongly recommends** that vessel owners, operators, and other maritime stakeholders:

- Immediately identify high-risk D-rings and similar lifting-point fittings. High risk factors include: Age, weather exposure, and lifting load. These factors will cumulatively cause corrosion losses on the fitting, increasing its stress and fatigue vulnerability during each lifting cycle.
- Thoroughly inspect all high-risk lifting points for damage, hidden corrosion, and wastage. Audio gauging, pull-testing, or even replacement may be appropriate.
- Consult with the manufacturer's instructions to ensure safe lifting limits are in place and that the effects of service life are considered in their determination.
- Establish a maintenance schedule for periodically inspecting all lifting points and audio gauging or testing any fittings as they age into high-risk status.

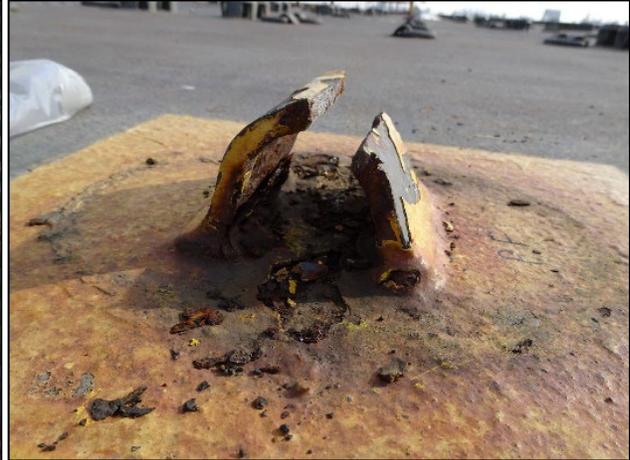
After the incident, the Coast Guard verified that the arrangement of the hatch cover lifting points were in accordance with all available drawings and design schematics. There were no records of any pull-tests or other testing conducted on these lifting points since their installation in the mid-1980s. There were also no records of any D-ring replacements, indicating that these have likely been in an exterior weather deck environment for several decades. Although there are requirements

Figure 4. Failed Securing Strap
