## **MARINE SAFETY ALERT**

Safety Alert 12-26

## **CHECK MATERIAL CONDITION OF AGING FIBERGLASS LIFEBOATS**

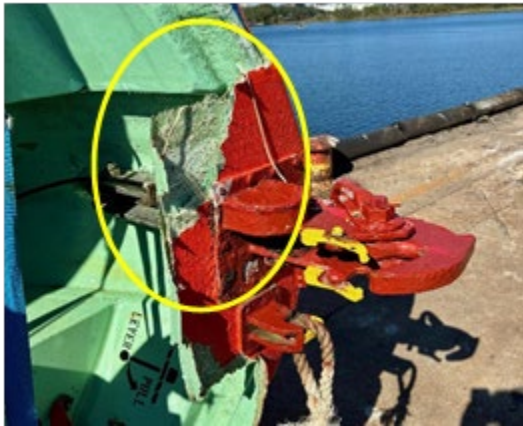
*Figure 1: Damaged hook.*

Lifeboats launched by falls use a hook release system that allows the boat to be detached from the lowering cables. In this case, while the lifeboat was being lowered, the fiberglass supporting the forward hook assembly failed, allowing the metal backing plate to pull free from the base. This caused the locking mechanism to rotate and the hook to open, which allowed the lifeboat to be unintentionally released.

The U.S. Coast Guard determined that the lifeboat was constructed in June 2002, making it 23 years old at the time of the incident. Neither current U.S. regulations nor the International Convention for the Safety of Life at Sea (SOLAS) requirements specify a maximum service life for lifeboats, and in this case, the manufacturer also did not provide a recommended service life for this model. However, the lifeboat's age and extended exposure to the marine environment contributed to the degradation and eventual failure of its fiberglass structure.

- Follow the guidance in U.S. Coast Guard [Navigation and Vessel Inspection Circular 03-19](#) and conduct thorough inspections of release mechanisms, focusing on hook assemblies, to identify any

compromised or delaminated fiberglass between metal backing plates and hook attachment points.

- Replace components that show signs of excessive wear, corrosion, cracking, deformation, or other damage that may degrade system integrity.
- Implement manufacturer-recommended inspection intervals and focus additional attention on high-stress and load-bearing areas. These areas should be inspected while under load (suspended in the cradle) to identify any areas with compromised structural integrity that could result in failure.

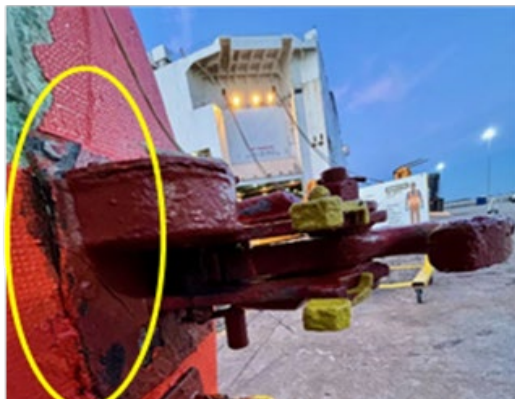
*Figure 2: Visible fiberglass delamination and backing plate corrosion at the lifeboat's hook attachment point.*

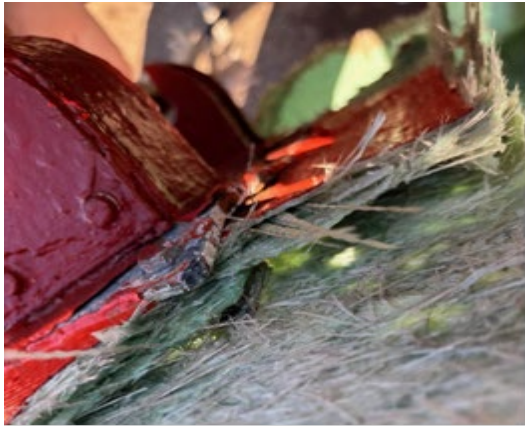
*Figure 3: Close up of delamination at the hook attachment point.*
