## MARINE SAFETY ALERT

Safety Alert 20-25

## **RISK OF PROPULSION LOSS FROM MATERIAL FAILURE OF MAIN ENGINE EXHAUST GAS RECIRCULATION COOLER WELD**

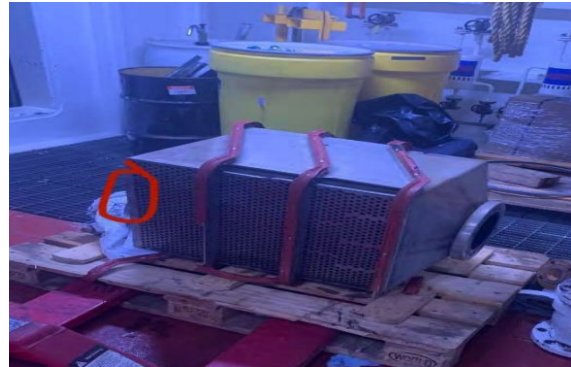
A Coast Guard inspected dredging vessel suffered a loss of propulsion on the starboard main diesel engine and subsequently required a tow into port. The subsequent investigation revealed that the engine's exhaust gas recirculation (EGR) cooler was cracked and leaking, which led to a high jacket water temperature alarm and an eventual shutdown of the starboard main engine. Coast Guard Marine Investigators traced the cause to a weld seam crack on the corner of the cooler belonging to a Wabtec Environmental Protection Agency (EPA) Tier 4/International Maritime Organization (IMO) Tier III (MDC) Marine Engine. After reviewing the vessel's service history, Marine Investigators discovered that on six separate occasions over the previous two years, the vessel's Wabtec engine EGR cooler had failed due to a weld seam crack. Each failed cooler was well below its designated overhaul interval.

EGR cooler with location of weld failure indicated

- Inspect the EGR coolers on their engines to check for signs of the failure described above.
- Conduct these inspections regularly, including prior to entering or leaving port.

- Include these regular inspections in the vessel's Safety Management System, if applicable.

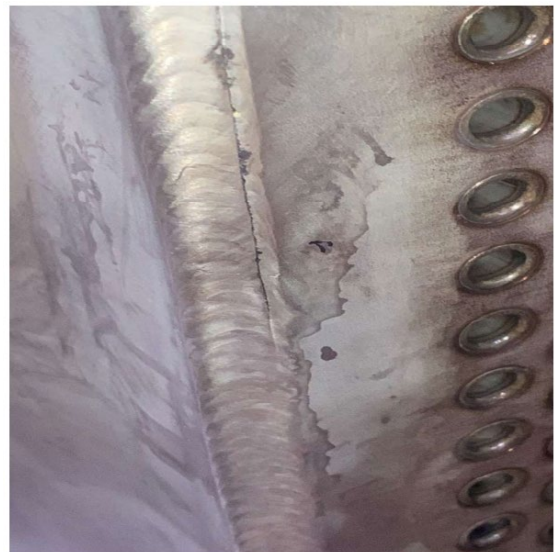
Close-up of cracked weld
