UNITED STATES COAST GUARD

REPORT OF THE INVESTIGATION INTO THE

COMMERCIAL FISHING VESSEL CAROL ANN (O.N. 906483), PRESUMED LOSS OF
LIFE AND TOTAL LOSS OF VESSEL NEAR BRUNSWICK, GA, ON
OCTOBER 14, 2023.

SINKING OF THE COMMERCIAL FISHING VESSEL CAROL ANN (O.N. 906483) AND PRESUMED LOSS OF THREE LIVES NEAR BRUNSWICK, GEORGIA ON OCTOBER 14, 2023

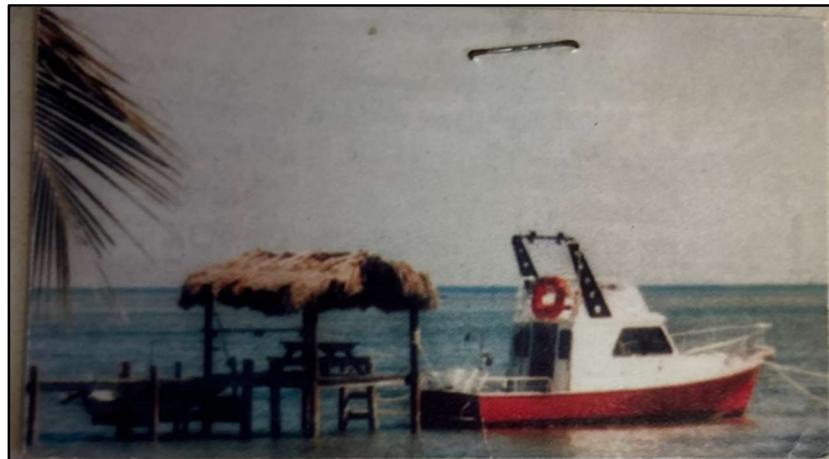
4.2.3.4.1 As the F/V CAROL ANN changed owners and services, multiple structural changes were made to the vessel. Sometime after 1990, before the current owner purchased the vessel in 2023, the flying bridge was removed, and a large fish box was placed on the aft deck. This would have caused a significant re-distribution of weight, lowered the center of gravity, and changed the stability of the vessel. See Figure 2.

Figure 2: Vessel in operation circa 1986. Source: Crusader.

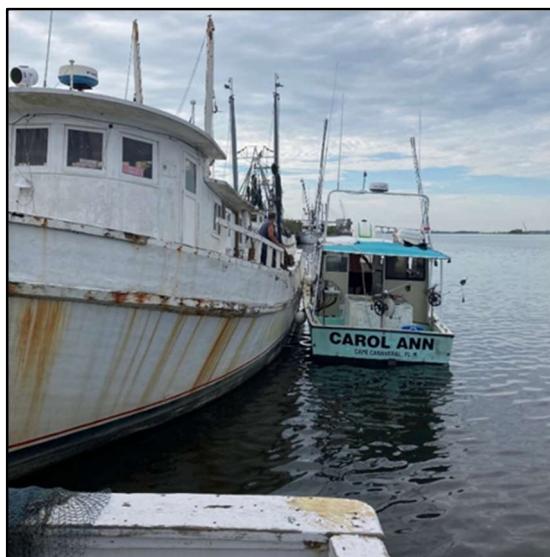
4.2.3.4.2 The current owner mounted a Revere SMLR-A-6 life raft over the starboard side of the wheelhouse. The life raft weighed approximately 160 pounds. A picture taken on August 16, 2023, (Figure 3) showed the vessel had a slight starboard list. The master purchased approximately 1,200 pounds of ice for the vessel two days prior (August 14, 2023). The exact amount of fuel and water onboard the vessel at the time of the picture were unknown.

Figure 3: F/V CAROL ANN showing a slight starboard list August 16, 2023. Source: USCG.

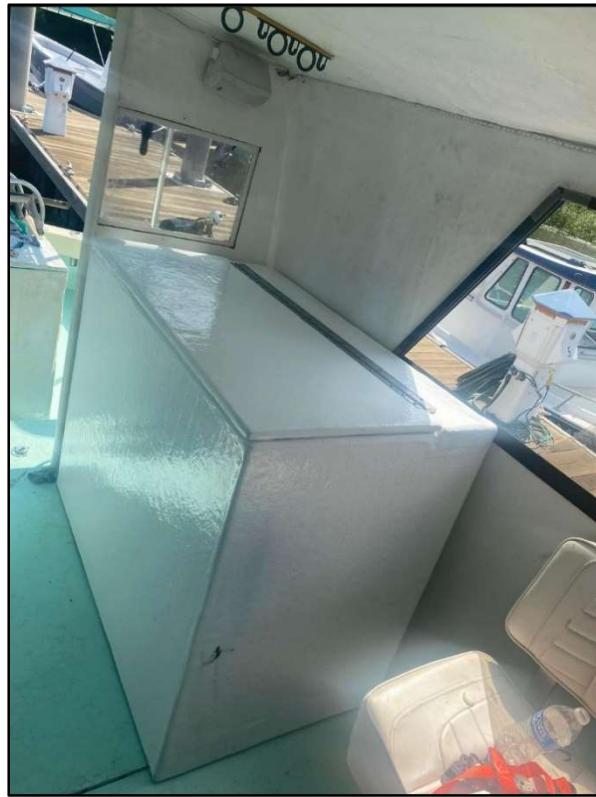
4.2.3.4.3 On August 24, 2023, the current owner installed an additional ice chest with a volume of approximately 11.11 cubic feet. The ice chest was located on the port side amidships inside the cabin. See Figure 4.

Figure 4: Ice chest installed by current owner. Source F/V CAROL ANN master's Facebook.

4.2.3.4.4 Any modifications made to the vessel after December of 1986 invalidated the stability test results from December of 1986.

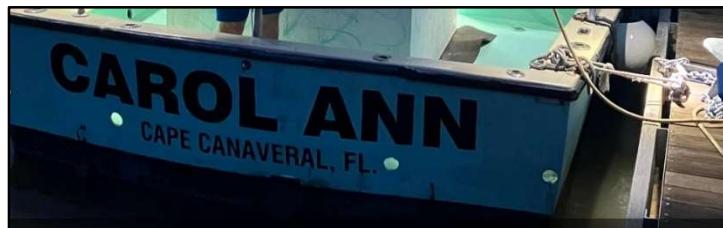
4.2.3.5.3 The master cut into the hull of the F/V CAROL ANN to expand already existing freeing ports and add freeing ports. At the time of the incident the vessel had six (one on each side and four on the stern) freeing ports approximately four inches in diameter each. The construction of the freeing ports allowed water to readily flow outboard and inboard. See Figure 5.

4.2.3.5.4 No documentation from Coast Guard inspections of the vessel in the 1980s was able to be located. Therefore, it is not known what the clear aggregate area of the freeing ports was during the time the vessel was certificated by the Coast Guard.

Figure 5: F/V CAROL ANN freeing ports. Source: F/V CAROL ANN owner's Facebook.

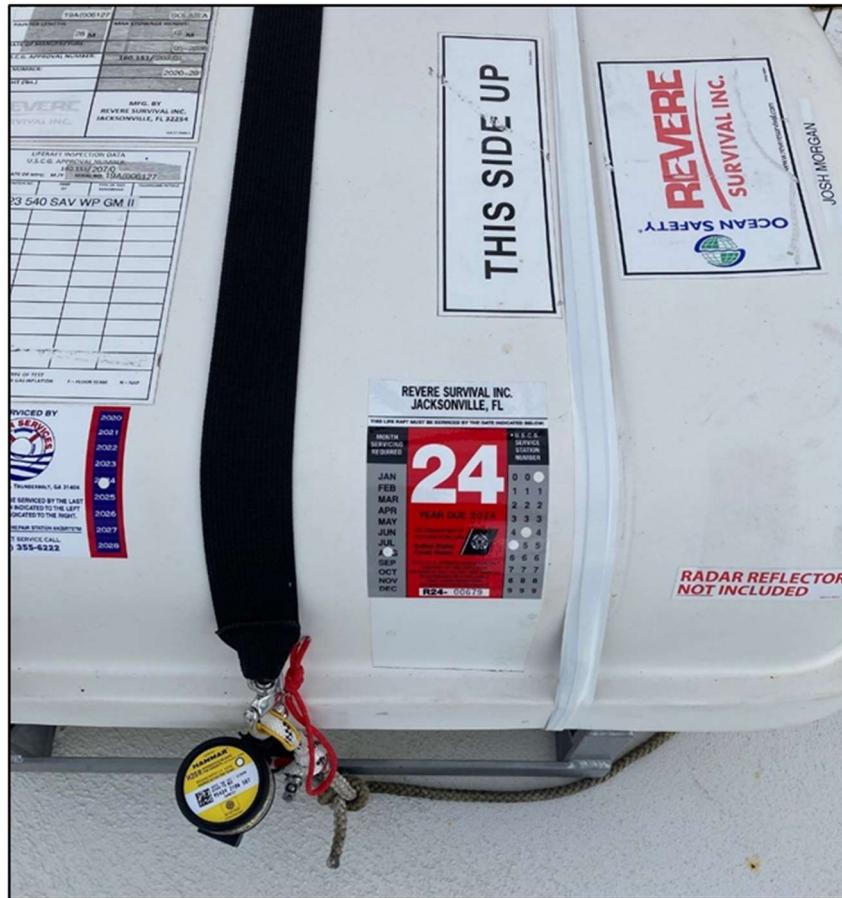
4.2.4.6 During the exam the vessel was equipped with a USCG approved Revere SMLR-A-6, Safety of Life at Sea (SOLAS) A-Pack, 6-man life raft. The life raft was properly rigged and fitted in an authorized float free arrangement as required by 46 CFR Part 28. The life raft was located on the top of the wheelhouse underneath the a-frame radar mount. It was last serviced in August 2023. See Figures 5 and 6.

Figure 6: Properly rigged Coast Guard approved life raft on the F/V CAROL ANN. Source: USCG.

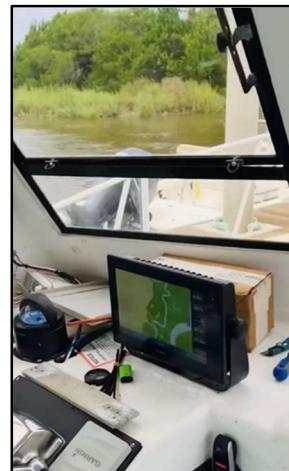
4.2.5.11 On September 16, 2023, the owner uploaded a video of the F/V CAROL ANN to Facebook showing the EPIRB box lying on the helm. See Figure 7.

Figure 7: EPIRB box on laying on helm September 16, 2023. Source: F/V CAROL ANN owner's Facebook.

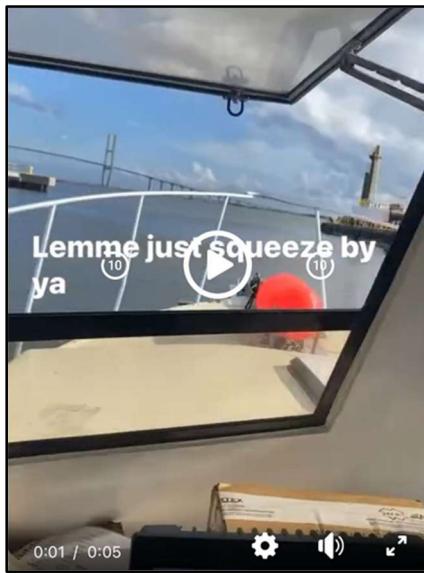
4.2.5.12 On September 21, 2023, and October 6, 2023, the master uploaded videos of the F/V CAROL ANN to Facebook showing the EPIRB box in the same place laying on the helm. See Figures 8 and 9.

Figure 8: EPIRB box laying on helm on September 21, 2023. Source: F/V CAROL ANN master's Facebook.

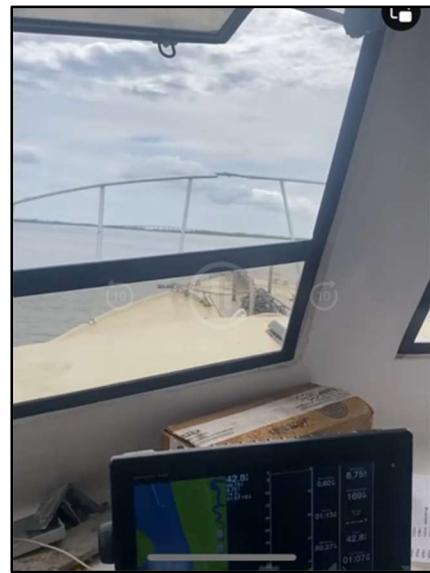
Figure 9: EPIRB box laying on helm on October 6, 2023. Source: F/V CAROL ANN master's Facebook.

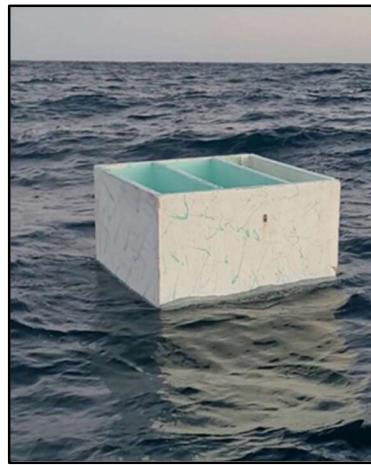
4.2.9.1.1 On November 19, 2023, the fish box from the F/V CAROL ANN was recovered approximately 17 miles off the coast of St. Augustine, FL, approximately 130 miles SW of the initial search area. See Figures 5 and 10.

Figure 10: F/V CAROL ANN fish box. Source: Good samaritan who located fish box.

4.2.9.1.9 The fish box had a large sail area above the water as seen in Figure 10 while the two lids of the fish box had very low profiles as seen in Figure 11. This means that the lids had significantly less sail area than the fish box, therefore, their drift would have been mainly determined by the current, while wind would have had a larger impact on the drift of the fish box. The location where the lids were discovered were in line with the reverse drift analysis in 4.2.9.1.5, indicating the lids entered the water prior to the Gulf Stream closer to shore.

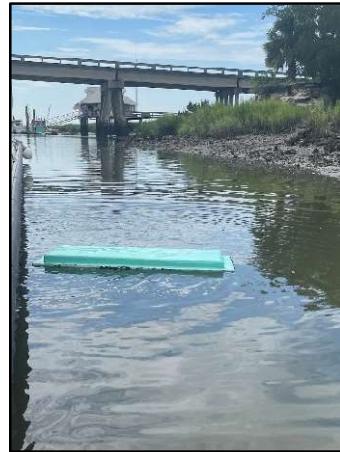
Figure 11: Simulation of fish box lid floating in Savannah River, GA, to show little to no sail area. Source: USCG.

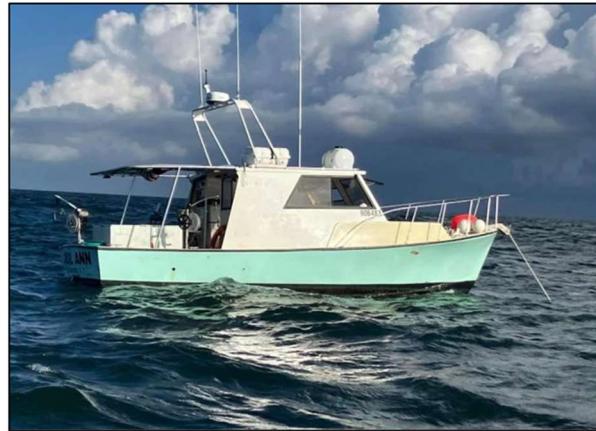
5.10 Stowage of life raft. The vessel was equipped with a properly rigged and recently serviced 6-person float free life raft. The life raft was stowed on the top of the wheelhouse but was underneath the a-frame radar mount (See Figure 13). To date the life raft has not been located. When the vessel lost stability and sank the hydrostatic release likely operated properly, but the life raft may have caught in the a-frame radar mount while floating to the surface. It is reasonable to assume that the life raft never reached the surface, and the crew of the vessel was not able to utilize it. Had the life raft been stowed forward on the wheelhouse, clear of the a-frame radar mount, it would have increased the ability of the life raft to float freely to the surface greatly increasing the survival chances of the crew.

Figure 13: F/V CAROL ANN life raft stowed underneath a-frame radar mount Source: F/V CAROL ANN owner's Facebook.

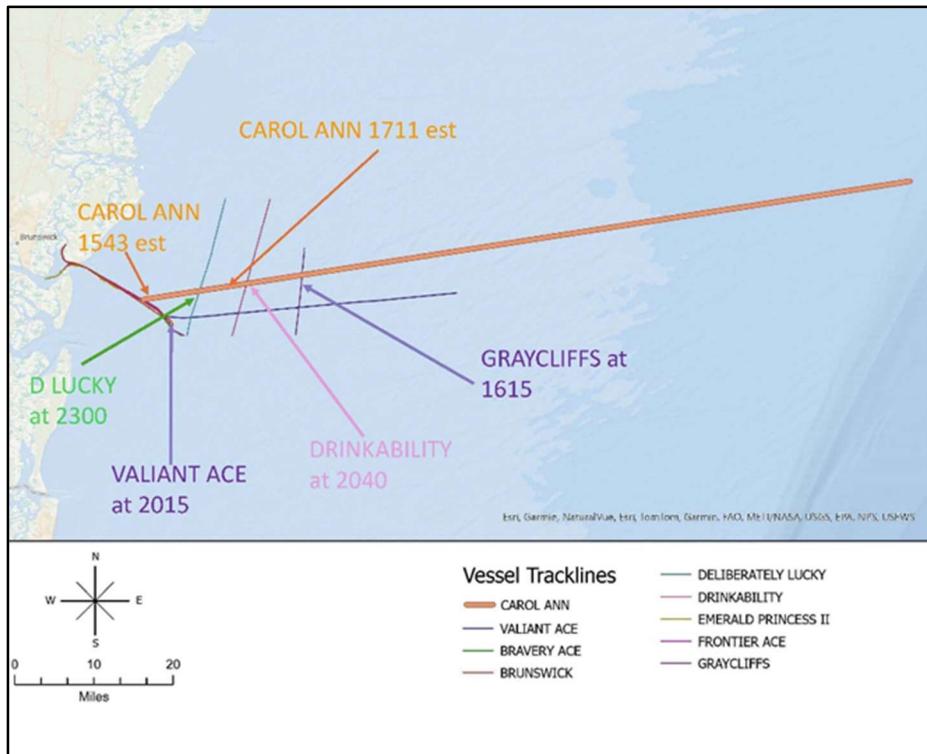
Figure 14: Vessels transmitting AIS crossing the probable path of the F/V CAROL ANN on October 14, 2023. Source: USCG.
