**REPORT OF THE INVESTIGATION
INTO THE
COLLISION BETWEEN THE RECREATIONAL
VESSEL TODO BIEN (O.N. 992174) AND THE
OIL TANKER EAGLE SAN ANTONIO (IMO
9594822) RESULTING IN THE LOSS OF TWO
LIVES ON THE CORPUS CHRISTI, TX SHIP
CHANNEL ON JULY 13, 2024**

INVESTIGATING OFFICER'S REPORT

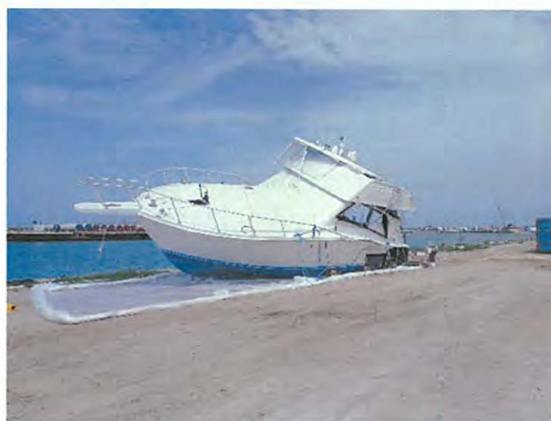
Figure 1. TODO BIEN Post Collision at Aransas Terminal Aransas Pass, TX.
(July 14, 2024/USCG)

4.2.6. The recreational vessel TODO BIEN was a 43-foot fiberglass vessel equipped with radar, AIS, GPS, VHF radio, and a depth finder. The vessel had a Certificate of Documentation issued on January 5, 2022. The structural design and reinforcements on

the TODO BIEN were not designed to absorb the impact of a tanker. The vessel was owned by OK Sportfishing LLC.

- 6.1.2.1. The vessel's design and construction were not equipped to absorb the impact of such a large and heavy ship, which significantly compromised its integrity upon collision.

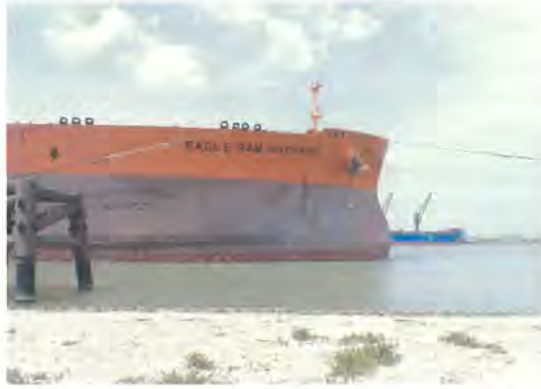
Figure 2. EAGLE SAN ANTONIO moored Eagle Ford Dock Corpus Christi Inner Harbor Post Collision. (July 13, 2024/USCG)

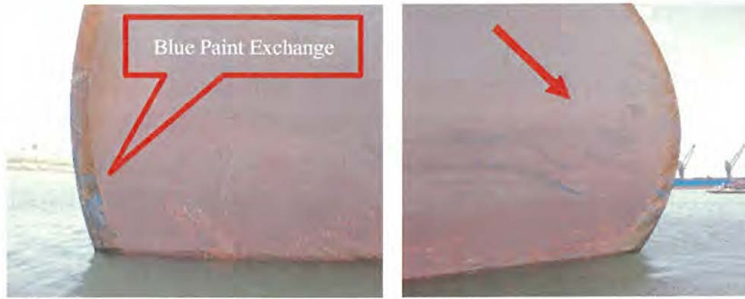
4.1.11. At 0527, the TODO BIEN and EAGLE SAN ANTONIO collided in the Corpus Christi Ship Channel between buoys 9 and 11. The TODO BIEN sustained a glancing blow to its starboard bow, while the EAGLE SAN ANTONIO exhibited blue paint transfer directly off the bow of the ship. The impact resulted in the TODO BIEN splitting into two halves. The Operator and two passengers on board the TODO BIEN entered the water, while the third passenger remained trapped below deck.

Figure 5/6. EAGLE SAN ANTONIO post collision photos moored Eagle Ford Dock Corpus Christi Inner Harbor. (July 13, 2024/USCG)

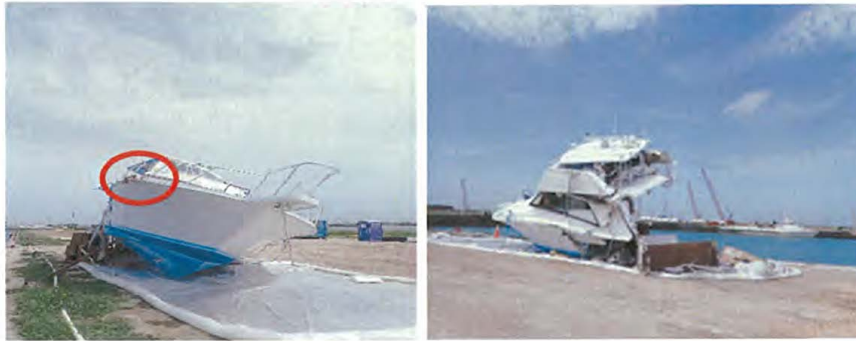
Figure 3/4. TODO BIEN post collision photos at Aransas Terminal Aransas Pass, TX. (July 14, 2024/USCG)

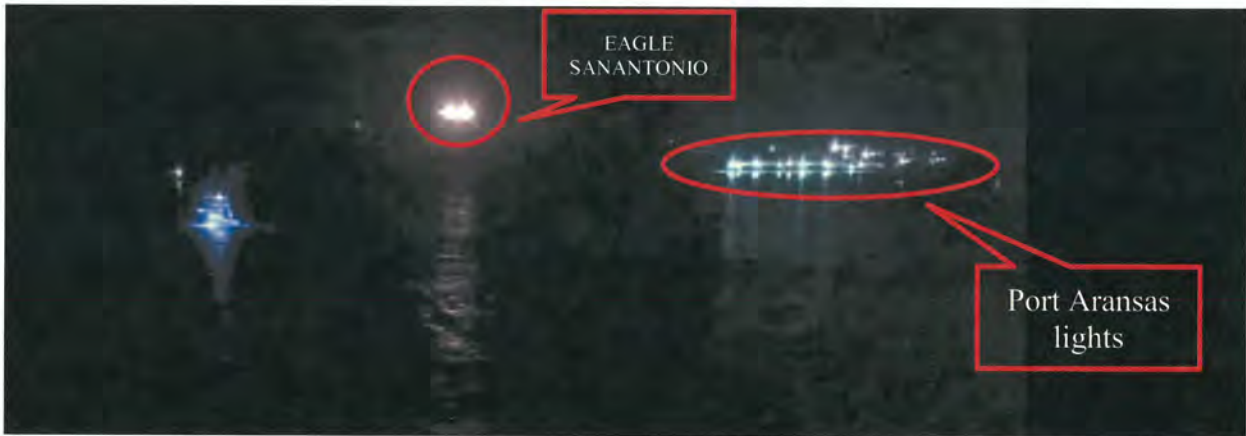
5.1. Light Pollution from Padre Island. The responding coxswain from Station Port Aransas highlighted a significant challenge posed by the bright lights emanating from Padre Island, particularly during low-light conditions. This light pollution can create a confusing backdrop, making it difficult to distinguish between natural navigational cues and artificial light sources. In this case, the bright lights may have hindered the crew of the TODO BIEN from visually identifying the inbound EAGLE SAN ANTONIO. If the light pollution from Padre Island had not been present, the crew of the TODO BIEN may have had a clearer view of the inbound tanker EAGLE SAN ANTONIO, potentially allowing them to identify the vessel earlier. This earlier recognition might have provided sufficient time for the TODO

BIEN to take evasive action or make proper passing arrangements, potentially preventing the collision.

Figure 7. EAGLE SAN ANTONIO inbound in the Corpus Christi Ship Channel with illuminated Navigational Lights. (July 13, 2024/Port of Corpus Christi CCTV)

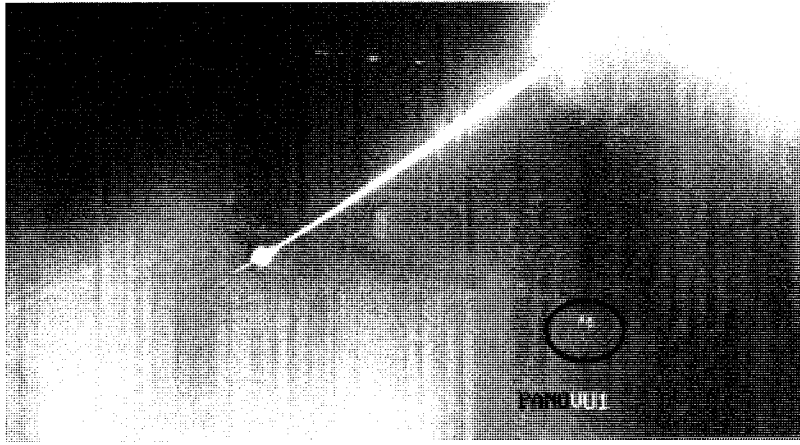
4.1.8. At 0526, closed-circuit television footage showed the Bosun positioned at the bow of the EAGLE SAN ANTONIO, assigned to lookout duty. The Bosun was observed loitering near the bow, frequently turning his back and not actively scanning forward. Voyage Data Recorder (VDR) audio indicated that no communication was initiated by the Bosun.

5.3. Improper Bow Lookout on the EAGLE SAN ANTONIO. Closed-circuit television footage revealed the Bosun was stationed at the bow of the EAGLE SAN ANTONIO for lookout and anchor watch duties. The footage showed the Bosun frequently turning his back and failing to consistently scan the water ahead. VDR audio confirmed the Bosun did not communicate with the bridge to report any potential hazards before the incident. Had the Bosun detected the approaching TODO BIEN earlier and communicated this information to the bridge, it could have prompted the EAGLE SAN ANTONIO to sound the danger signal (five short blasts) sooner, potentially giving the TODO BIEN to take evasive action and avoid the collision.

Figure 8. EAGLE SAN ANTONIO Bow Lookout with back turned to bow.
(July 13, 2024/EAGLE SAN ANTONIO CCTV)

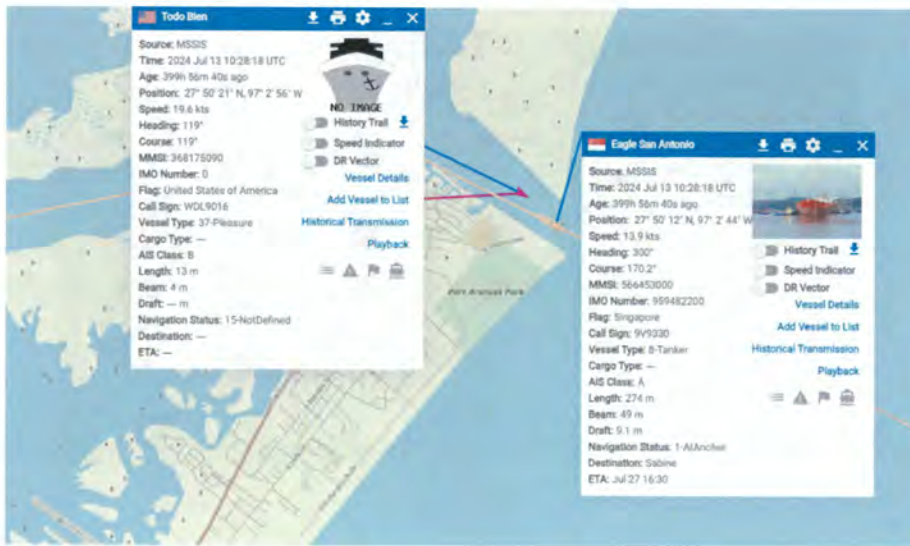
5.5. Failure to adhere to Rule 9 of the COLREGs by the TODO BIEN. The AIS data indicated the Operator of the TODO BIEN violated Rule 9 of the COLREGs, which addresses vessels navigating in narrow channels. Rule 9 requires vessels operating in such channels to keep as far to the starboard side of the channel as is safe and practicable, and it gives priority to vessels that are constrained by their draft, such as large tankers, which are limited in their ability to maneuver. The EAGLE SAN ANTONIO, a large oil tanker, was restricted in its ability to deviate from its course due to its size and draft, making it the stand-on vessel. Had the Operator adhered to Rule 9 and kept the TODO BIEN out of the middle of the channel the collision may have been avoided.

Figure 9. AIS Screen Shot. (July 13, 2024/USCG NAVCEN)
