**MISLE INCIDENT INVESTIGATION REPORT FOR
INDUSTRIAL VESSEL GENERAL MACARTHUR
(O.N. 1301331), LOSS OF LIFE WHILE IN DRY
DOCK AT CONRAD SHIPYARD IN AMELIA, LA,
ON JUNE 19, 2023, 14:15:00 CDT**

**INDUSTRIAL VESSEL GENERAL MACARTHUR (O.N. 1301331), LOSS OF LIFE
WHILE IN DRY DOCK AT CONRAD SHIPYARD IN AMELIA, LA, ON JUNE 19, 2023**

INVESTIGATING OFFICER'S REPORT

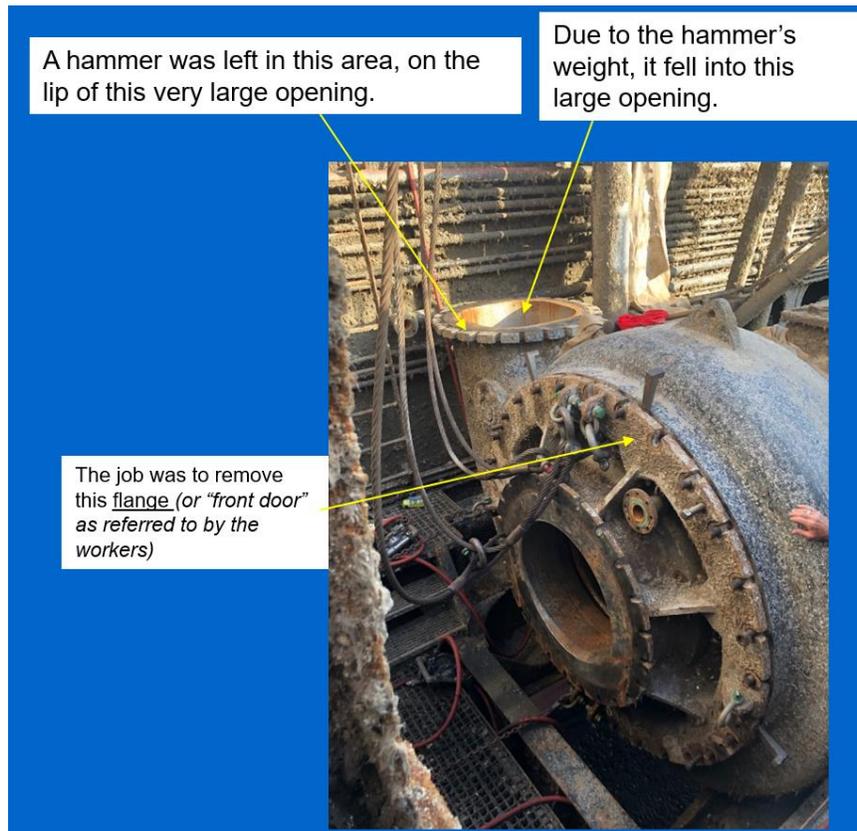
Figure 3: Coast Guard Photo of the Industrial Vessel GENERAL MACARTHUR’s pump impeller area, taken on June 19th, 2023.

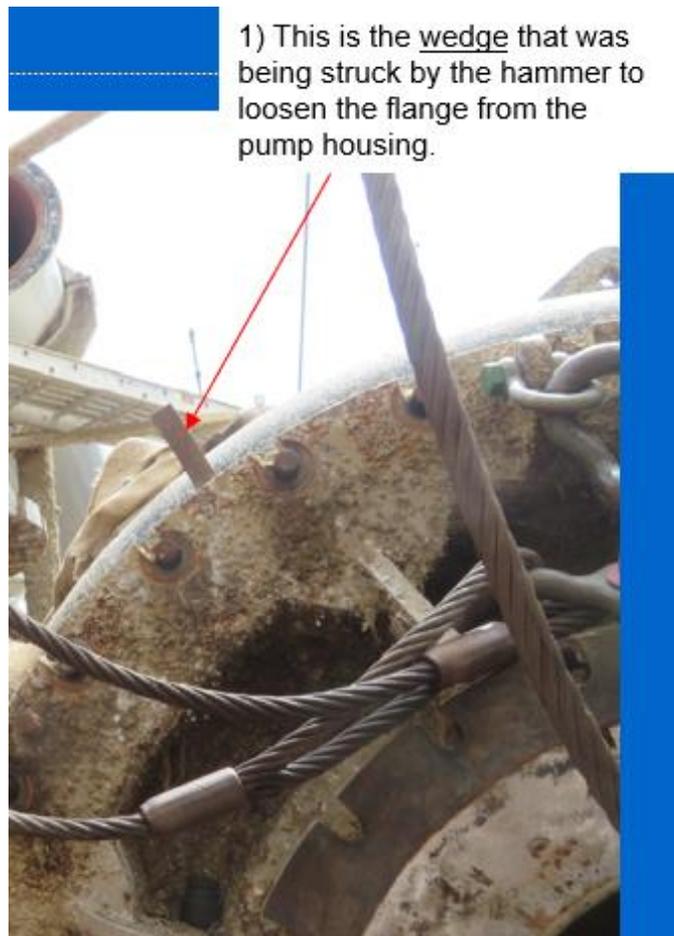
4.1.4. To remove the pump's impeller front, "the front door", steel wedges were placed around the perimeter.

Figure 4: Coast Guard Photo of the Industrial Vessel GENERAL MACARTHUR's pump impeller area, taken on June 19th, 2023.

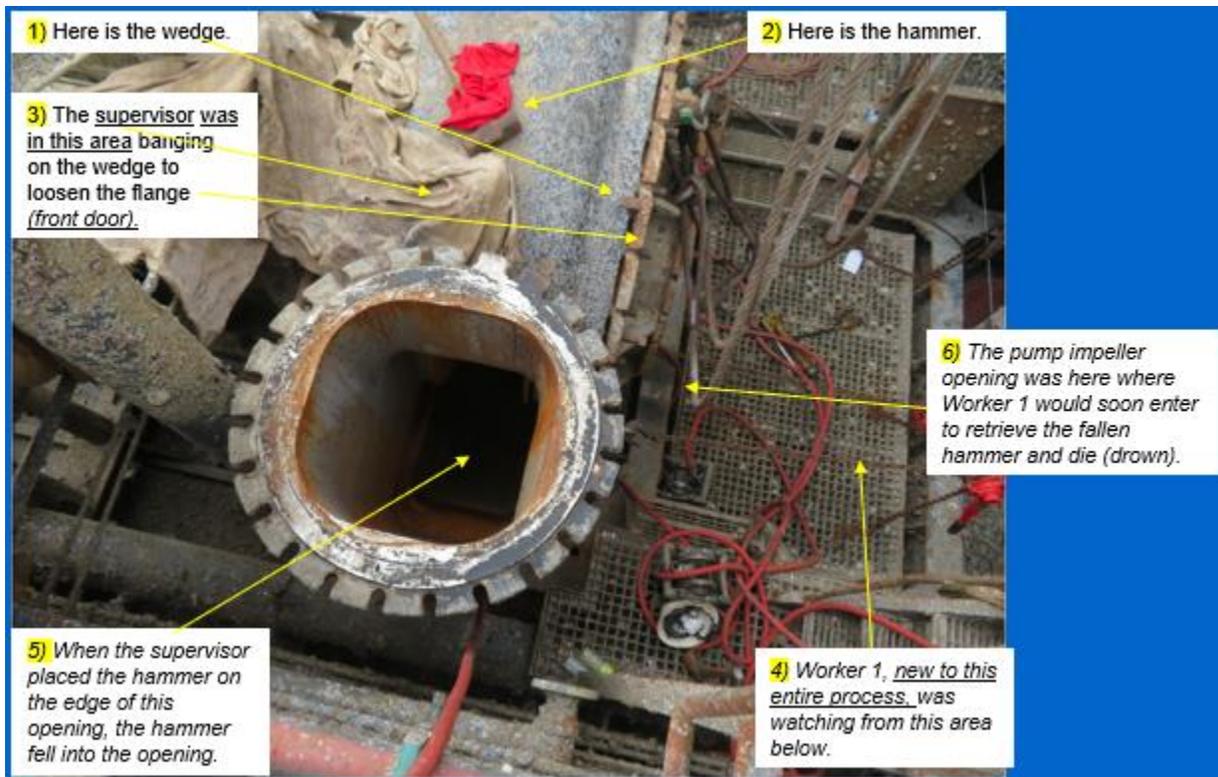
4.1.5. Then, the wedges were hammered in to loosen the flange seal, “front door” seal, between the flange and the pump’s housing. One of the men, the job supervisor, got on top of the pump’s housing. He used a hammer to beat a steel wedge between the flange “front door” and the pump’s housing.

Figure 5: Coast Guard Photo of the Industrial Vessel GENERAL MACARTHUR’s dredge pump impeller area overhead view, taken on June 19th, 2023.

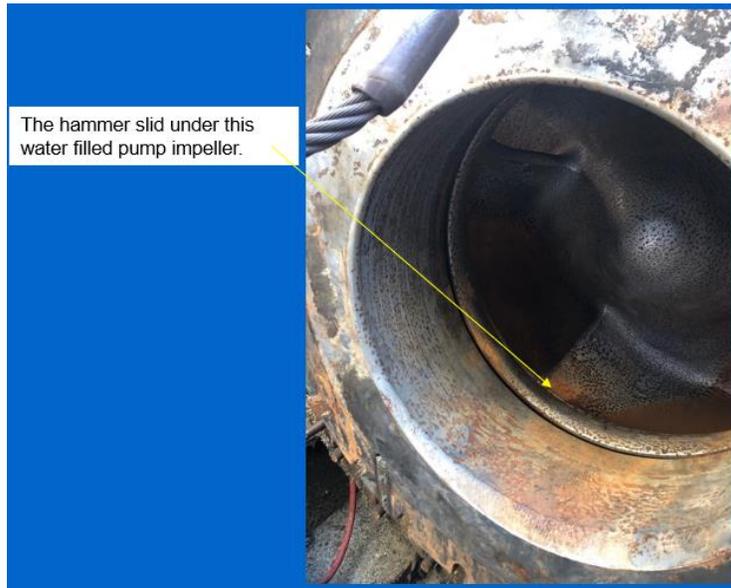
4.1.7 Then, the supervisor placed the hammer he was using on the lip of the pump housing opening atop. The weight of the hammer made it fall into the pump housing outlet opening. Then it slid under the pump impeller that was filled with water.

Figure 6: Coast Guard Photo of the pump impeller opening, taken on June 19, 2023.

5.4. Inadequate company JSA for tool handling. The company failed to address tool handling that could have prevented the hammer from falling into the large, waterfilled pump impeller opening in the first place. Ergonomically designed tool belts, coveralls or carpenter's pants with hammer loops could have been used to holster and secure the hammer between usage. Instead, the hammer was laid to rest on the ledge of the large, overhead pump impeller opening. Then the hammer's imbalanced weight caused it to fall into the pump's large discharge tube opening and settle under the waterfilled pump impeller. Had an ergonomically designed tool holder been used, the hammer likely would have not fallen in the first place. Which could have prevented the incident from occurring.

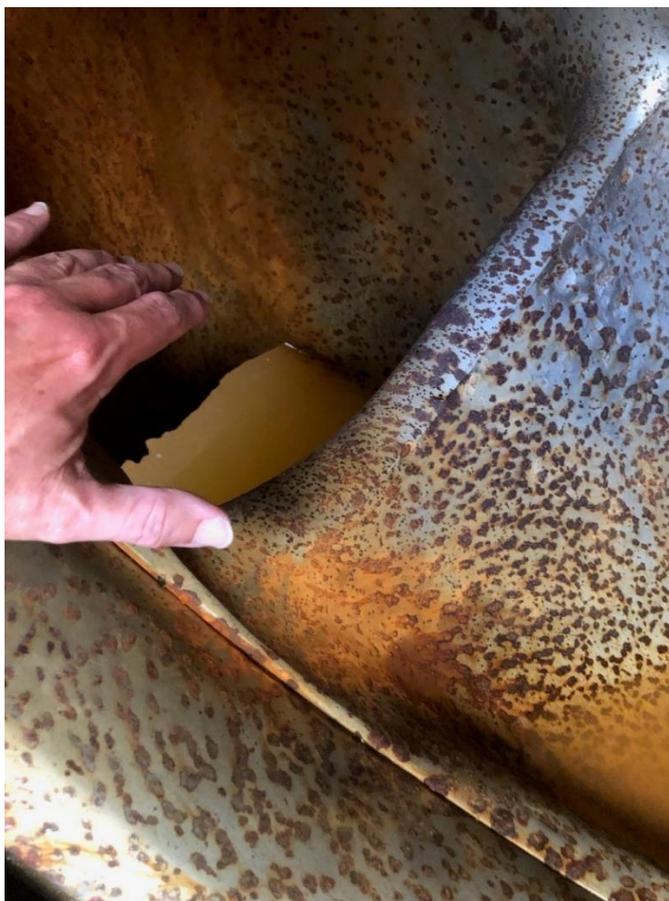
4.1.9 While reaching for the hammer, Worker 1’s weight shifted, and he fell into the waterfilled pump impeller opening face first. Then Worker 1’s upper body became lodged between the pump impeller vanes with his head submerged in approximately three feet of water.

Figure 8: Coast Guard Photo reenactment of someone reaching into the water filled impeller opening to retrieve a submerged hammer, taken June 19, 2023.

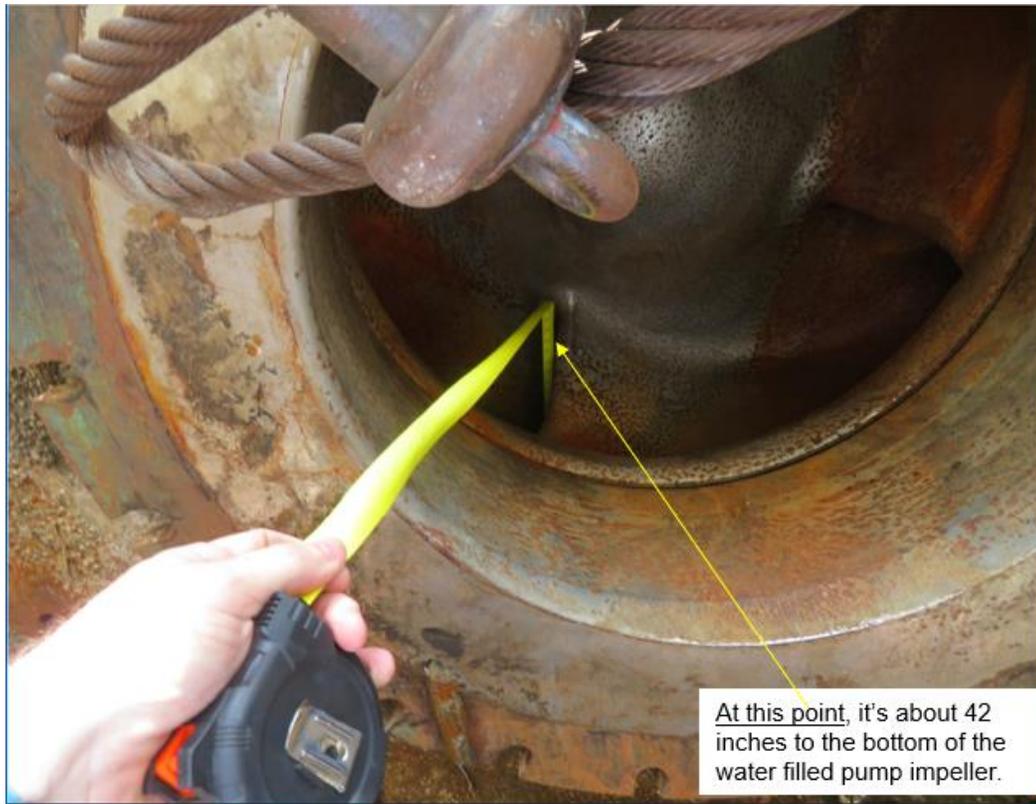
At this point, it's about 42 inches to the bottom of the water filled pump impeller.

Figure 9: OSHA Photo of the pump impeller opening, taken on June 20, 2023.

5.3. Lack of company policy to drain or dewater all pump impeller casings. The company had no policy or procedure to drain or dewater the pump impeller casings prior to beginning any maintenance work. At the time of the casualty the pump impeller casing was filled with about three feet of water. Had the pump impeller been drained or dewatered beforehand, it could have prevented Worker 1 from drowning after he became stuck inside the pump impeller opening.

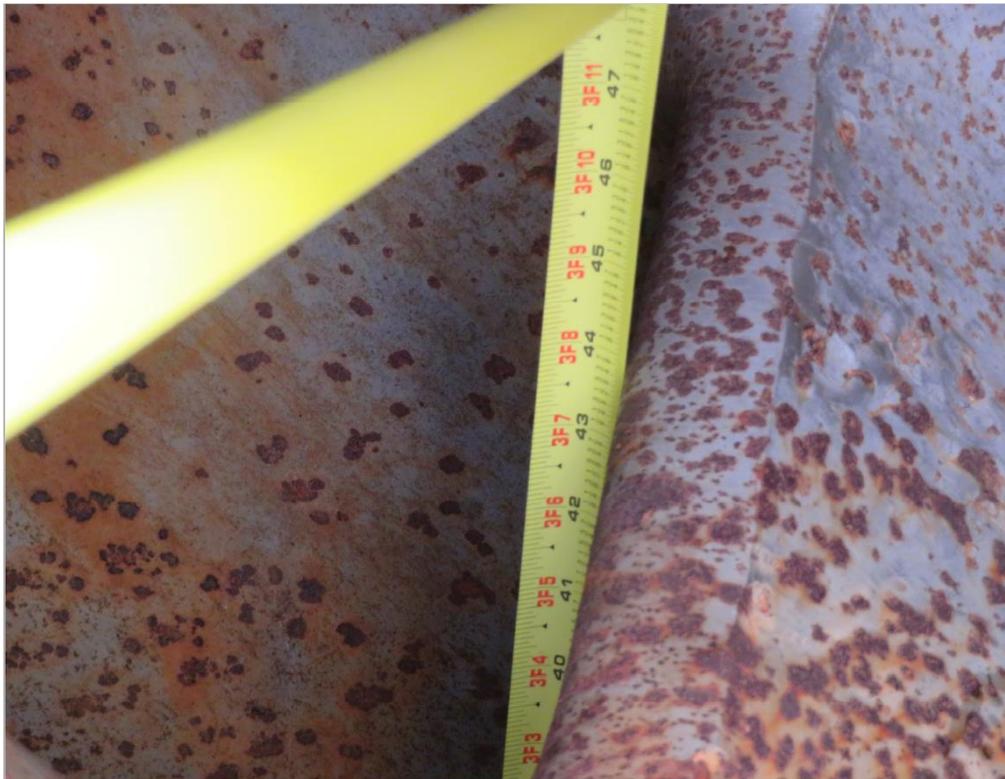
Figure 10: OSHA Photo, close in photo of the ruler reading showing the approximate water depth inside the pump impeller, taken on June 20, 2023. The water depth was about three feet deep.

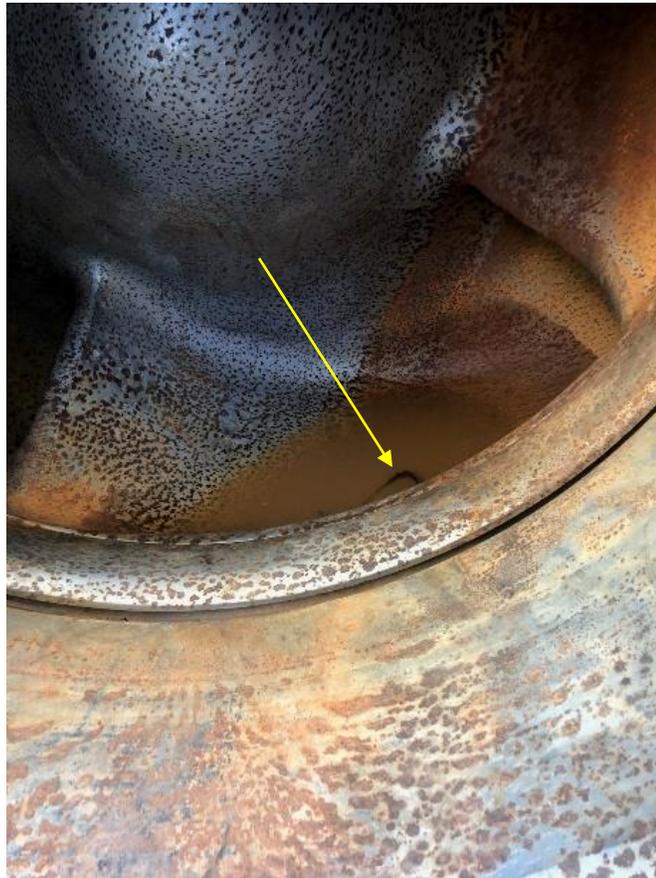
4.1.11. Worker 1's upper body was stuck between the pump impeller vanes, with his head submerged in the pump impeller opening for several minutes until others arrived and eventually freed Worker 1 from the impeller opening.

Figure 11: Coast Guard Photo of the pump impeller opening, taken on June 19, 2023. Safety glasses of the Deceased noted by the yellow arrow.

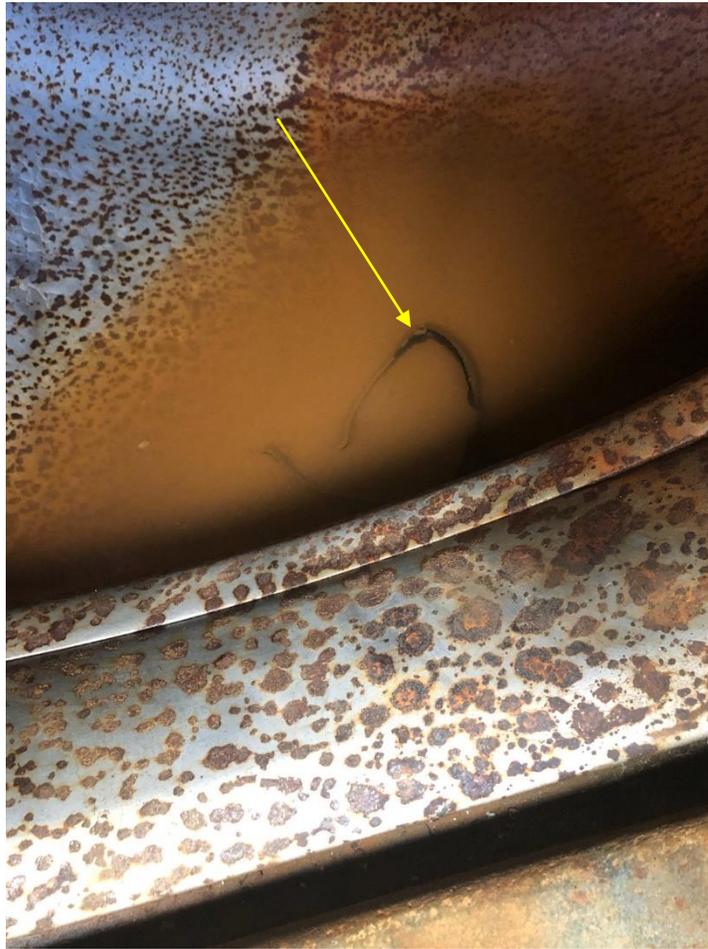
Figure 14: Coast Guard Photo of the pump impeller opening, taken on June 19, 2023. Safety glasses of the Deceased noted by the yellow arrow.
