**UNITED STATES COAST GUARD**

**REPORT OF THE INVESTIGATION  
INTO THE  
FIRE AND SUBSEQUENT LAND-BASED FIREFIGHTER  
FATALITIES ONBOARD GRANDE COSTA  
D'AVORIO (9465382) WHILE CONDUCTING CARGO  
OPERATIONS AT BERTH 18, PORT NEWARK, NEW  
JERSEY ON JULY 5, 2023**

16732/IIA #7735267  
03 Dec 2025

**FIRE AND SUBSEQUENT LOSS OF TWO LAND-BASED FIREFIGHTER LIVES  
ABOARD THE ITALIAN FLAGGED ROLL-ON ROLL-OFF/CONTAINER VESSEL  
GRANDE COSTA D'AVORIO (IMO# 9465382) WHILE CONDUCTING CARGO  
OPERATIONS AT BERTH 18, PORT NEWARK, NEW JERSEY ON JULY 5, 2023**

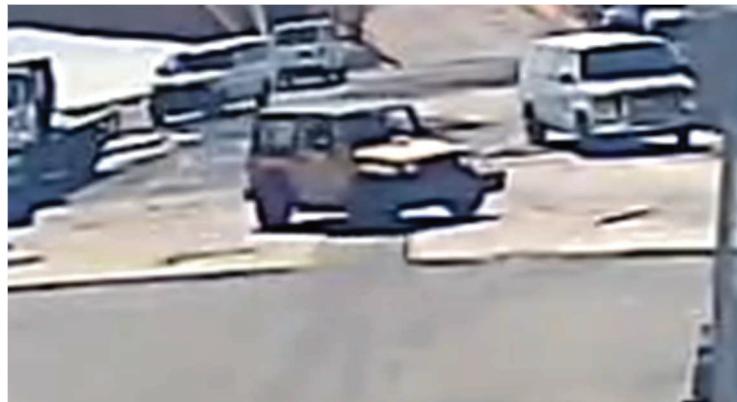
<sup>3</sup> “Pusher” vehicle: an otherwise stock passenger vehicle retrofitted with a reinforced front bumper, and in some cases weights in the back, used to push non-running cargo vehicles on and off a Ro-Ro vessel.

*Figure 2. Photograph of the JEEP taken from Port Newark security footage of July 5, 2023.*

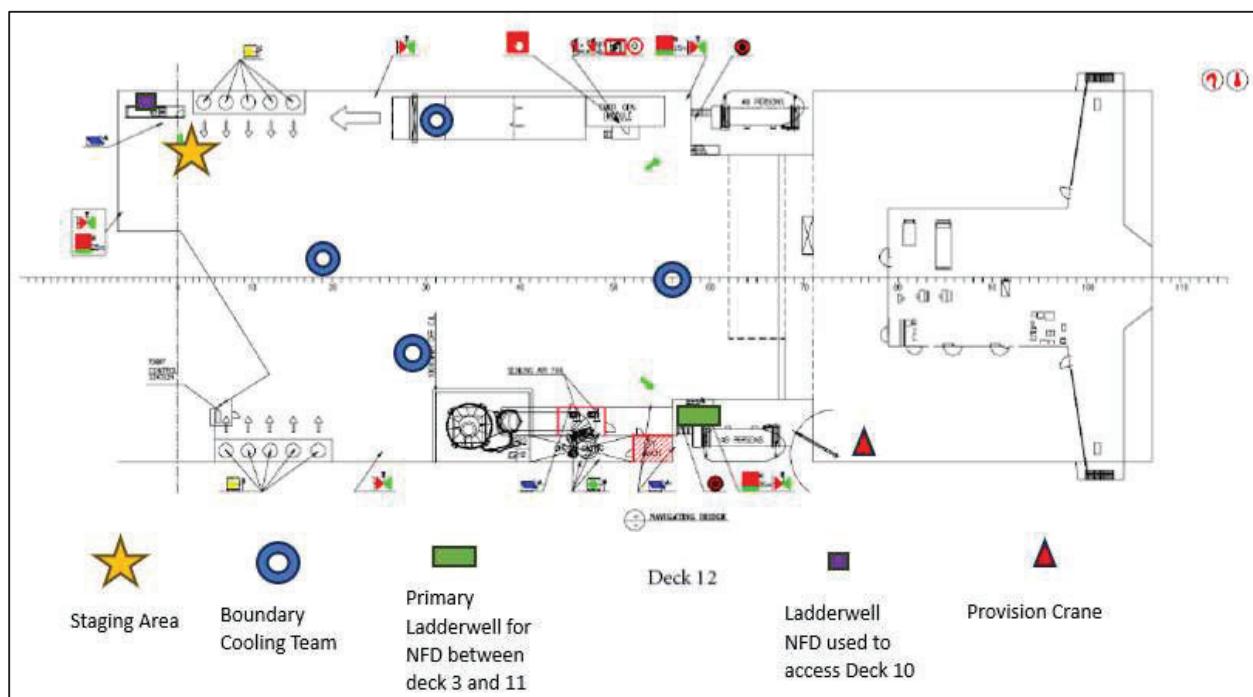
4.1.33. Shortly after, BC-4 arrived at the command post, checked in with DC-1, and then proceeded to deck 12 by way of the starboard ladderwell, the location of which is indicated by the green rectangle on the diagram of deck 12 firefighting operations in the following Figure 4.

Figure 4. Diagram of deck 12 firefighting operations. Developed by Coast Guard Investigators.

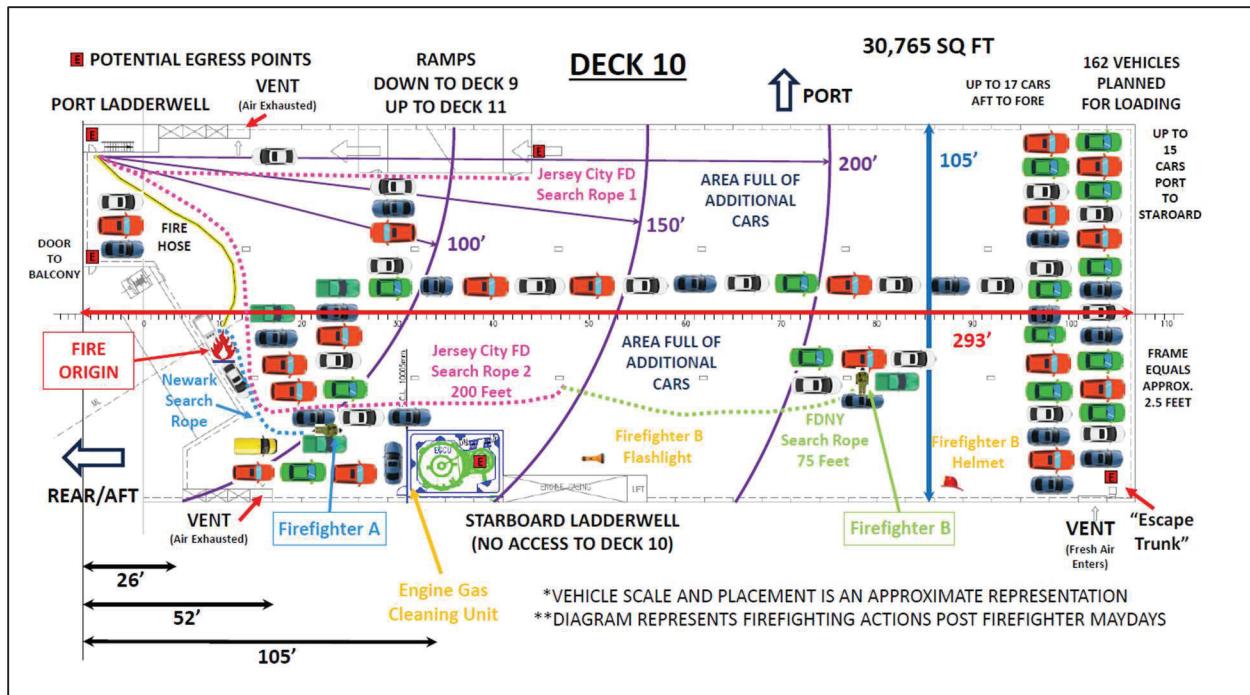
were a few pockets of visible flames emanating from the rear section of the JEEP. This entry path into the space is represented in the following Figure 5 by the yellow line marked "fire hose."

Figure 5. Diagram of fire departments' rescue efforts on deck 10. Generated through NIOSH FFFIPP Investigator.

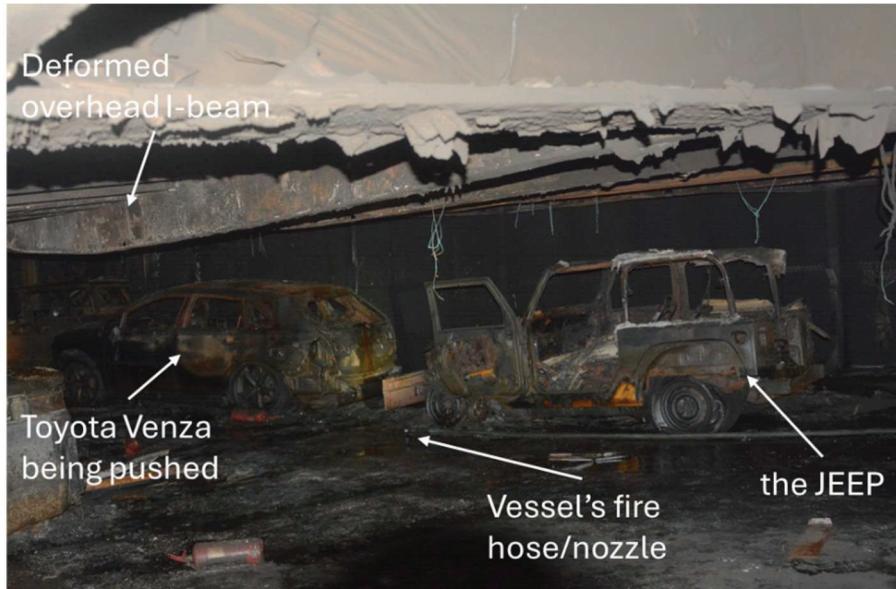
4.1.43. Through his Thermal Imaging Camera (TIC), Capt L-4 noticed an overhead I-beam above the JEEP deforming and with a very hot heat signature. This I-beam is visible post-fire in the following Figure 6. He attempted to give a report to BC-4 via radio, but his transmission was unsuccessful.

Figure 6. The JEEP and Toyota Venza post fire. Photograph taken by ATF on July 10, 2023. Developed by Coast Guard Investigators.

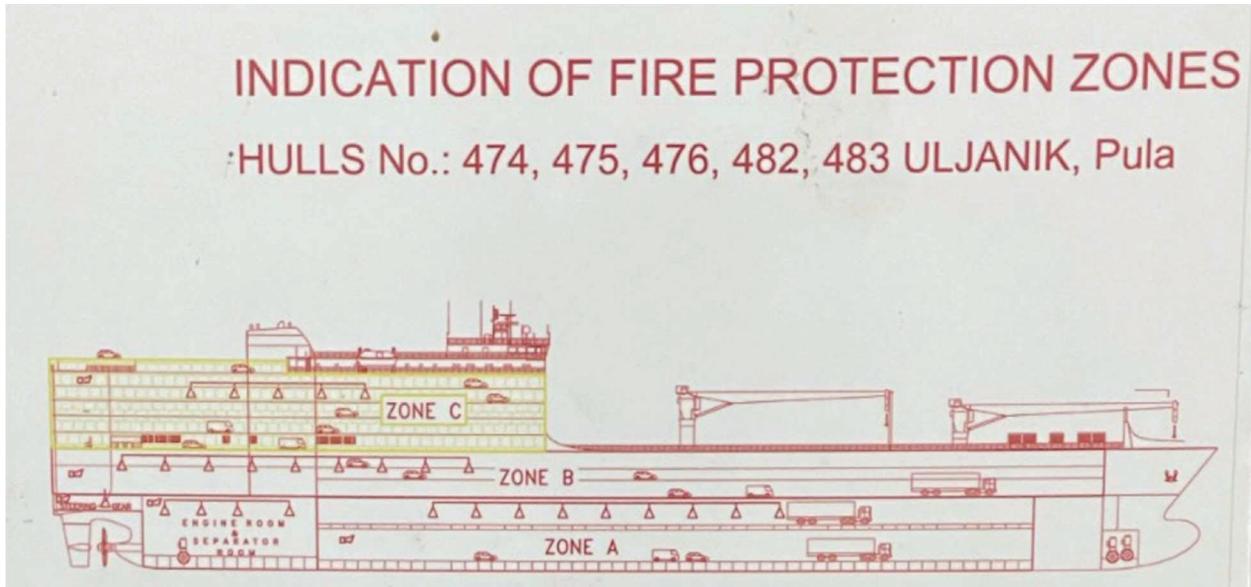
4.2.1.3.4.1.1. *Fire Protection Zones.* The vessel's low-pressure CO<sub>2</sub> fire suppression system was organized into six fire protection zones as depicted in the following Figure 9.

Figure 9. Depiction of fire protection zones on GRANDE COSTA D'AVORIO.

Fire Protection Zones A through C were designed to discharge for ten minutes when activated, and the Steering Gear Room, Engine Room, and Separator Room were designed to discharge for two minutes. The quantity discharged during the automated period was based on the zone's volume. During the ten-minute discharge, the system was designed to release 30.3 metric tons of CO<sub>2</sub> into Fire Protection Zone C. Discharge times were an automated function of the system once manually activated. Primary controls for activating the system were in the CO<sub>2</sub> Room on deck 3, which could control a discharge into any of the six zones. There were secondary controls capable of discharging into Fire Protection Zones A through C located in a space behind the navigation bridge on deck 12. Secondary controls capable of discharging into the Steering Gear Room, Engine Room, and Separator Room were located at the Cargo Control Room on deck 3. Each set of controls included an "Add CO<sub>2</sub>" button that could be used to activate manual second discharge of CO<sub>2</sub>. Various boundary openings (e.g., doors, WTDs) existed in each fire protection zone.

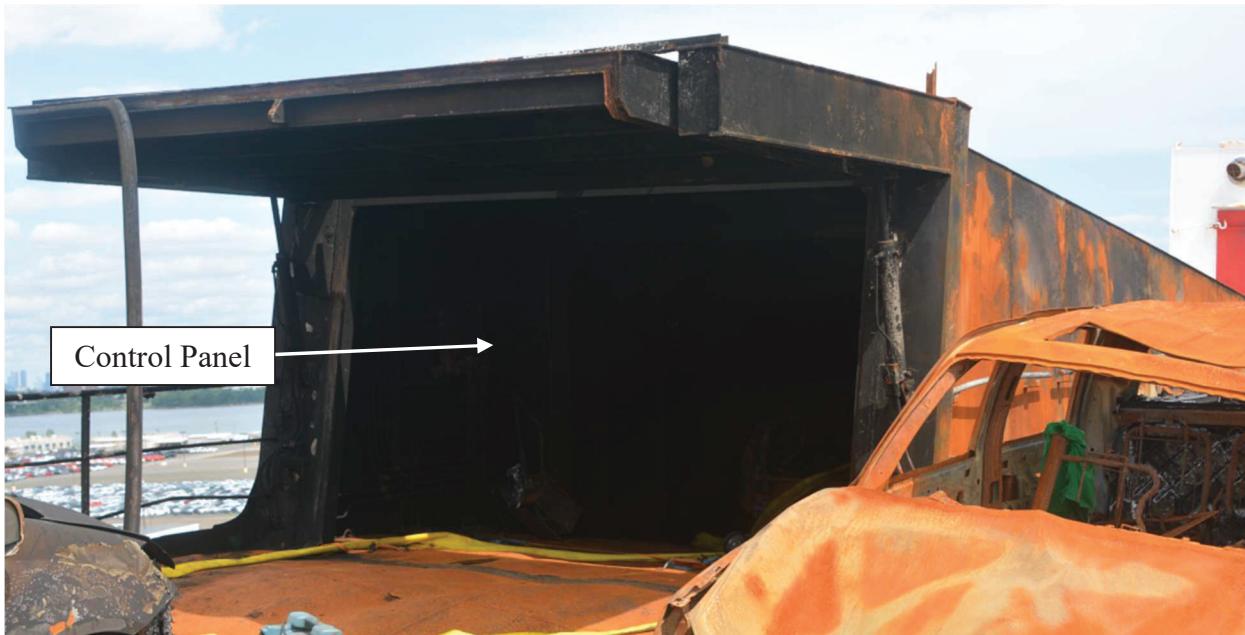
4.2.1.3.5. *WTD-12*. The vessel had a hydraulically actuated WTD at the top of the vehicle ramp from deck 11 to deck 12 as indicated by the red circle on deck 12 in Figures 7 and 8 and pictured in the following Figure 10. This door was opened at 0554 after the vessel arrived in port and remained open throughout the loading of the vessel and the incident. No policy or regulation existed to prohibit this door from remaining open while not in use in port and this was common practice throughout the Ro-Ro industry. IMO regulation only required this door to be closed before proceeding to sea and at all times while underway. The door functioned to close-off and protect the vehicle ramp and cargo vehicle garage spaces from weather while at sea. It was considered a watertight door by the vessel's Damage Control Plan<sup>37</sup> and served as part of the boundary for sealing Fire Protection Zone C.

Figure 10. Post-fire photo of WTD-12. Taken by Coast Guard Investigators.

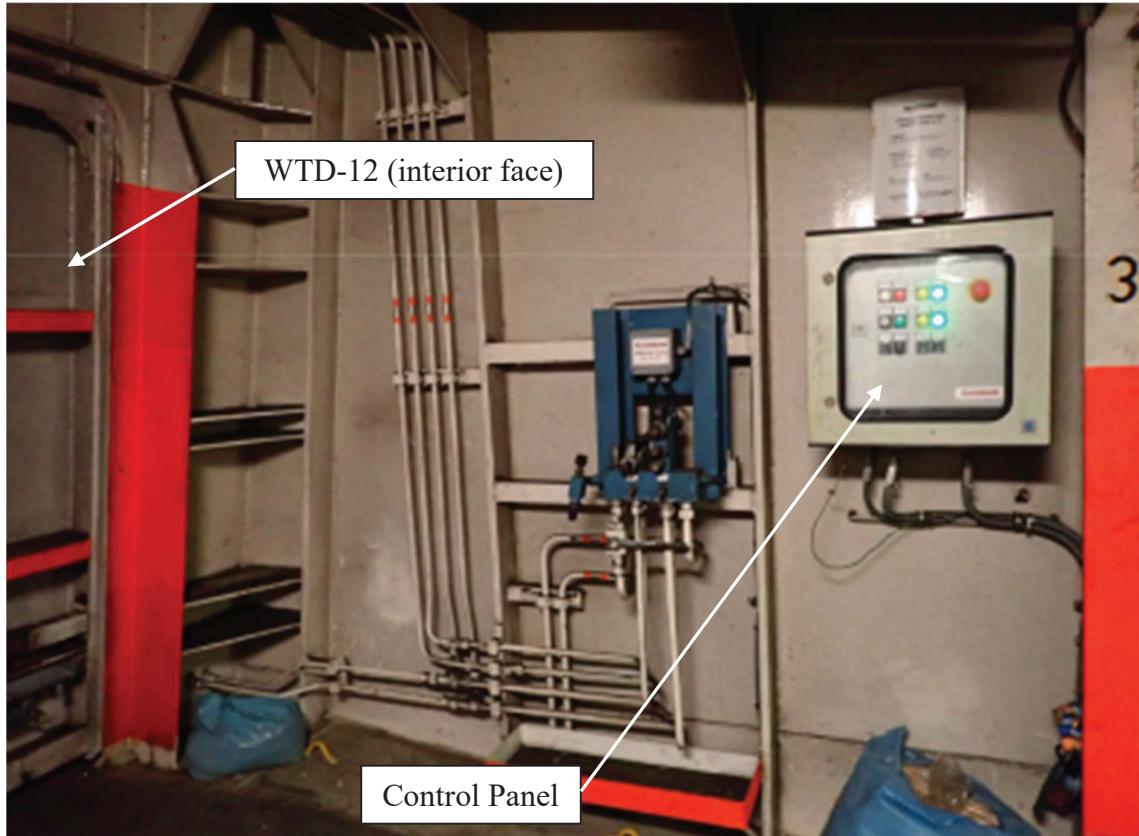
4.2.1.3.5.1. *WTD-12 Operation Procedures*. The door could only be closed locally using a control panel inside the space as depicted in Figure 10 and the following Figure 11. A manual for all hydraulically operated doors on the vessel included details on the normal and emergency (manual) means of operation. The manual labeled this door as "RAMPWAY DOOR DK 12." The door was arranged in one section hinged at the top with an operation effected by direct acting hydraulic cylinders.

Figure 11. WTD-12 PLC control panel on sister vessel. Taken by Coast Guard Investigators.

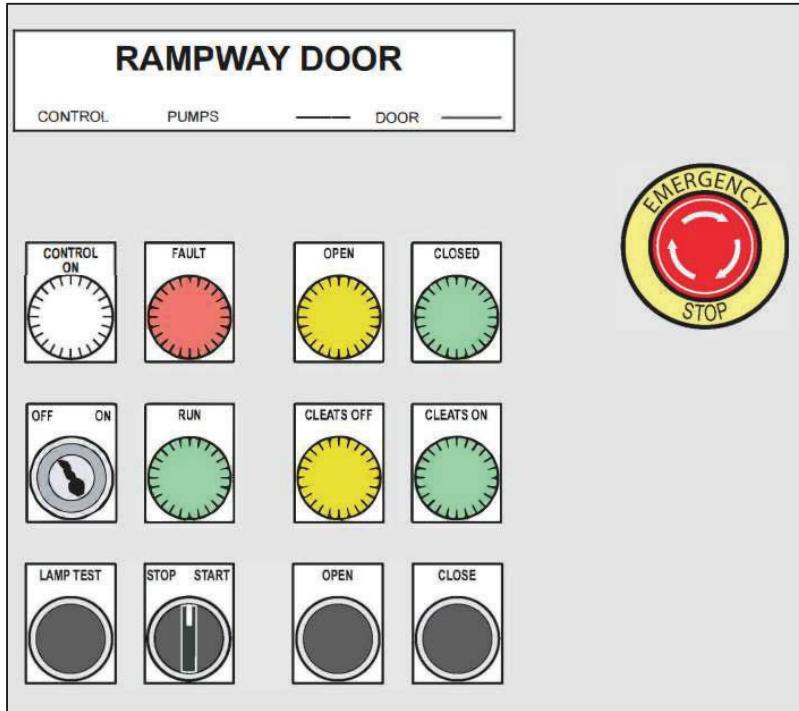
Figure 12. Rampway door control panel diagram from the MacGregor Door Manual extracts contained in CG-EX-10.

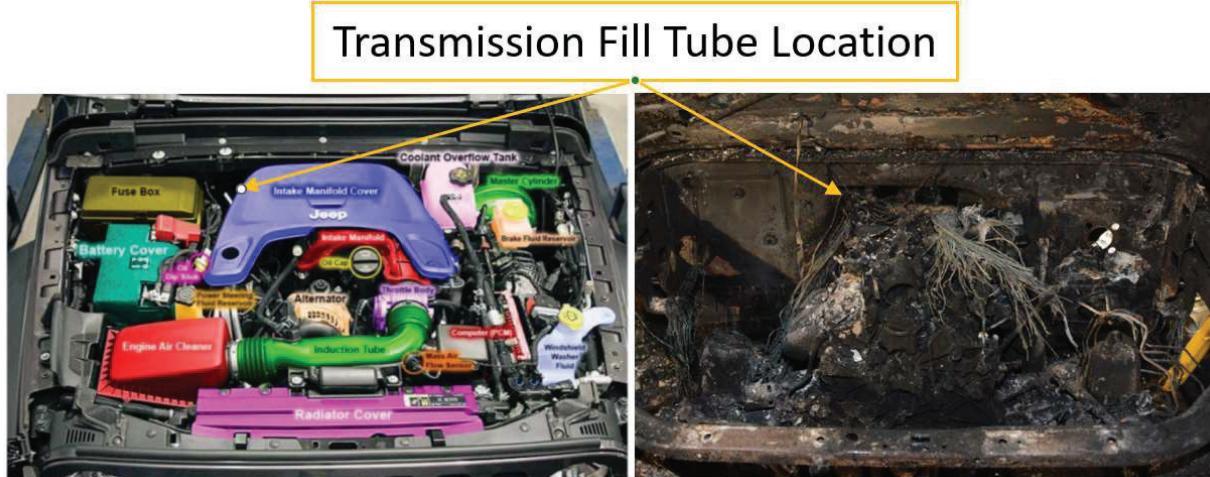
**5.1. *Fire Origin, Cause, and Spread.*** Based on the totality of evidence, it is certain that the fire originated in the JEEP. With consideration to the ATF Certified Fire Investigator's determination that informed this investigation, it is most probable that the fire was caused by a mechanical failure that expelled a flammable fluid onto a nearby hot engine or exhaust system component. More specifically, this investigation concurs with the ATF's finding that it was most likely that the JEEP's transmission overheated, and its transmission fluid expelled from the transmission fluid filler tube encountering a hot surface within the JEEP's engine compartment (approximate location shown in the following Figure 16).

Figure 16. Exemplar JEEP engine compartment layout (left) compared to the post-fire JEEP (right). Derived from CG-EX-06.

When this flammable fluid and competent ignition source came into contact, hot surface ignition occurred. Witnesses, who described fire dripping from beneath the JEEP, likely saw burning flammable fluid that dripped from the vehicle onto the deck beneath the JEEP thereafter creating a pool fire. This pool fire allowed elevated flame heights and increased flame temperatures in the engine compartment. Burning fluid then dripped through the lashing holes onto deck 9 as witnessed by vessel crewmembers. The fire began to cause convective, conductive, and radiant heat transfer to surrounding vehicles and decks. Then it progressed

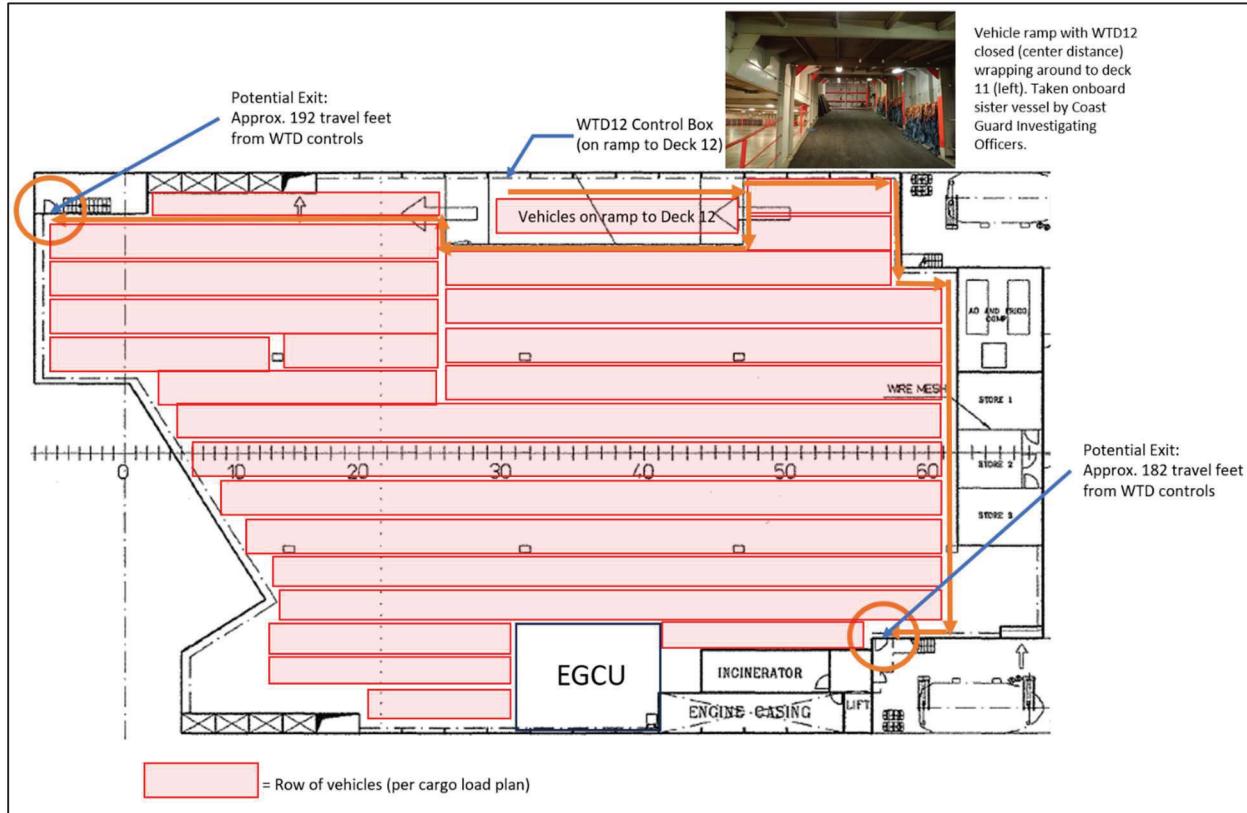
Additionally, based on VDR data, the cargo door hydraulic control system did not experience any type of documented fault or mechanical issue until 2208, approximately 45 minutes after the CO<sub>2</sub> system had been released. This indicated that WTD-12 could have been closed if a crewmember was able to access the control panel in the early hours of the fire. Fire modeling by the ATF indicated that WTD-12's open state had significant effect on depleting CO<sub>2</sub> levels on deck 10 and 11 beginning 30 minutes after discharge as depicted in the following Figure 18. In fact, this was found to be the most significant factor in this incident that prevented the effectiveness of the CO<sub>2</sub> system. Therefore, if WTD-12 was closed, Fire Protection Zone C would have been fully sealed off, the chimney opening that excelled fire spread would have

been eliminated, and effectiveness of the CO<sub>2</sub> in suppressing the fire would have increased, all without any additional crewmembers or firefighters entering the space.

Figure 17. Potential paths from WTD-12 controls to an exit on deck 11. Developed by Coast Guard Investigators.

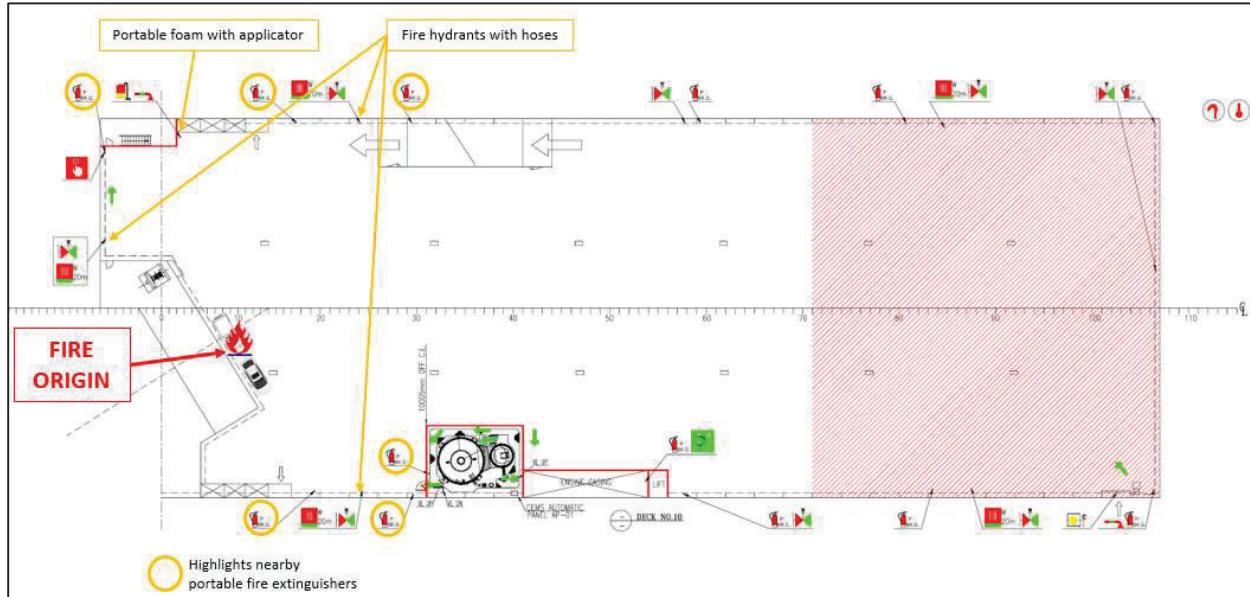
foam and an applicator located near the port aft stairwell inside of deck 10 and nearby the fire hydrant used as depicted in the following Figure 19.

Figure 19. Deck 10 fire suppression equipment locations. Developed by Coast Guard Investigators using CG-EX-07B.

The use of foam was also mentioned in the Grimaldi Safety Management Manual as a recommended option for use in cargo space fires. However, the vessel's crew never attempted to utilize the foam. Based on their testimony, the Chief Mate and Master believed foam would have been ineffective due to the lashing holes in the deck, which would have allowed leakage of the foam down into deck 9. Given the proximity of the foam to the fire hydrant used in the initial fire attack and ability for quick integration into the original hose line setup, this investigation finds a rational basis for its use, regardless of the potential impact such leakage may present. Accordingly, this investigation finds that the fire may have been potentially controlled and/or extinguished before it spread further if the foam had been used in the fire response.

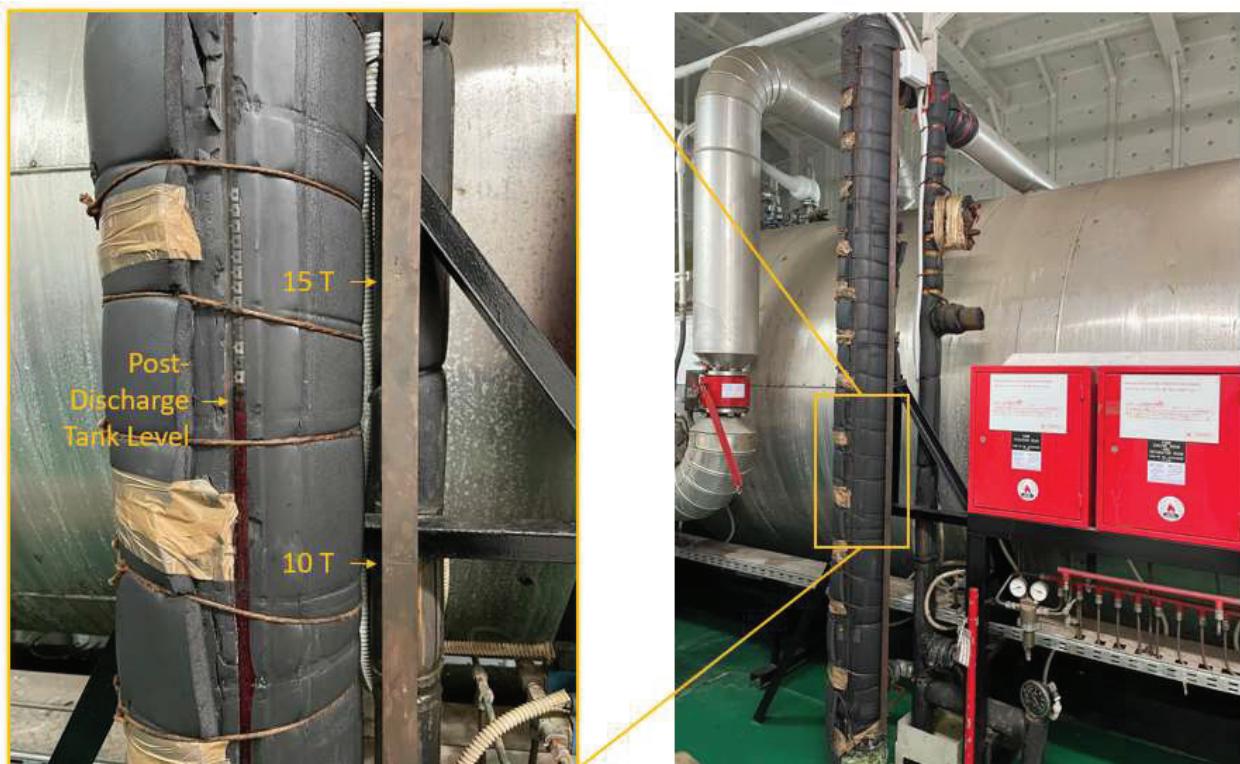
**5.11.3.1. System Performance.** Based on space volume and use, the system was designed to discharge approximately 30 metric tons of CO<sub>2</sub> into Fire Protection Zone C during a ten-minute period. A disparity in actual versus anticipated post-discharge tank level indicator readings called into question the actual quantity of CO<sub>2</sub> that the system released. The Chief Engineer, who activated the system and was present in the CO<sub>2</sub> Room during discharge, testified that the system released agent into Fire Protection Zone C for the full ten minutes as anticipated. However, he also testified that only 20 metric tons of CO<sub>2</sub> were discharged based on his reading of the tank level indicator after the ten-minute automated release concluded. On July 16, 2023, Coast Guard Investigators personally observed the CO<sub>2</sub> storage tank level indicator<sup>53</sup> showing that approximately 14 metric tons of CO<sub>2</sub> remained in the tank, as indicated by the red bar in the following Figure 20, corroborating the Chief Engineer's testimony.

Figure 20. Low-pressure CO<sub>2</sub> storage tank level indicator post-discharge. Developed by Coast Guard Investigators from photographs taken by the same on July 16, 2023.

This investigation later learned that a surveyor, acting on behalf of Grimaldi, observed the tank level indicator on July 13, 2023, at which time it showed a solid red bar up to approximately 14 metric tons like seen in Figure 20, but then a break and additional red bar above the 15 metric ton mark. Daily inspection records of

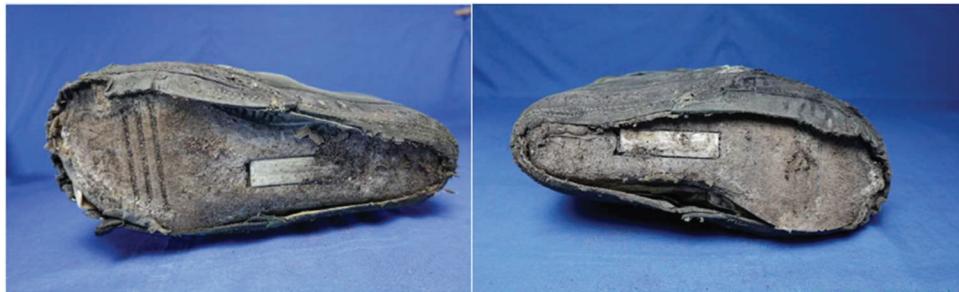
<sup>58</sup>It is this investigation's understanding that NFPA equipment testing standards do not address use of boots in the maritime environment, but the maritime environment includes such unique hazards and conditions that such standards may be necessary. In this case, the firefighter boots that failed had glued soles, which were likely impacted by the standing, near boiling salt water, on deck 12 from boundary cooling.

protection to continue in the fire response. Not recognizing his boot failure when Capt L-4 left the space and FF B on the line, the investigation believes that Capt L-4 anticipated that he would return and rejoin FF B. Regardless, Capt L-4 did not adhere to the “two-in, two-out” rule when he departed the space and doing so would have impacted the outcome of this incident.

Figure 21. Photographs of failed firefighter boots. Provided by NIOSH FFFIPP Investigator.

**Action:** I concur with the intent of the recommendation. After the vessel's crew took initial actions, evacuated the space, and discharged the fixed CO<sub>2</sub> system, NFD's further entry into the space placed firefighters and their equipment in a hazardous environment that should have been avoided. While equipment failure did occur, the primary causal factor for the loss of the two firefighters in this case was the lack of shipboard firefighting training by NFD personnel, not major differences in equipment standards. A USCG review of international firefighting boot standards indicates minor differences in testing standards. The USCG will provide those findings to the
