**REPORT OF THE INVESTIGATION  
INTO THE  
SINKING OF THE FISHING VESSEL  
MERRICK (CT1979BK) WITH THE  
SUBSEQUENT LOSS OF ONE LIFE, IN  
THE VICINITY OF MILFORD, CT, IN  
LONG ISLAND SOUND ON NOVEMBER  
4TH, 2024**

16732/IIA # 8031230  
March 13, 2026

**INVESTIGATING OFFICER'S REPORT**

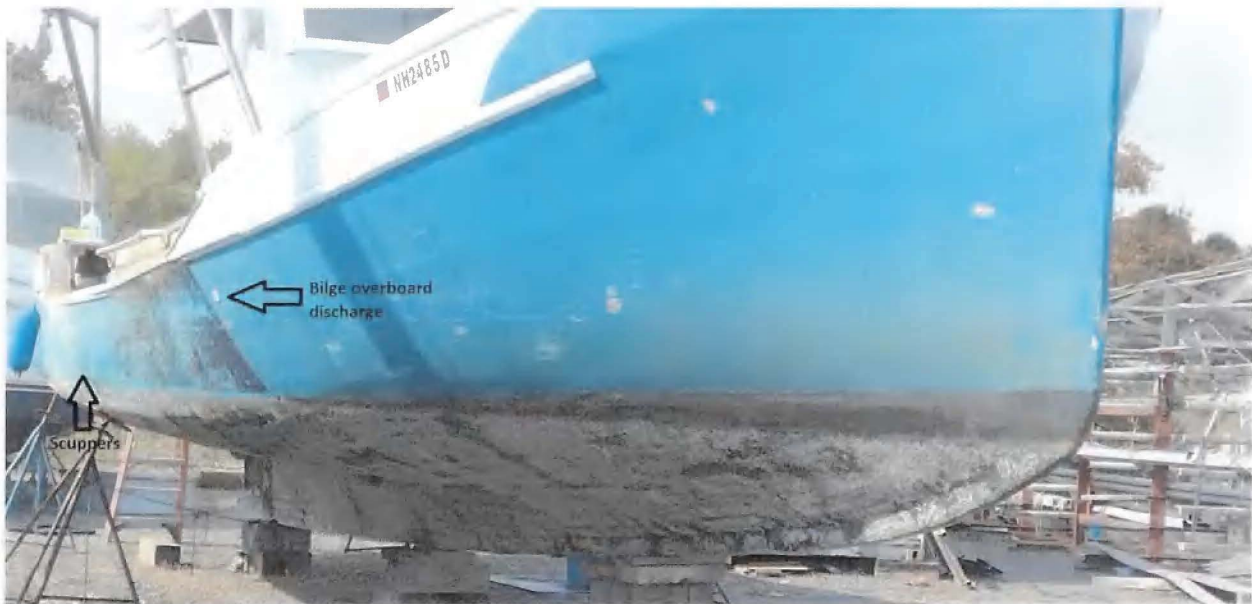
Figure 3. Undated photograph of MERRICK provided by Owner

4.2.8. The MERRICK was a NOVI-style commercial fishing vessel. The NOVI hull design originated in Nova Scotia and is typically recognized by its step-up bows, rounded bottom, and upturned sterns. The MERRICK displayed these characteristics and more. It had an open transom, low midships, and a closed keel cooler system. The wheelhouse was located forward of midships. The helm station was on the starboard side, inside the wheelhouse. The engine compartment was accessed via a hatch inside the wheelhouse on the port side. Just aft of the wheelhouse on the starboard side was a mounted davit and winch system for setting and retrieving the oyster dredge. The aft deck/work deck had three flush aluminum hatches along the centerline. The forward-most hatch was located just behind the wheelhouse and provided access to the primary bilge pump and high-water alarm (float switch). The bilge pump overboard discharge was located on the starboard side in the vicinity of the helm station. The middle hatch was located in the middle of the work deck and provided access to the shaft packing. The aft-most hatch was located close to the stern and provided access to the steering gear. The owner stated that he replaced all three hatch gaskets each year. There was a 100-gallon plastic fuel tank installed below the deck and located between the forward and middle hatches with the fill located on deck. There were two 2-inch scuppers on each side of the aft deck. The first set was located approximately midship, and the second set was approximately 12 inches aft of the first set.

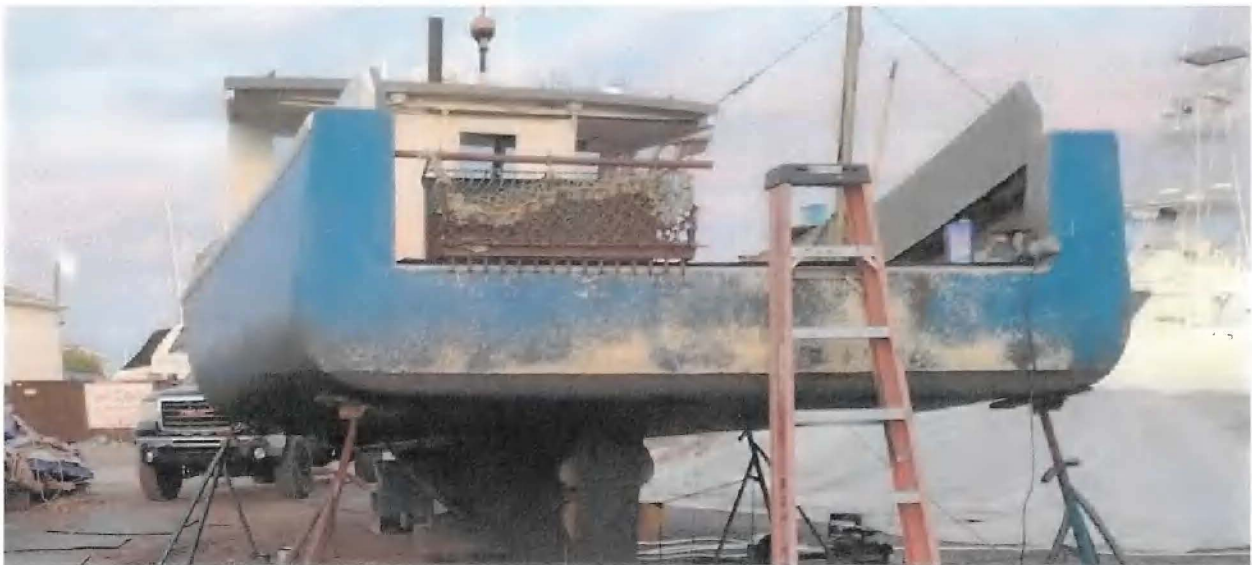
Figure 4. Undated photograph of MERRICK provided by Owner

4.2.8.1. The MERRICK was fiberglass-over-wood construction. The owner estimated 8 to 10 layers of fiberglass had been installed over the original wood hull prior to his purchase of the vessel. The owner described that the fiberglass did not continuously flow from the horizontal deck and up the inside of the gunwale, and over to the outside/shell hull. The fiberglass stopped approximately 18 inches up from the weather deck; exposing the wood structure of the inside rail.

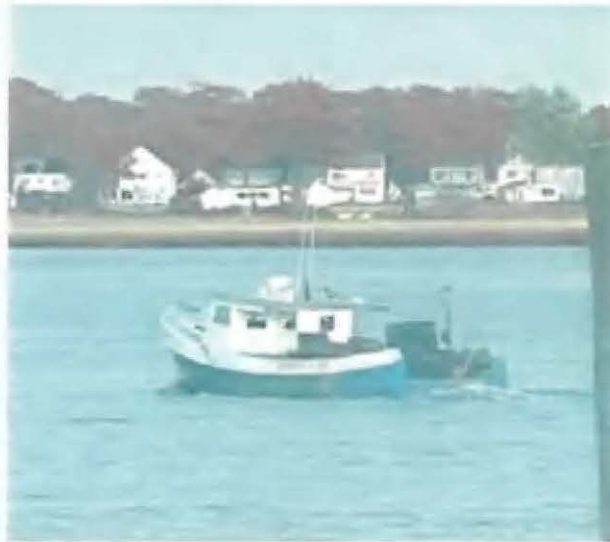
Figure 5. Undated photograph of MERRICK underway provided by Deckhand 1

5.2. The MERRICK was a NOVI-style fishing vessel and naturally sat low in the water at midships. Unloaded, the vessel displayed approximately four inches of freeboard below the deck scuppers at midships. The open stern had 4-6 inches of freeboard due to the vessel design (upturned stern).
