**REPORT OF THE INVESTIGATION
INTO THE
LOSS OF LIFE ABOARD THE RED STAG (O.N.
1251769) IN PORT FOURCHON, LA
ON OCTOBER 14, 2023**

**LOSS OF LIFE ONBOARD THE OFFSHORE SUPPLY VESSEL RED STAG
(O.N. 1251769) IN PORT FOURCHON, LOUISIANA ON OCTOBER 14, 2023**

INVESTIGATING OFFICER'S REPORT

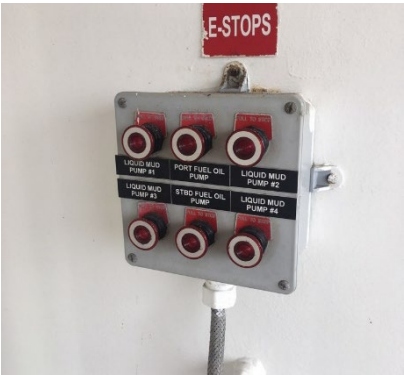
Figure 2. Aft deck emergency shut off. Taken on October 20, 2023.

4.1.2. At approximately 2000, the 1st Engineer leveled off the vessel using the mud pump system and secured the system by activating the emergency stop located on the aft deck. The system utilizes 480 volts for operation.

4.2.2. The mud pump system emergency stop was located on the aft deck. However, the system's only place of operation is located in the engine room, and lacked an audible or visual indicator to bring awareness when the emergency stop was activated.

4.2.3. Activation of the emergency stop cuts power to the mud pump but it does not cut power to the 480 volt panel. The emergency stop was still activated at the time of the incident with the Unqualified Engineer.

5.3. *Missing Visual or Audible Indicator of Emergency Stop Activation.* It is common for machinery installed onboard vessels to have indicators, whether visual, audible, or both, incorporated in the systems to alert crew members when an emergency stop has been activated. The intended purpose of the indicators is, first and foremost, to alert crew members of an emergency and secondly to make personnel aware the stop is activated and needs to be deactivated prior to use. It is reasonable to assume that if the mud pump system had a method to alert personnel when the emergency stop was in an activated state, the Unqualified Engineer would have been aware of the need to deactivate the emergency stop and not accessed the energized panel.

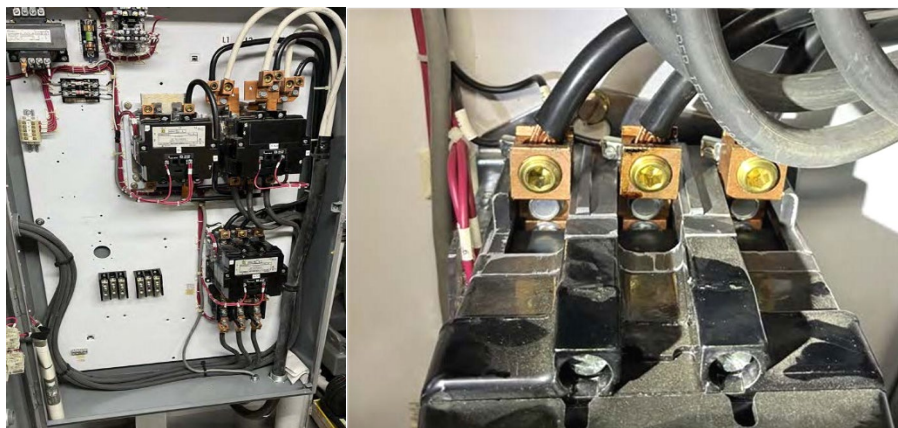
Figure 3. Inside of panel and high voltage conductor with fingerprints. Taken on October 14, 2023

4.1.7. The Unqualified Engineer opened the panel for the mud pump system and touched the high voltage conductors containing 480 volts.

4.1.12. On November 14, 2023, the Lafourche Parish Coroner's Office classified the manner of death as accidental, and the cause of death to be electrocution.

5.4. *Missing Locking Device on High Voltage Panel.* It is common practice to restrict access to machinery that pose hazards to personnel or the environment. Normally, this is done by an installing a locking device which the Master or highest-ranking engineer has the key and are the only crewmembers who can grant access to the equipment. It is reasonable to conclude that if a locking device was installed on the high voltage panel, the Unqualified Engineer would have had to notify the Master or 1st Engineer for access to the panel, which may have prevented the Unqualified Engineer from entering the panel unsupervised.

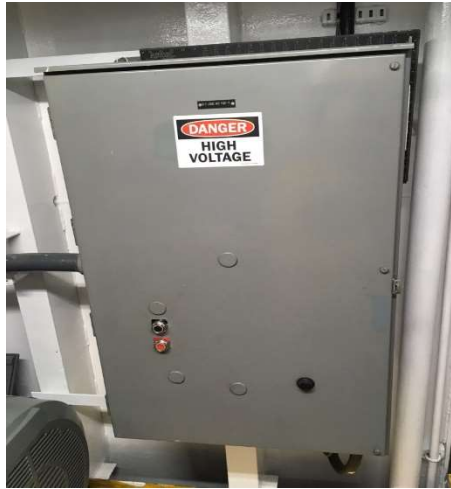
Figure 5. Mud Pump operation panel. Taken October 20, 2023

5.1. *Lack of Engineering Experience.* The mud pump systems installed on board Offshore Supply Vessels are equipped with an emergency stop, which is normally located on the aft deck, so that the crewmember using the system can secure the operation remotely, instead of requiring the operator to go to the engine room to secure the system. The emergency stop is activated when the button is pulled, opening the circuit, stopping the flow of electricity to the pump. To re-energize the pump, the circuit must be closed by pushing in the button. It is common practice on OSV's to secure the system utilizing this method. The Unqualified Engineer's lack of engineering experience with the electrical system may have led to his belief that the mud pumps suffered an electrical failure due to the open circuit created by the activated emergency stop. It is reasonable to assume that if the Unqualified Engineer was more experienced with the operation of the mud pump system, he may have verified the status of the pump's emergency stop and de-activated it, preventing him from having to open the 480 volt panel and prevented the incident from occurring.
