**REPORT OF THE INVESTIGATION  
INTO THE  
SEA MULE (NY6762HE) FALL OVERBOARD IN  
SMITH POINT COUNTY PARK CANAL WITH THE  
LOSS OF ONE LIFE ON NOVEMBER 18, 2022**

**FALL OVERBOARD AND SUBSEQUENT LOSS OF ONE LIFE INVOLVING  
THE UNINSPECTED TOWING VESSEL SEA MULE (NY6762HE) IN THE SMITH  
POINT MARINA COUNTY PARK CANAL NEAR SHIRLEY, NEW YORK  
ON NOVEMBER 18, 2022**

### INVESTIGATING OFFICER'S REPORT

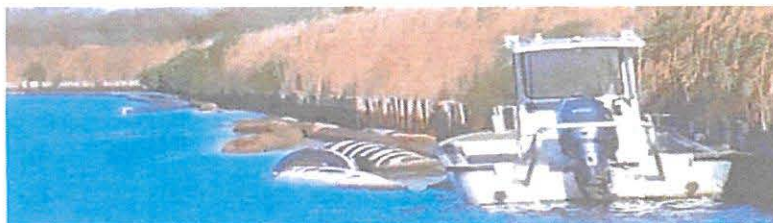
Figure 1. Photograph of SEA MULE (NY6762HE), Shirley, NY, taken November 19, 2022 by USCG

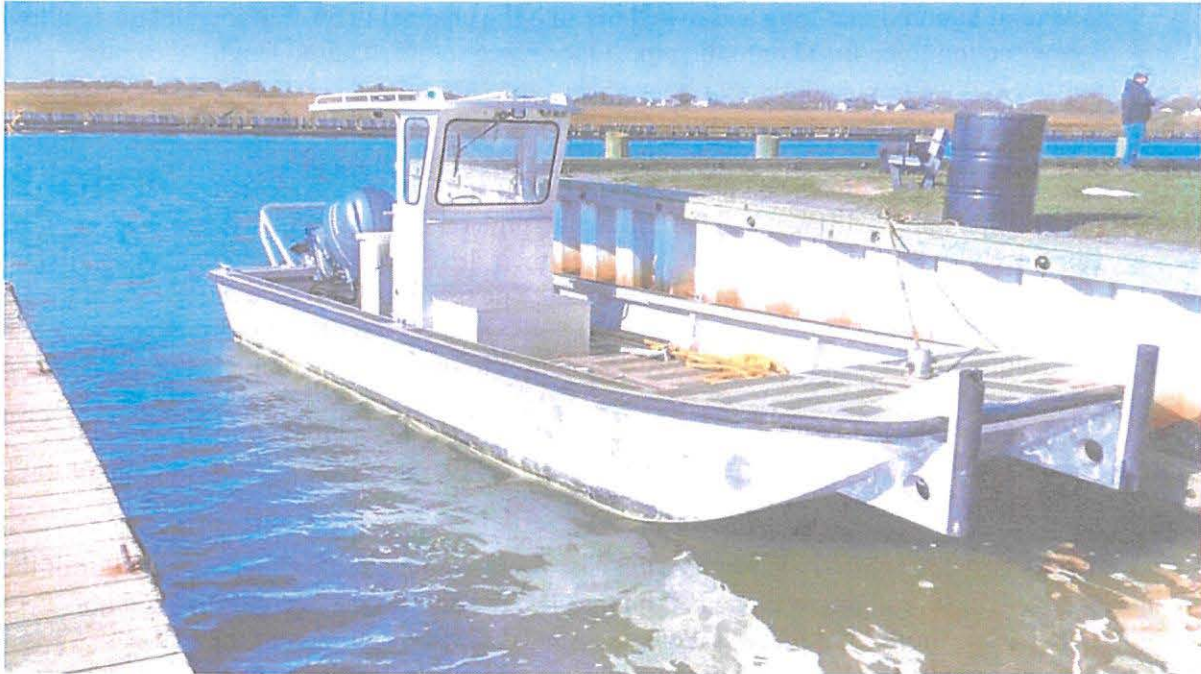
Figure 2. Photograph of SEA MULE (NY6762HE), Shirley, NY, November 19, 2022 by USCG

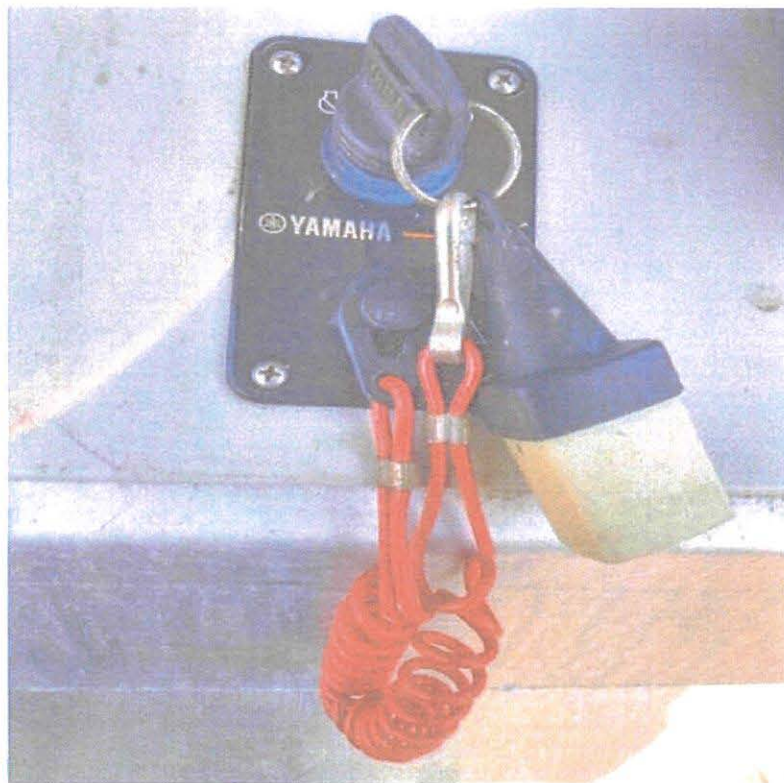
5.1. The SEA MULE operator failed to wear the engine safety ignition cutoff switch. The SEA MULE was equipped with an engine safety ignition cutoff switch. The safety device should be connected to the operator's clothing or lifejacket. Its purpose is to immediately shut down the outboard engine if the operator or helmsman becomes separated from the immediate vicinity of the controls. The SEA MULE was found with no persons onboard and the engine running with the engine safety ignition cutoff switch in place and attached to the ignition key chain. Had the engine cutoff been properly utilized, the engine would have automatically shut off once the operator left the vicinity of the controls. If the operator was in the water and able to swim, he could have returned to the vessel. Also, the injuries to the operator could not be definitively linked to a specific event or as a causal factor for the incident. If the operator was not injured in the fall overboard, it is possible that the vessel, moving in a circular pattern, came around and struck the operator. If the cutoff switch had been properly utilized, this course of events could have been ruled out.

Figure 3. SEA MULE engine safety ignition cutoff switch taken on November 19, 2022 by USCG

6.1.1.1.1. The SEA MULE operator did not attach the engine safety ignition cutoff switch to his clothing or life jacket. The engine safety ignition cutoff switch should have been properly secured to the operator's person to immediately shut down the engine if the operator left the helm.

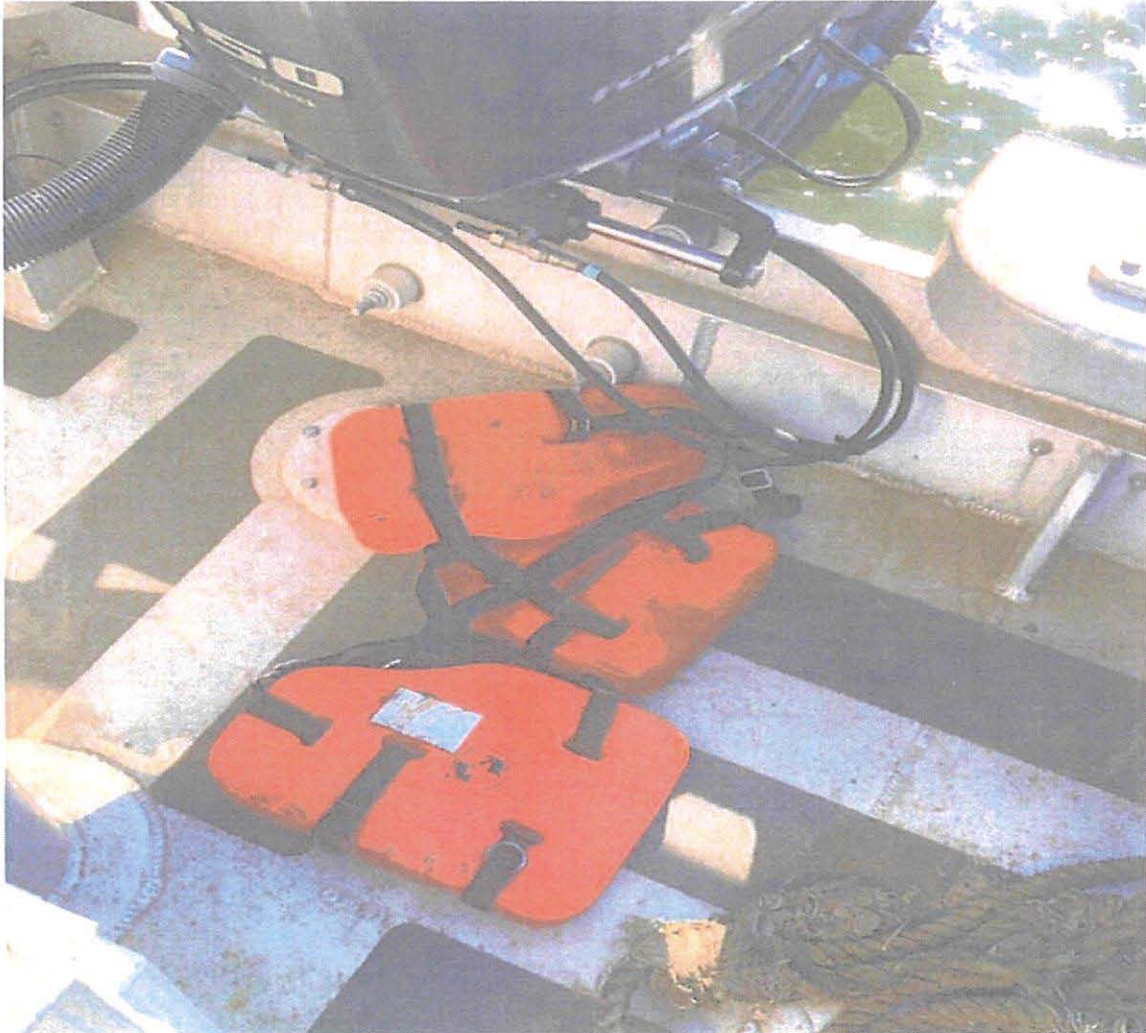
5.2. Failure to wear a properly outfitted lifejacket. Through the investigation, it was discovered that the vessel had two Type V PFDs that were work vests only. One was stowed amidship in the compartment forward of the center console. The second Type V PFD was found lying on the aft deck behind the seat and in front of the outboard engine. Coworkers did not notice the SEA MULE operator's absence until 45- minutes to an hour after the SEA MULE operator towed the dredge pipe into the canal. If the SEA MULE operator had been wearing a properly donned life jacket or work vest, he may have been able to stay afloat and visible long enough to swim to shore or long enough for his coworkers or good Samaritans to find him before he drowned.

Figure 4. Picture of Type V PFD found on SEA MULE aft deck taken on November 19, 2022 by USCG

5.2.2. The work vest PFD in the amidship compartment was a PFD that stayed onboard the SEA MULE. The Work Vest PFD that was found on the aft deck was a work vest PFD that the SEA MULE operator removed from the onshore storage shack. The shack housed a Type III PFD and a Type V PFD work vest. The PFDs were not assigned to individuals. The operator removed the Type V PFD from the shack and brought it to the SEA MULE.

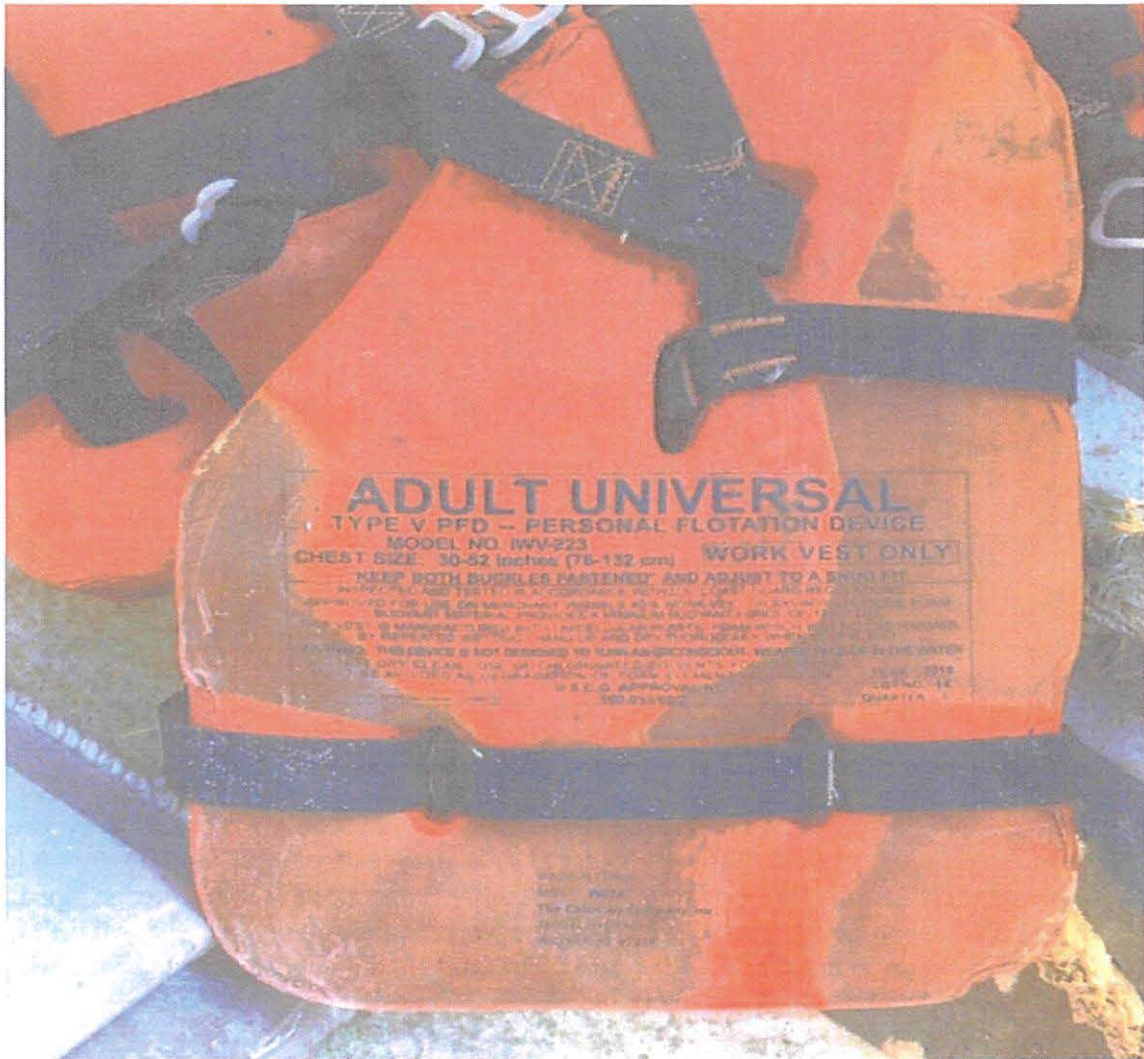
Figure 5. Picture of Type V PFD found on SEA MULE aft deck taken on November 19, 2022 by USCG

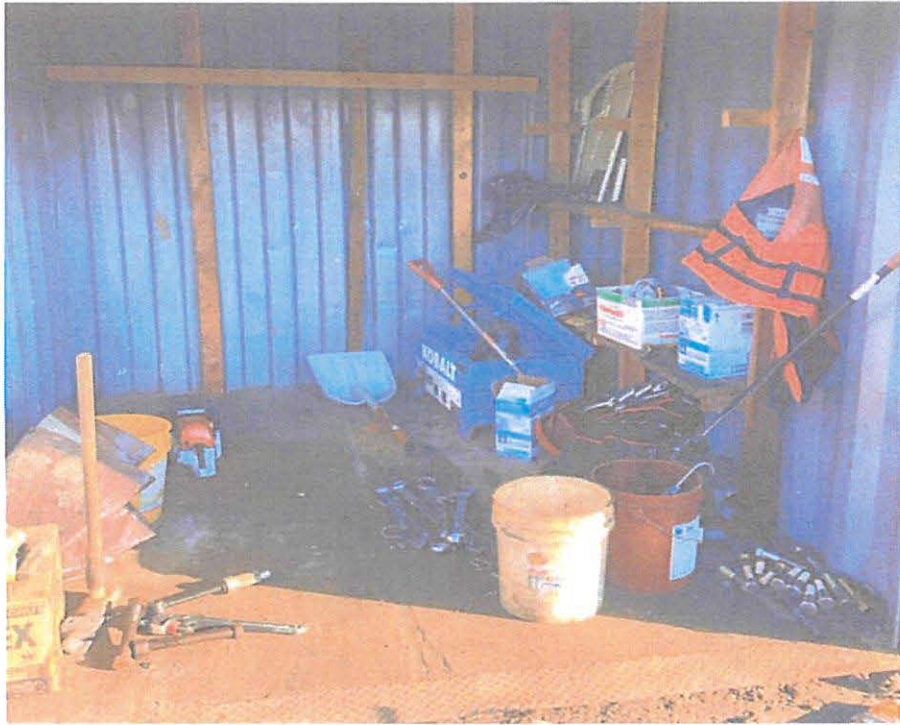
Figure 5. Picture of the storage shack onshore at work site taken November 19, 2022 by USCG

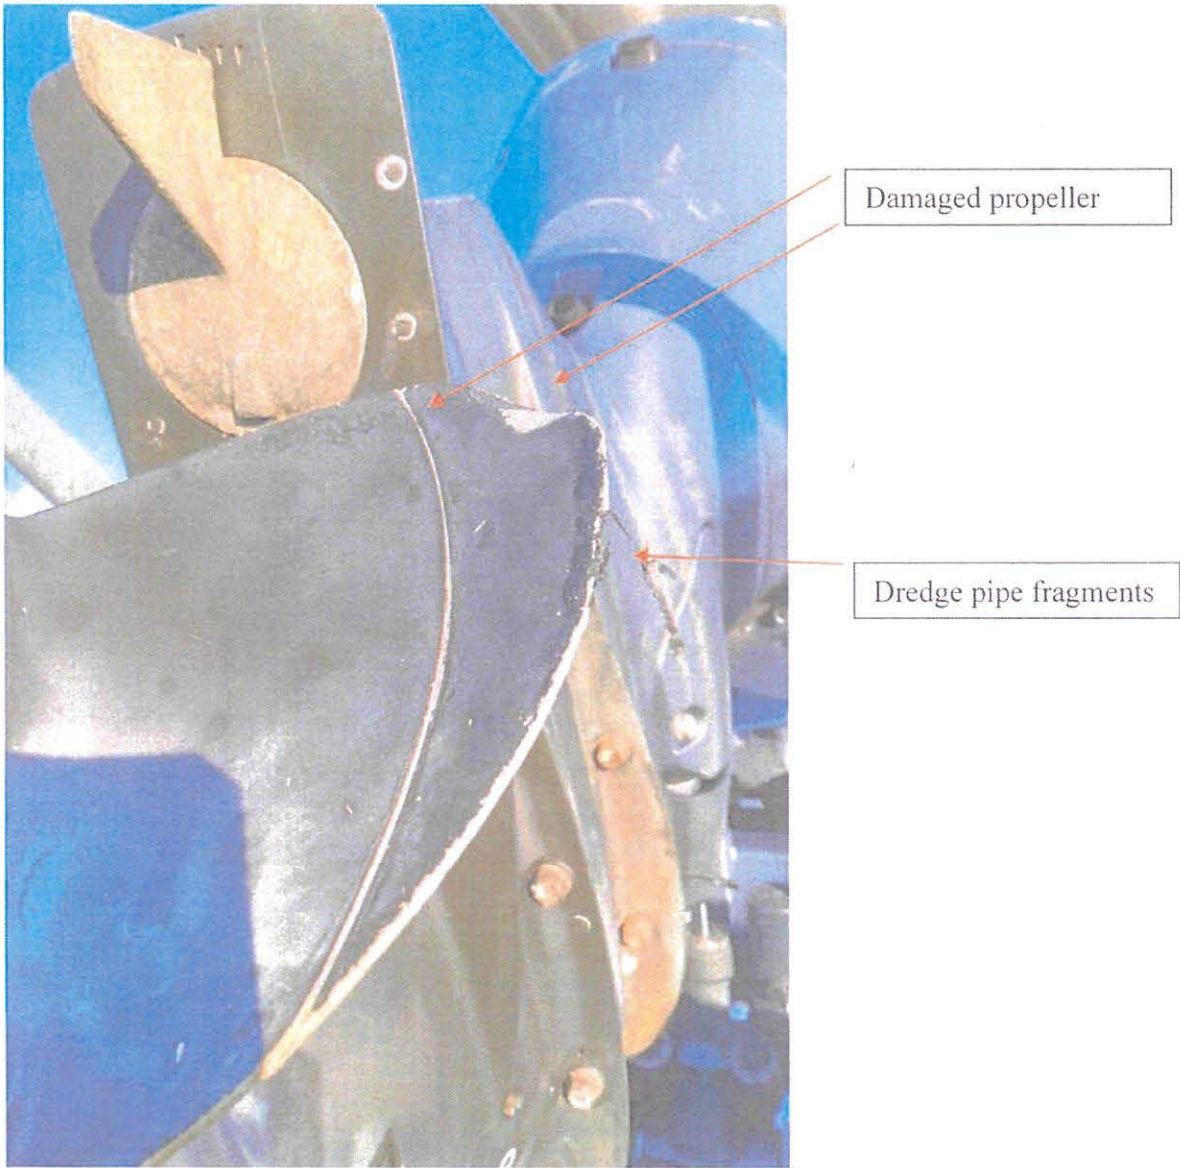
5.4. Damage Analysis: there was evidence on the SEA MULE's propeller that the propeller blade struck at least one submerged object and one of the objects was a dredge pipe. There was evidence of impact damage to the vessel's hull near the bow. However, it is not known if the damage was the result of a previous strike, a strike that resulted in the SEA MULE operator falling overboard or occurred after the SEA MULE operator fell overboard. It is also not possible to determine if the SEA MULE struck a dredge pipe while the operator was onboard or after the operator fell overboard since the vessel was found in the vicinity of staged dredge pipe. Before the SEA MULE arrived at the work site the week prior, the propeller had no known damage.

Figure 6. Photograph of SEA MULE propeller taken December 1, 2022 by USCG

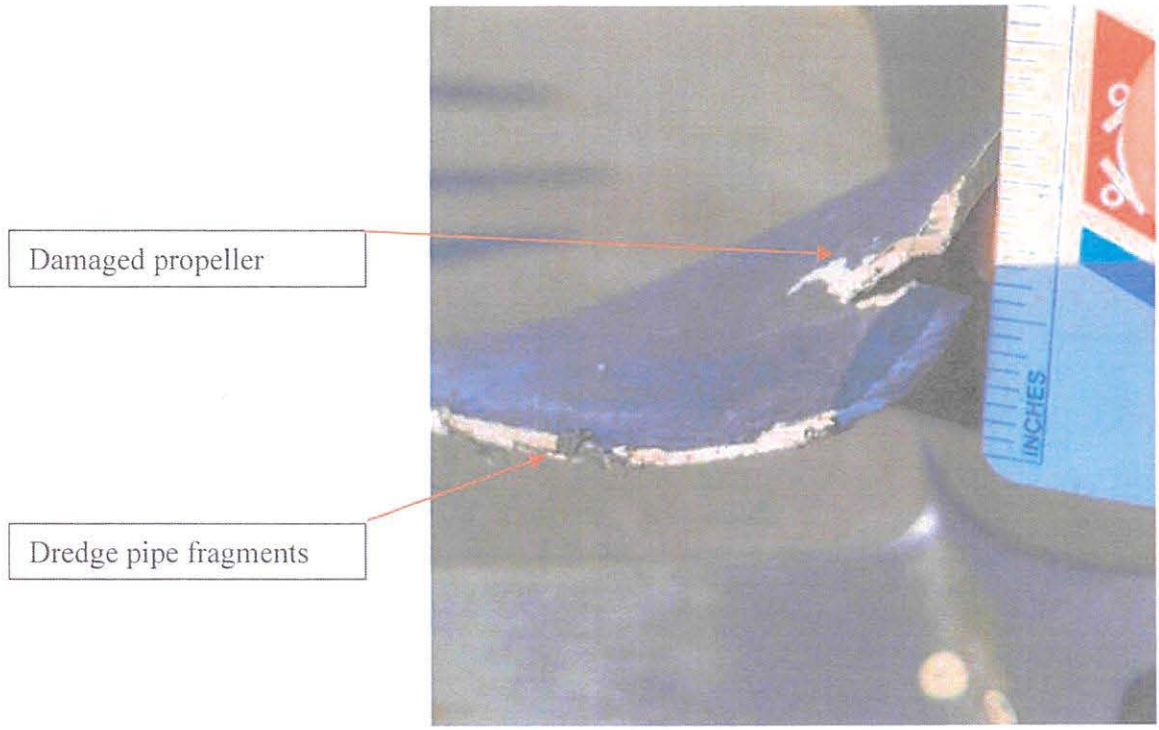
Figure 7. Photograph of SEA MULE propeller taken November 19, 2022 by USCG

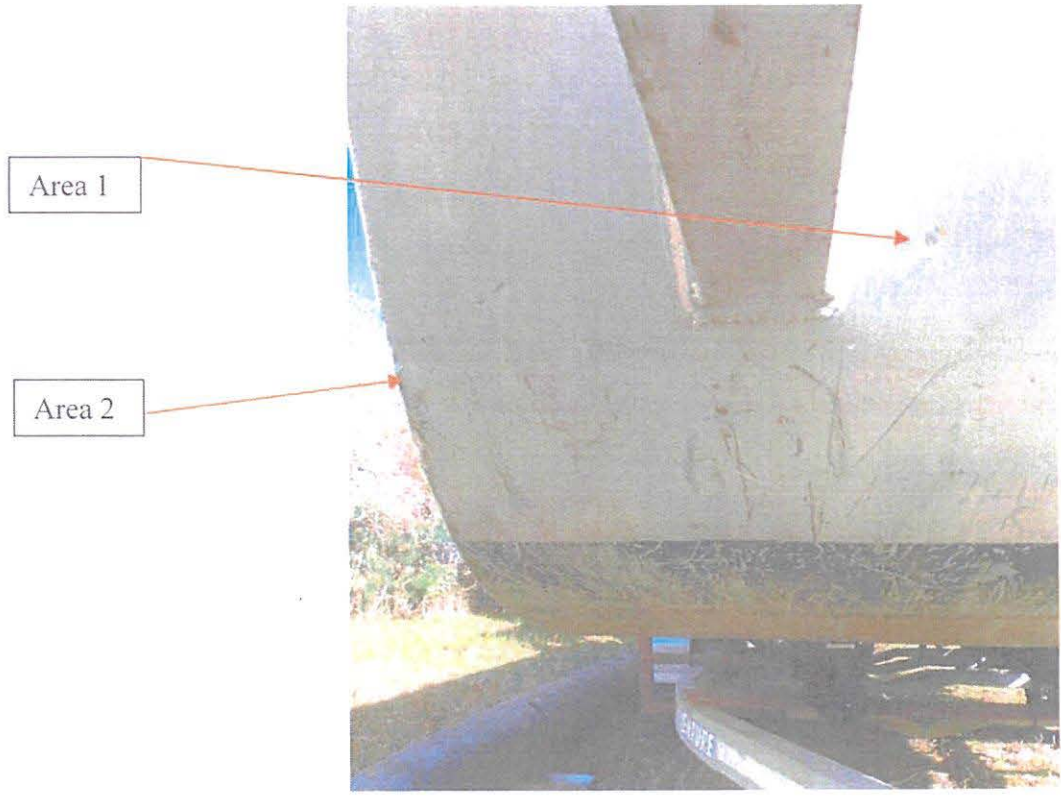
Figure 8. Photograph of SEA MULE damaged bow taken December 1, 2022 by USCG

The boat was seen going counterclockwise, then beached on the east side of the canal facing north, with the throttles fully engaged, the engine turned to the left, and the bow and propeller damaged. Underwater searches in the area the next day identified various debris throughout the canal. Therefore, it is presumed that the operator struck a submerged object in the water which damaged the bow and propeller and possibly turned the engine. This sudden movement jolted the operator forward and onto the throttles thrusting the vessel forward quickly. The sudden surge of the vessel contributed to the operator losing his balance and falling overboard. The operator was not wearing the engine safety ignition cutoff switch which would have disabled the engine if the operator left the helm which is why the SEA MULE kept moving. The SEA MULE, with its engine turned left and throttles engaged, continued in a counterclockwise movement until the vessel struck pipes on the east bank of the canal and stopped. This position is where the vessel was found.

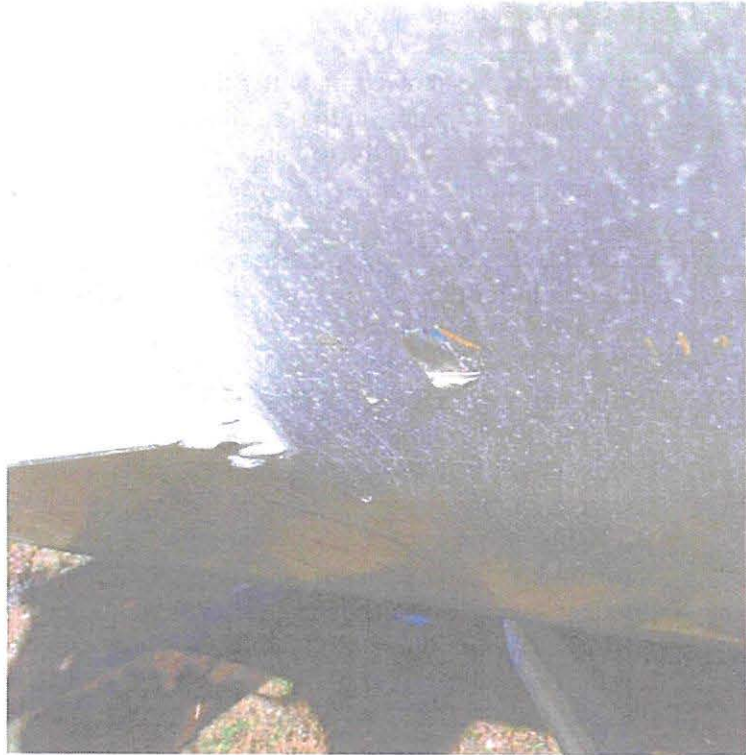
Area 1

Figure 9. Photograph of SEA MULE damaged bow taken December 1, 2022 by USCG

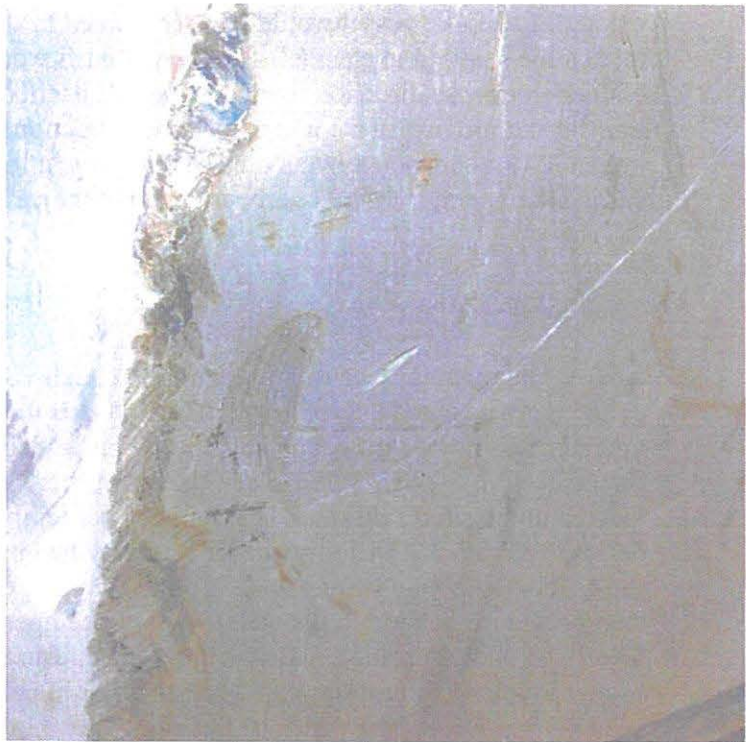
Area 2

Figure 10. Photograph of SEA MULE damaged bow taken December 1, 2022 by USCG
