**REPORT OF THE INVESTIGATION  
INTO THE  
ASSISTANCE TOWING VESSEL CAJUN  
SPECIAL (LA7706BC) CAPSIZING AND LOSS  
OF LIFE IN THE PORT ISABEL TURNING BASIN  
ON FEBRUARY 24, 2018**

**THE CAPSIZING AND SUBSEQUENT LOSS OF LIFE ON THE ASSISTANCE  
TOWING VESSEL CAJUN SPECIAL (LA7706BC) IN THE PORT ISABEL  
TURNING BASIN (TEXAS) ON FEBRUARY 24, 2018**

### INVESTIGATING OFFICER'S REPORT

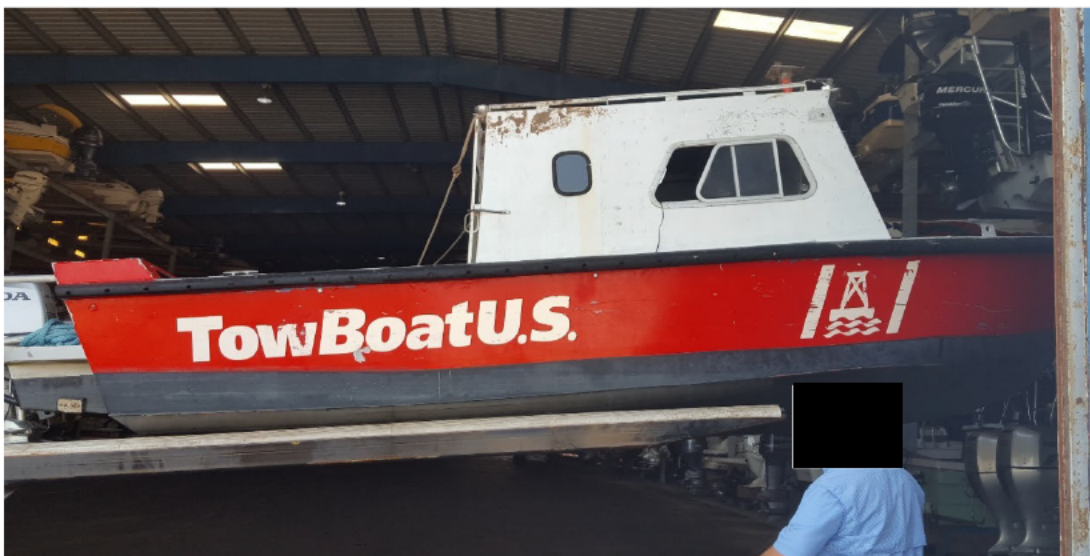
Figure 1. Starboard aspect of the CAJUN SPECIAL in a dry storage facility. (February 26, 2018/USCG)

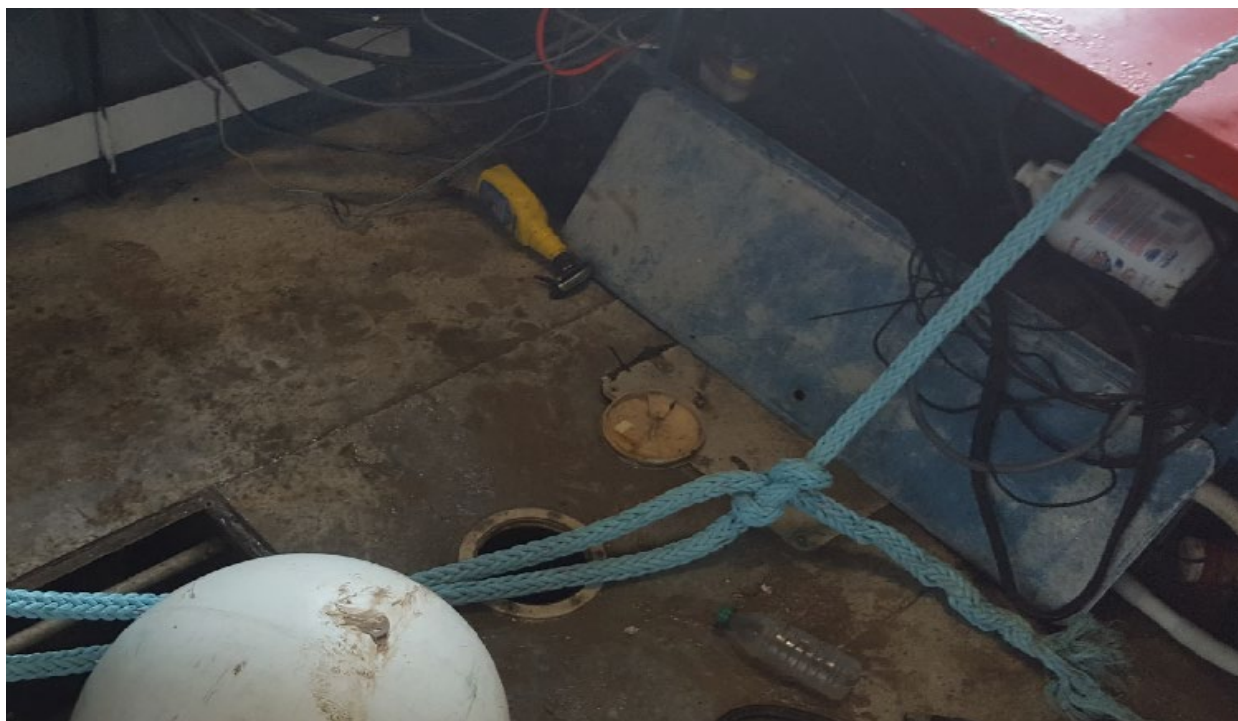
4.1.7. At 1646, after making up the now severed towline to the tow bridal, the Master made another attempt to pull the sailing vessel free. As she came up hard on the throttles, the CAJUN SPECIAL turned slightly to left before banking hard to the right as it came to the end of the towline. The CAJUN SPECIAL then rolled violently to right and capsized, throwing the Crewmember who was standing on the bow of the vessel into the water. The Crewmember was able to swim to and board the grounded sailboat. However, the Master was unable to escape from the capsized CAJUN SPECIAL wheelhouse.

Figure 2. Towing bridle coming from top of wheelhouse, with severed line, coming over the stern of the vessel, tied to it. Photo taken after vessel was salvaged. (February 27, 2018/USCG)

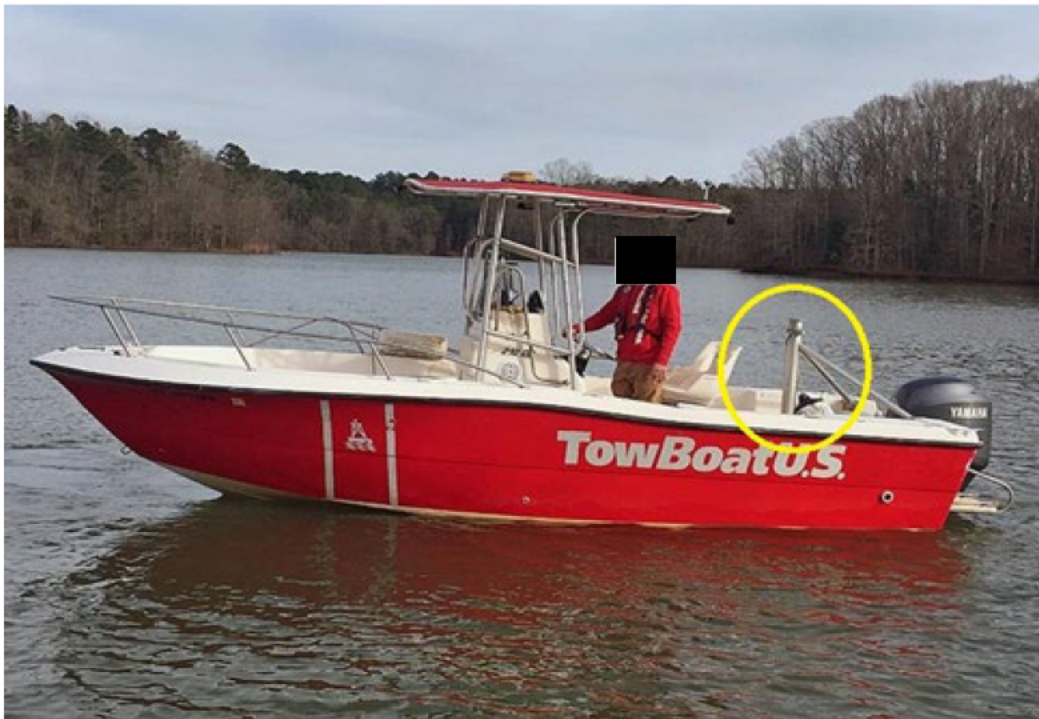
4.2.15. The CAJUN SPECIAL did not utilize a standard tow configuration as seen in *Figure 3* below. An example of a standard tow configuration would be a tow post, permanently affixed on the centerline of the vessel, as far aft and low as practicable; this configuration is important as this point is where all the force is exerted on the tow vessel. The designed tow configuration for the CAJUN SPECIAL included a bridal made off to port and starboard handrails on top of the wheelhouse and a line tied off to port and starboard cleats, which was used as a fairlead to bring the towline down to the transom and lower the center of gravity. However, during this evolution, the tow line bypassed the fairlead and was tied off directly to the bridal on top of the wheelhouse as seen in *Figure 4* below. In addition, the Owner did not have any written procedures for his employees to follow when providing assistance towing.

Figure 3. Example of standard tow configuration for assistance towing. The yellow circle shows the specific point of hook-up for the towing line. (December 12, 2018/Google)

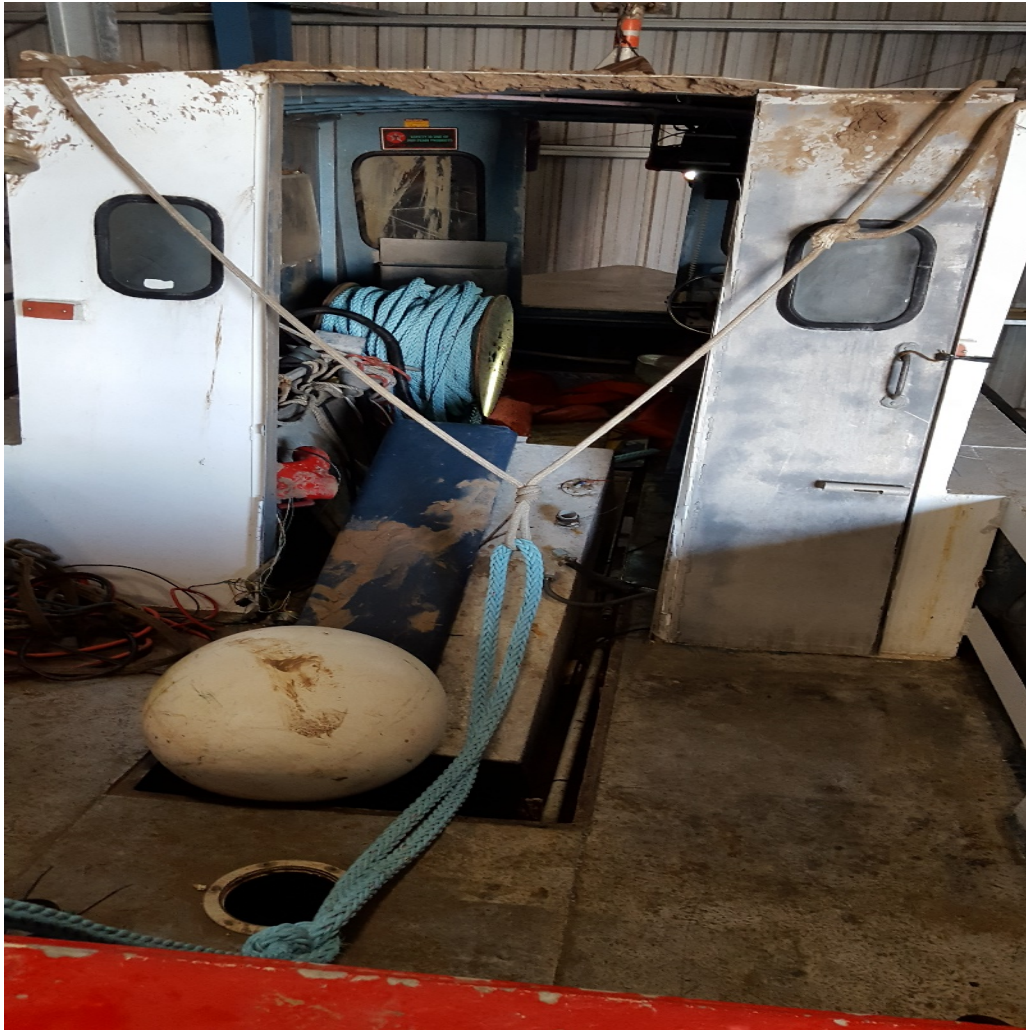
Figure 4. CAJUN SPECIAL's towline configuration as it was on the day the incident occurred. Photo taken after salvage of the vessel. Tow bridle is attached to handrails on top of wheelhouse. The blue towline goes aft over the transom (stern) of the vessel and should be under a fairlead (line) that is attached to cleats on the port and starboard aft gunwales to bring the towline low. The fairlead was missing. (February 26, 2018/USCG)

5.5. *Failure of the CAJUN SPECIAL Owner to comply with OSHA Act of 1970, Section 5.* The Vessel Owner, as an employer, also failed to supply the Operator with a properly outfitted towing vessel to be able to perform safe towing in all situations. The fact that the Operator was using a line made up to the highest point of the vessel when placing another

vessel in tow, significantly altering the stability, demonstrated the Owner's unwillingness to properly outfit the vessel for safe towing. Additionally, the Vessel Owner failed to properly maintain vital systems crucial to the safe operation of the vessel. The vessel's steering system was found to be approximately 5.7 ounces low in steering fluid. During tests conducted by USCG Investigating Officers, Vessel Inspectors and witnessed by the Owner along with his attorney, it was found that the boats wheel needed to be turned approximately 1.5 times before the steering ram began to respond. When the ram was fully cycled from hard Port to hard Starboard it took approximately 10 turns of the boats wheel to fully swing the motor. Once steering fluid was filled to the correct capacity and air bled out of the system, the steering ram and response was almost immediate. Turns of the boat's wheel to fully cycle the steering ram from hard Port to hard Starboard was reduced to approximately 6 turns. According to the engineers with SeaStar Solutions, the manufacturer of the steering components, a 5.7 ounce loss of fluid is considered a "substantial amount," in this vessel's specific steering system set up. As stated by the manufacture's engineer, "when just 6.6 ounces of fluid is absent, steering control is essentially lost." A previously employed captain of this vessel complained about the condition while towing another disabled vessel where the CAJUN SPECIAL lost complete steering in the middle of the towing operation. Additionally, the Crewmember the Owner hired to assist the Master with guiding the vessel to the grounded vessel needing assistance had no experience with providing assistance towing nor had he ever been aboard the CAJUN SPECIAL prior to the incident. His only experience on vessels was having served as a deckhand on charter fishing vessels in the local area. The use of a second person on the vessel, also with no training pertaining to the job at hand, further exacerbated the unfolding situation.

5.9. *Ineffective Towing Setup on the CAJUN SPECIAL.* At the time of the incident, the towing configuration on the vessel consisted of a 1 inch line serving as a bridal made up to the handrails on top of the wheelhouse. The Owner stated that the designed tow configuration for the CAJUN SPECIAL included a bridal made off to port and starboard handrails on top of the wheelhouse and an additional line tied off to port and starboard cleats that was used as a fairlead to bring the towline down to the transom and lower the center of gravity. The vessel was found with this fairlead not in place at the time on the capsizing. Although the Owner stated that he verbally instructed the Master via cell phone of the importance of utilizing this second line, it is unlikely that she did due to a witness stating that on the first pull on the grounded vessel, they saw the spool of line jerk straight up off of the deck almost level to the top of the wheelhouse.
