**REPORT OF THE INVESTIGATION
INTO THE
COLLISION BETWEEN CGC WINSLOW GRIESSER
(WPC-1116) AND COMMERCIAL FISHING VESSEL
DESAKATA WITH LOSS OF LIFE OFF THE COAST OF
DORADO, PR AUGUST 8TH, 2022**

**THE COLLISION BETWEEN U.S. COAST GUARD CUTTER WINSLOW GRIESSER
(WPC-1116) AND COMMERCIAL FISHING VESSEL DESAKATA WITH THE LOSS
OF ONE LIFE OFF THE COAST OF DORADO, PUERTO RICO ON AUGUST 8, 2022**

INVESTIGATING OFFICER'S REPORT

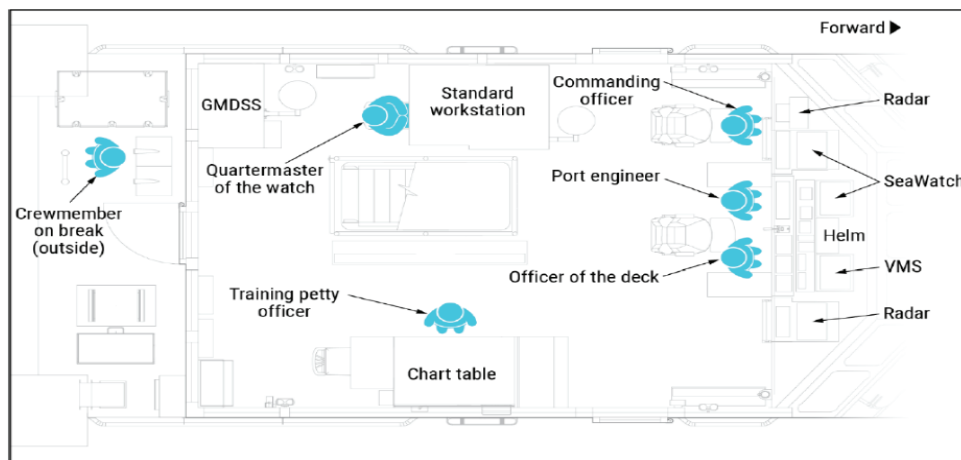
3.1.13. See the diagram below for the crewmembers' position on WINSLOW GRIESSER at the time of the collision:

Figure 4. WINSLOW GRIESSER's crew positioning at the time of the collision. (Source: NTSB Report MIR-23-14)

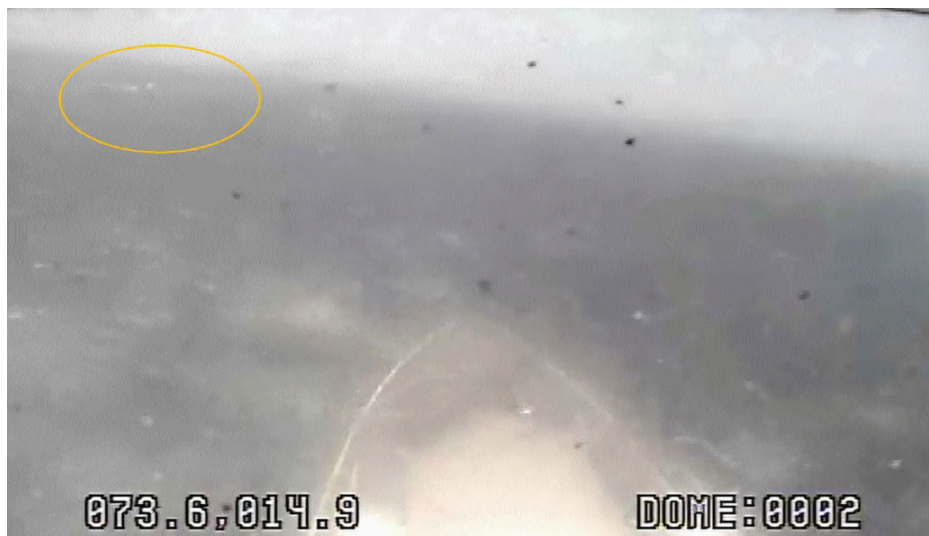
3.1.19. At approximately 1409, DESAKATA was 309 yards off the port bow of WINSLOW GRIESSER, and after 4 seconds it disappeared below the trough of the wave. DESAKATA's crew was talking and setting up the lines as they were heading to the FAD. DESAKATA's operator was sitting on the starboard side operating the vessel and the crewmember was sitting on the portside.

Figure 5. DESAKATA as recorded from the WINSLOW GRIESSER's salt encrusted mast camera at 1416:53, 19 seconds before collision. (Source: Coast Guard)

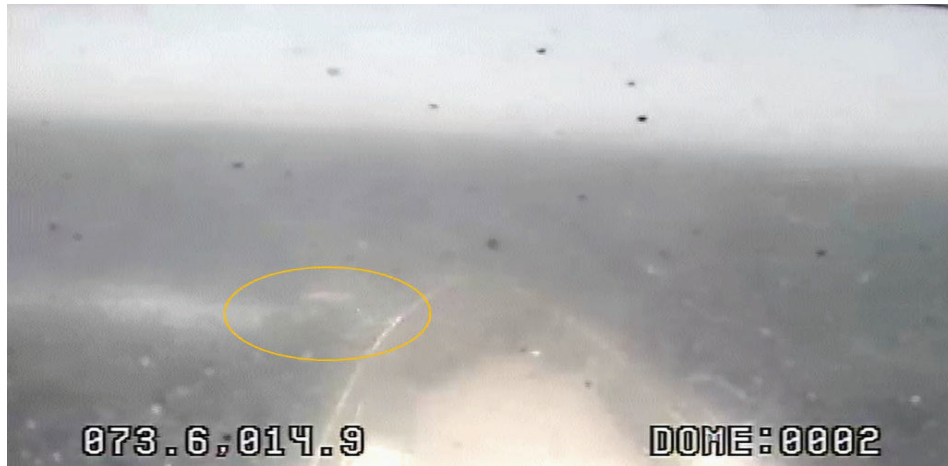
3.1.20. At approximately 1410, DESAKATA reappeared at WINSLOW GRIESSER port bow nearly 120 yards and remained visible until impact at 1410:13.

Figure 6. DESAKATA as recorded from the WINSLOW GRIESSER's salt encrusted mast camara at 1417:12, immediately before collision. (Source: Coast Guard)

3.1.21. At approximately 1410, DESAKATA had WINSLOW GRIESSER on their starboard side and WINSLOW GRIESSER. DESAKATA didn't clear WINSLOW GRIESSER's bow. The two crewmembers of the vessel DASAKATA were ejected from their vessel and injured.

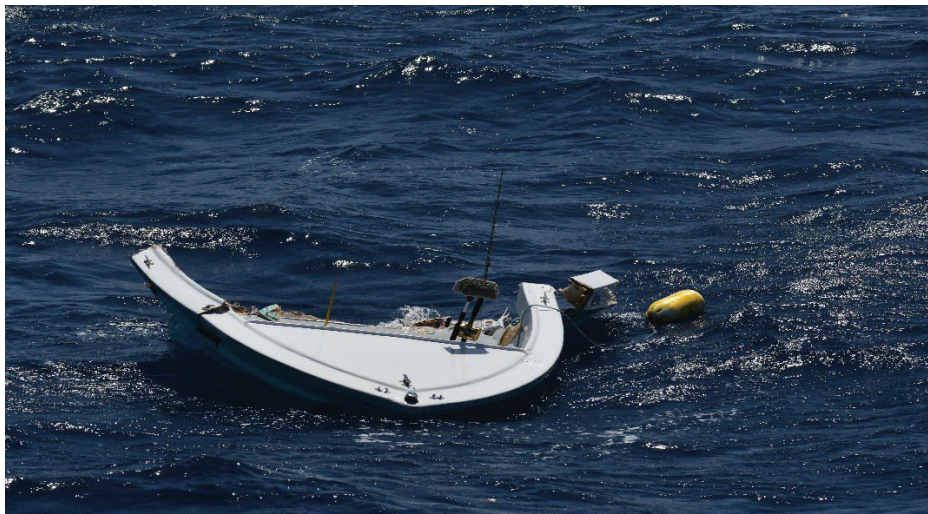
Figure 7. DESAKATA's bow section adrift immediately after collision. (Source: Coast Guard)

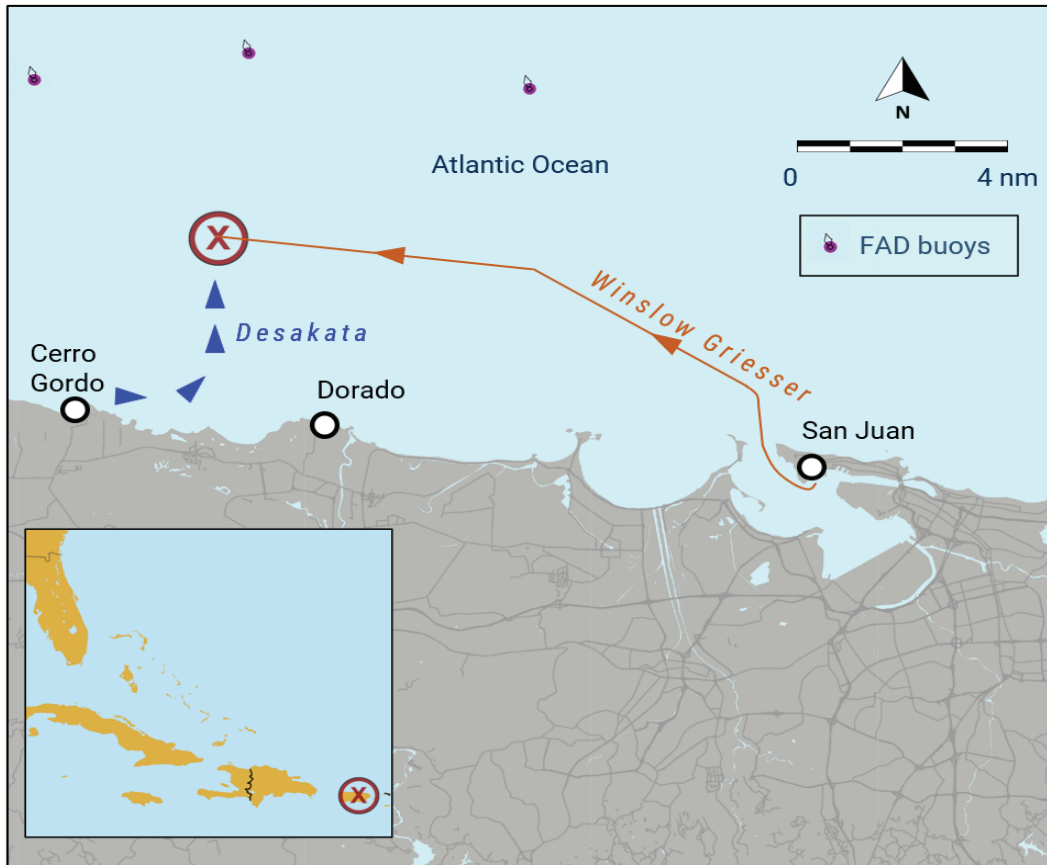
Figure 8. Area where WINSLOW GRIESSER and DESAKATA collided, as indicated by the red X. DESAKATA's trackline is approximate. (Source: NTSB Report MIR-23-14)

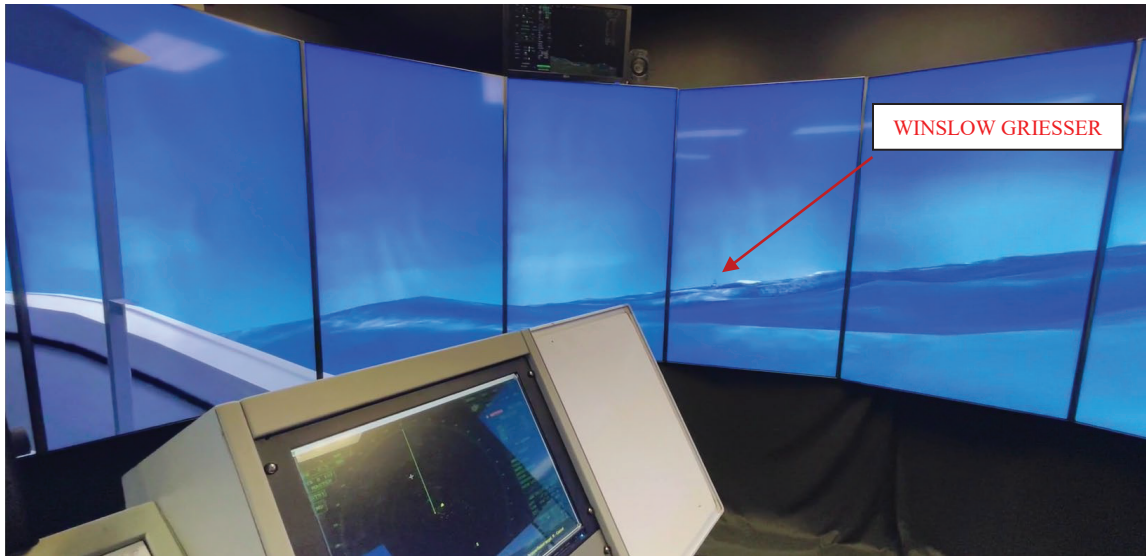
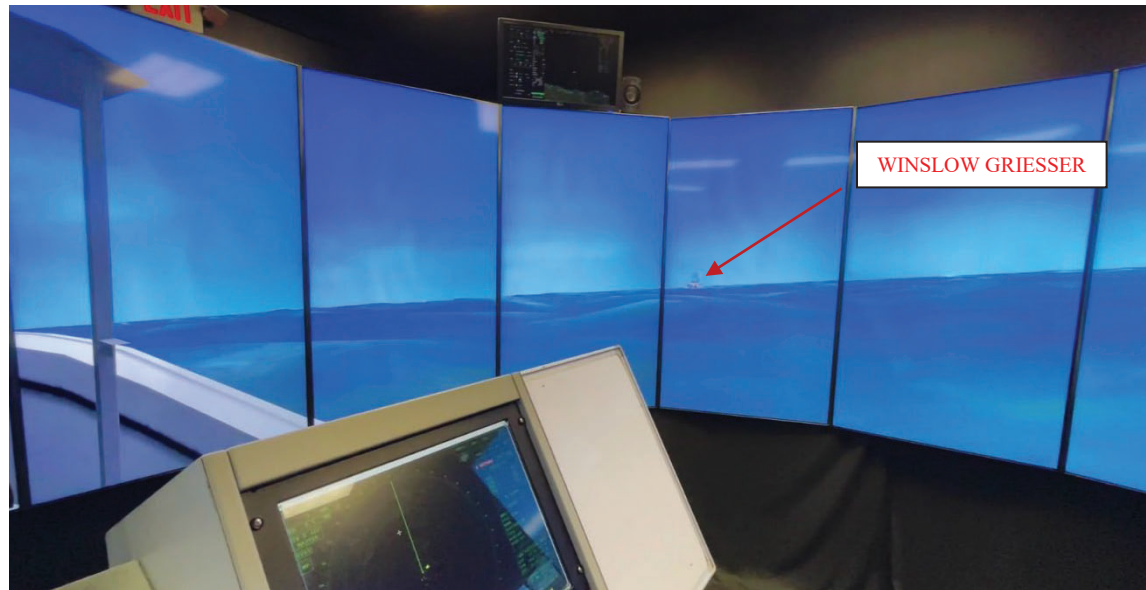
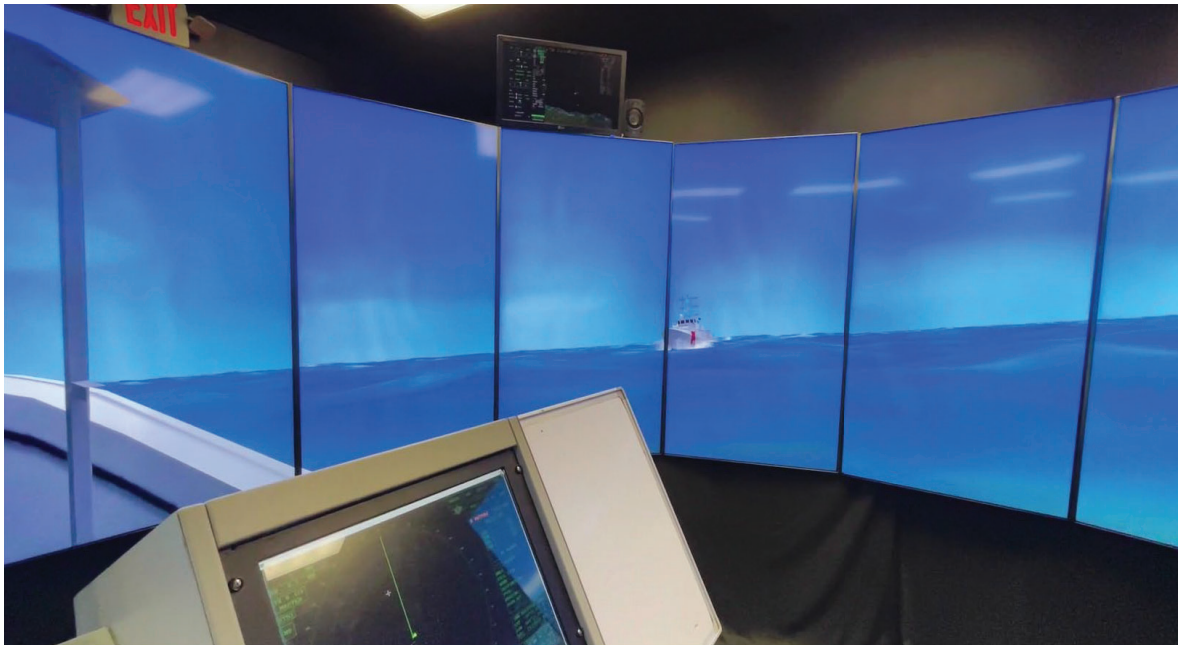
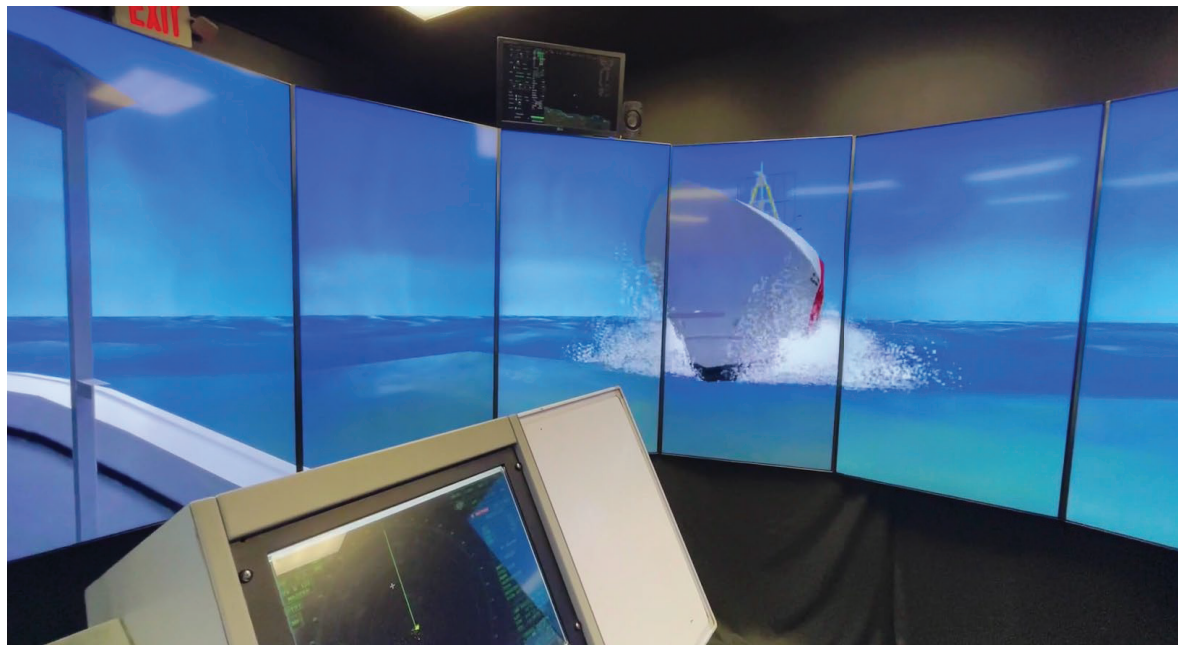
4.1.1. The investigation revealed DESAKATA was the give-away vessel in a *Crossing Situation under Rule 15* with WINSLOW GRIESSER. DESAKATA had WINSLOW GRIESSER on her starboard side and should have kept out of the way and avoided crossing ahead. Additionally, DESAKATA had the responsibility to actions to *Avoid Collision under Rule 8* and maintain a proper *Look-out* under Rule 5.

Figure 12. DESAKATA's view from the center console on a simulation voyage of the day of the incident. (Source: Coast Guard)

In the simulation and from the view of DESAKATA, WINSLOW GRIESSER's superstructure was barely visible at approximately 1500 yards. At 1000 yards, WINSLOW GRIESSER is more recognizable as another vessel, but occasionally dips below the crest of a wave. At 800 yards, WINSLOW GRIESSER is fully visible for the remainder of the scenario.

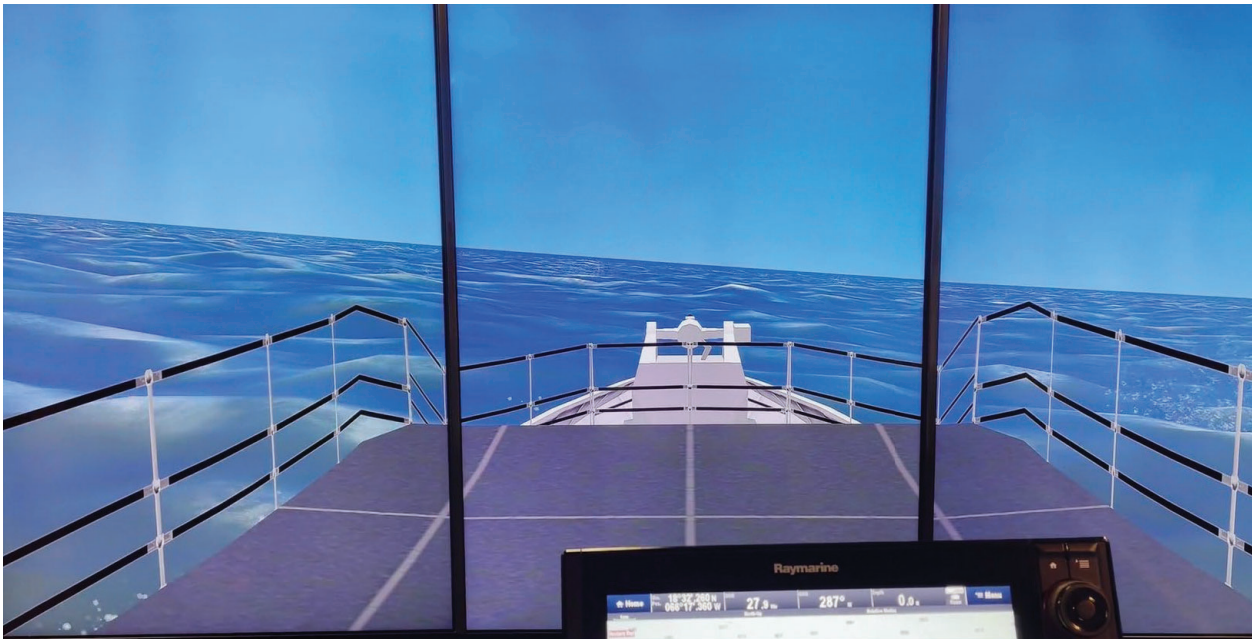
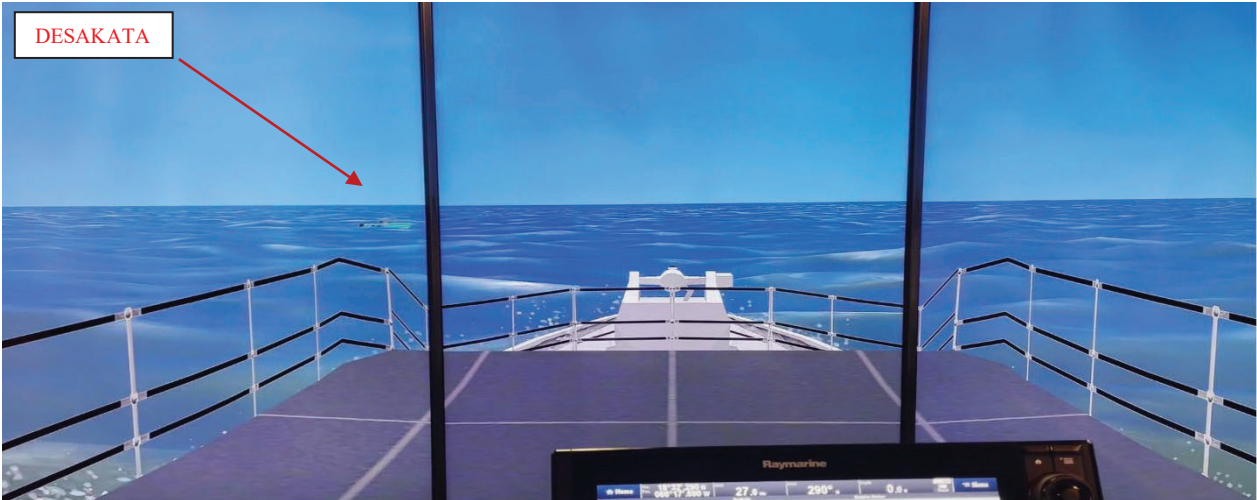
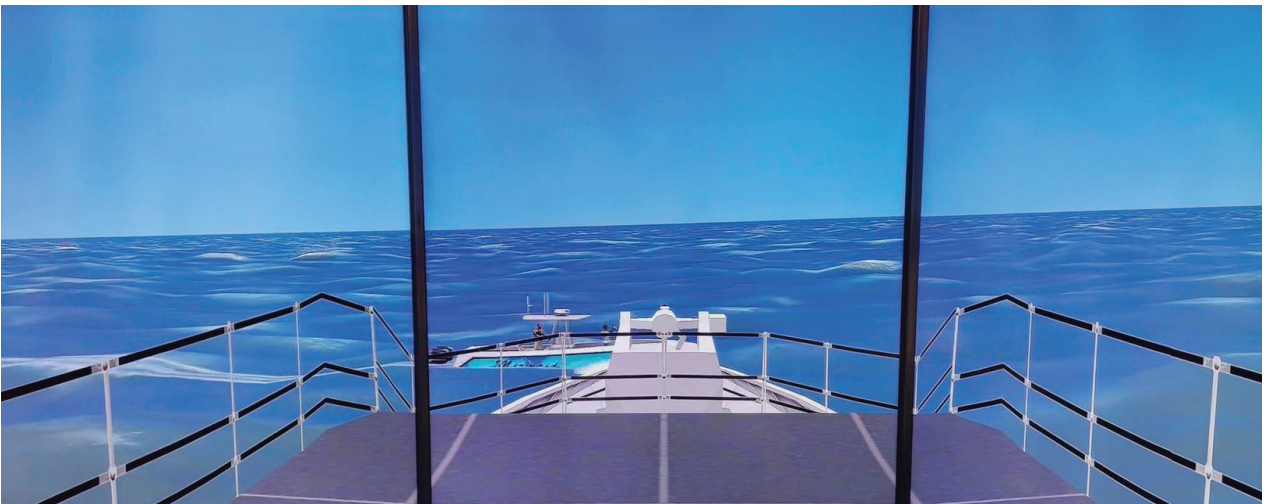
- 4.1.2 The investigation revealed WINSLOW GRIESSER failed to maintain a proper *Look-out* under Rule 5. Additionally, WINSLOW GRIESSER failed to maintain *Safe Speed* under Rule 6. If WINSLOW GRIESSER would have a proper Look-out and maintained a safe speed it would have enabled the crew to take the necessary action to avoid collision.

Figure 16. WINSLOW GRIESSER's view from the bridge on simulation of the voyage of the day of the incident. Source Coast Guard)

Figure 17. WINSLOW GRIESSER's view from the bridge of DESAKATA on a simulation of the voyage of the day of the incident. (Source:

Coast Guard)
Figure 18. WINSLOW GRIESSER's view from the bridge of DESAKATA before the collision on a simulation of the voyage of the day of the incident. (Source: Coast Guard)

In the simulation and from the view WINSLOW GRIESSER's bridge, DESAKATA would appear and disappear at approximately 1200 yards. DESAKATA would appear and disappear at 1200 yards. At approximately 600 yards, DESAKATA mostly remains visible, but it dips below the swell until approximately 300 yards.
